PlanGrid Task Report - Sep 25, 2024

L05649_Blairs Ferry Rd FSU (IA)

3241 Blairs Ferry Road Northeast, Cedar Rapids, Iowa

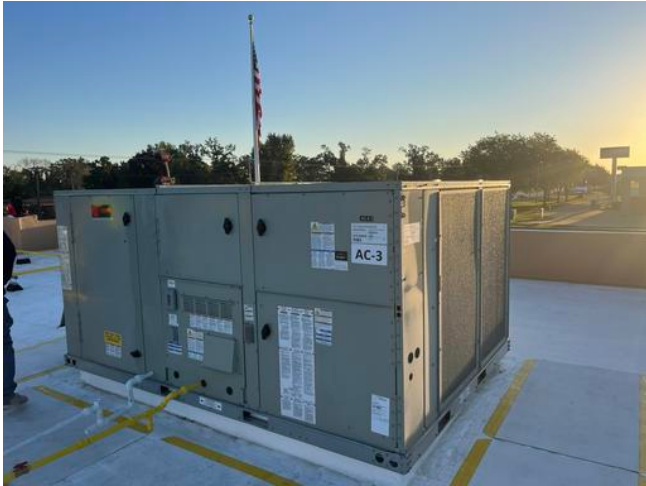
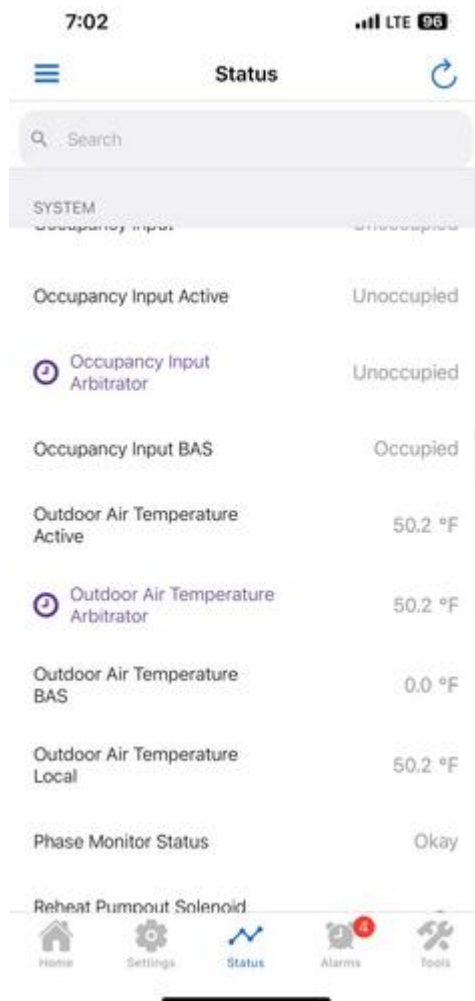
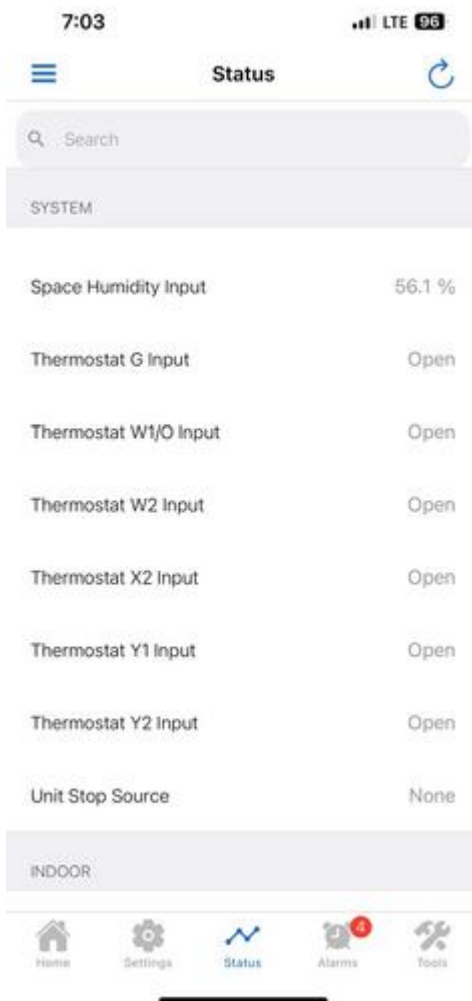
#109 [UNIT 999][NEW] (MISC) AC-3 Constant Fan ON

AC-3 is running fan only constantly, despite occupancy input / thermostat signal. When in unoccupied, unit runs fan only with no call for fan, no demand, and no voltage at G. All settings parameters appear correct. Recommend TRANE is contacted. Service needed.

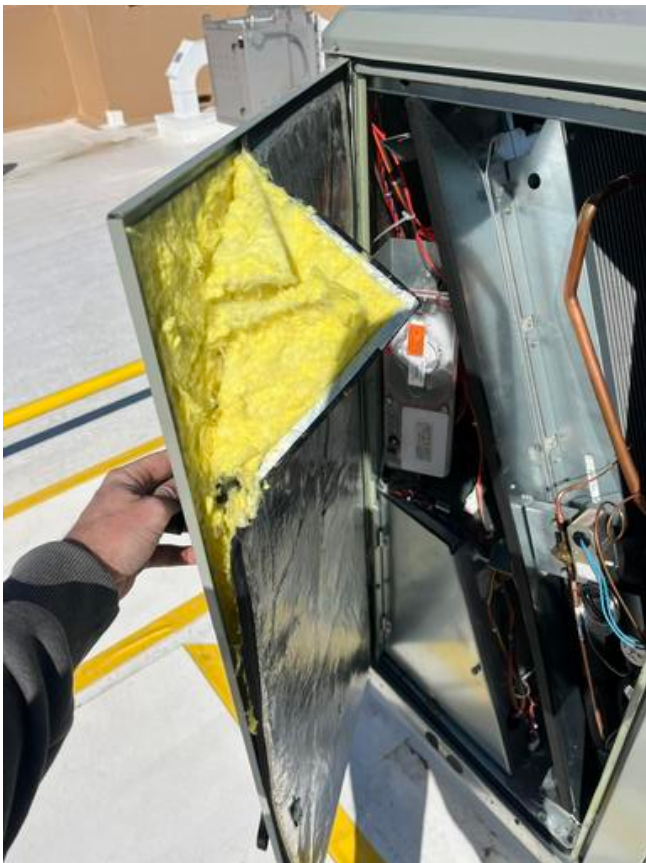
#106 [UNIT 999][NEW] AC-2: Interior insulation loose

Insulation on interior of Filter Access door is coming off. Recommend it is secured.

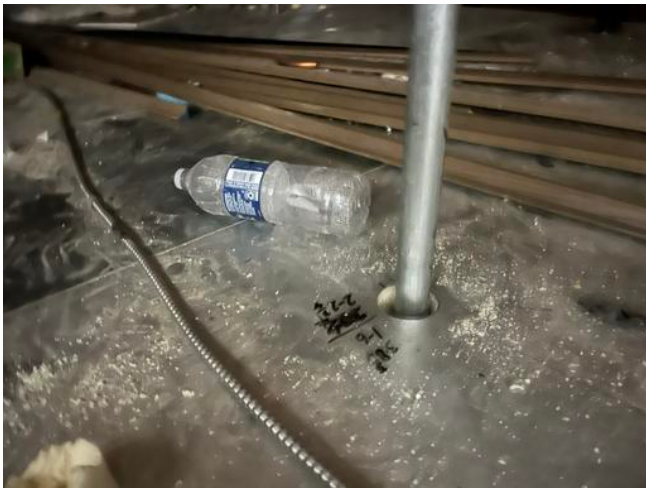
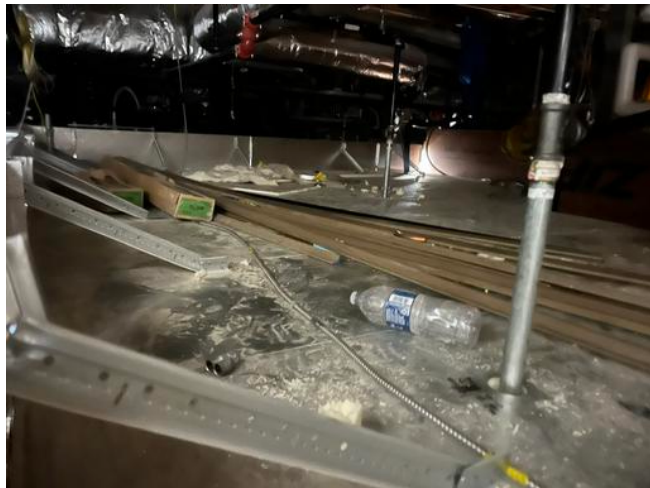
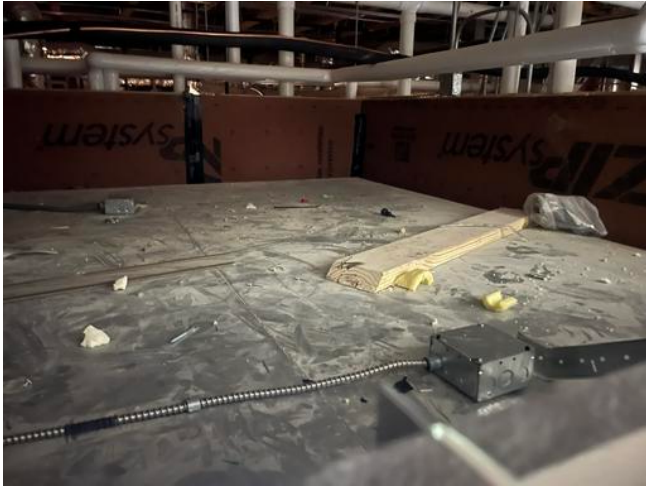
#88 [REFG 508][NEW] WIC/WIF panel penetrations

At time of TAB WIF/WIC penetrations are not sealed inside with silicone and above ceiling panel with 2 layers of 1/4" foam tape 12" above panel. Recommend trash/debris above WIC/WIF is removed.

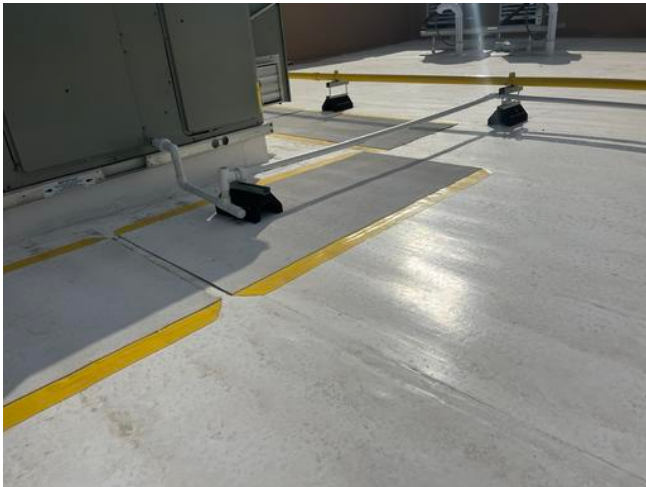
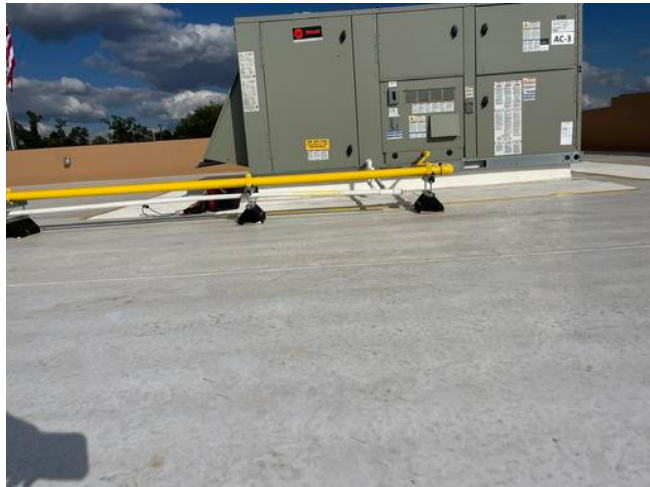
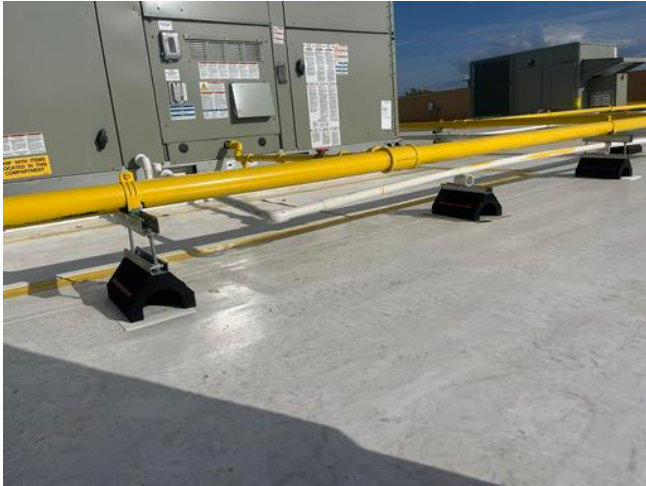
#86 [UNIT 516][NEW] Condensate Piping Pitch

Equipment condensate piping pitch is not sloped correctly in several instances. Piping also lacks support in some spots, usually coinciding with incorrect pitch.

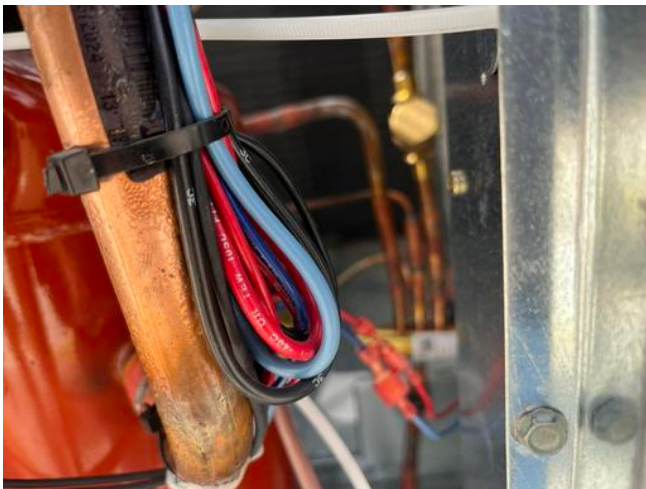
#54 [UNIT 499][NEW](MISC) AC-4 Dehumidification-Hot Gas Reheat

AC-4 is overcooling space when running dehumidification. Hot gas reheat does not appear to be functioning properly. Recommend service.

Humidity sensor disconnected until issue can be diagnosed. Unit will just continuously dehumidify, overcool, then heat space.

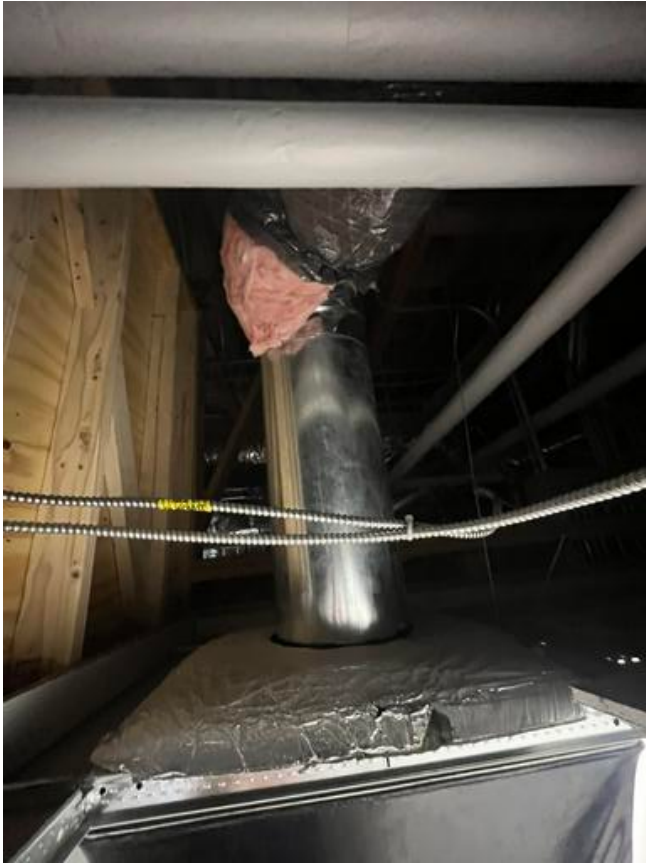
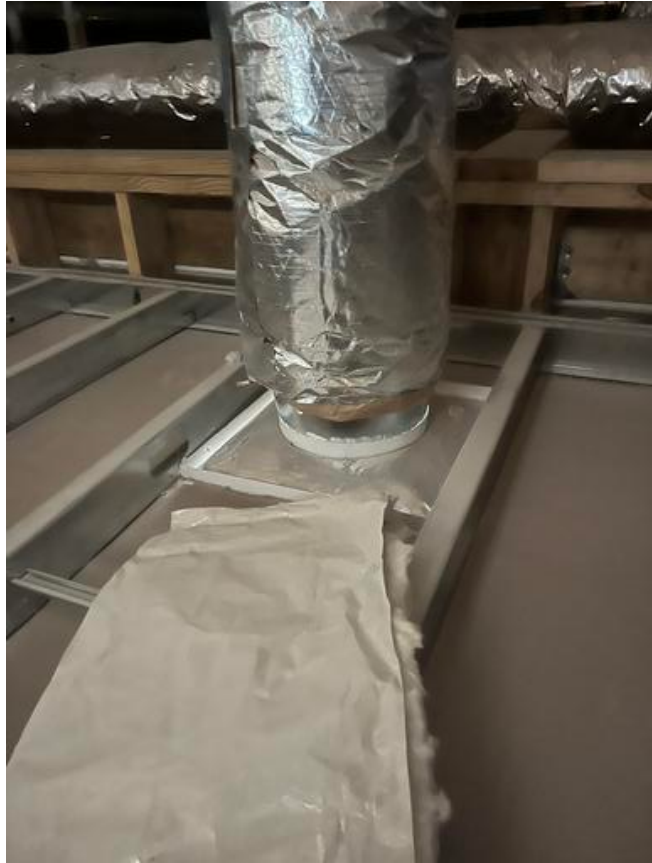
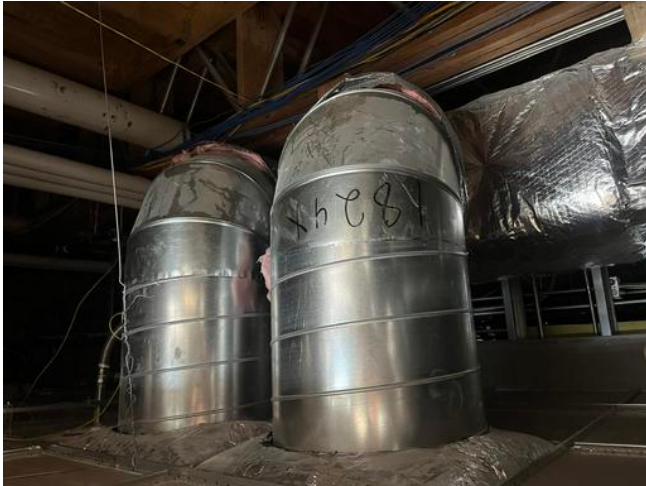
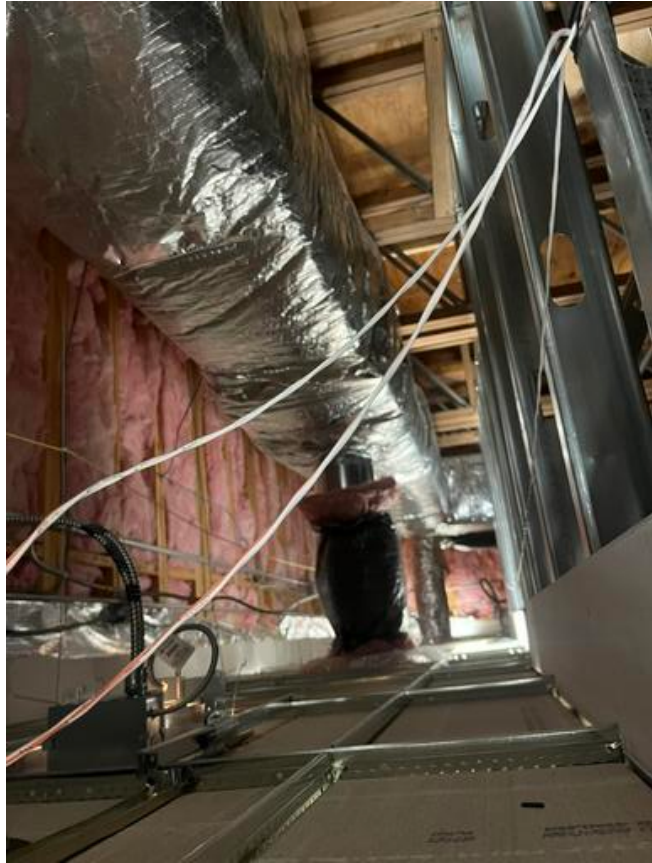
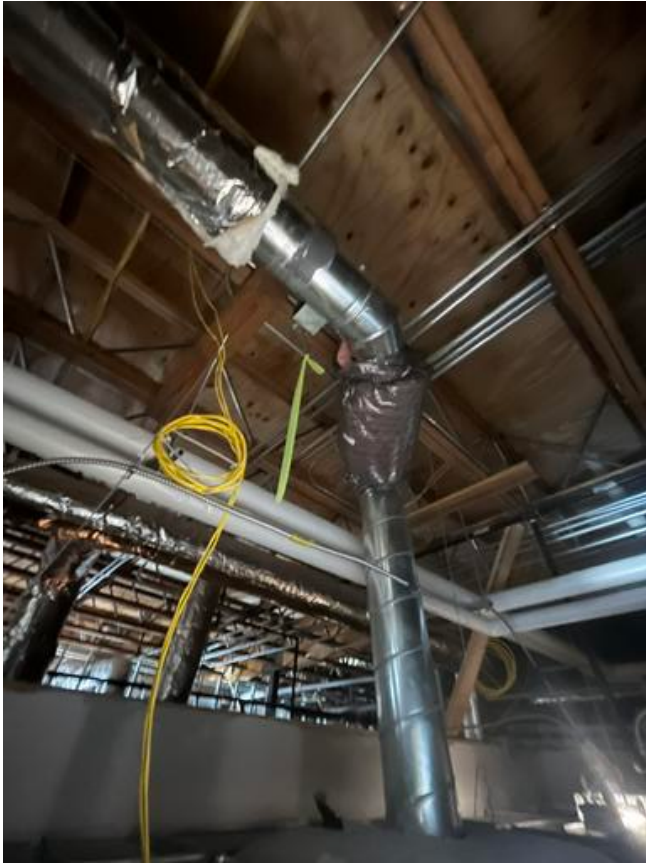
#53 [DUCT 507] [NEW] Ductwork is not fully insulated. Not all seams taped.

Ductwork not fully insulated. Some areas are missing insulation, or ductwork is poorly insulated with exposed areas and seams not taped/secured. Present on all systems.

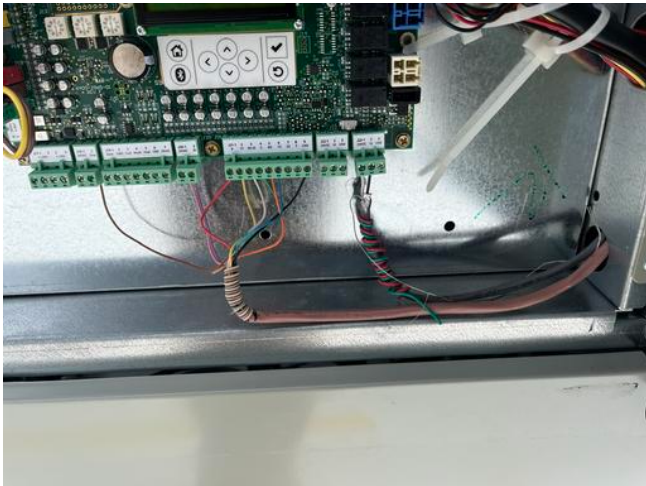
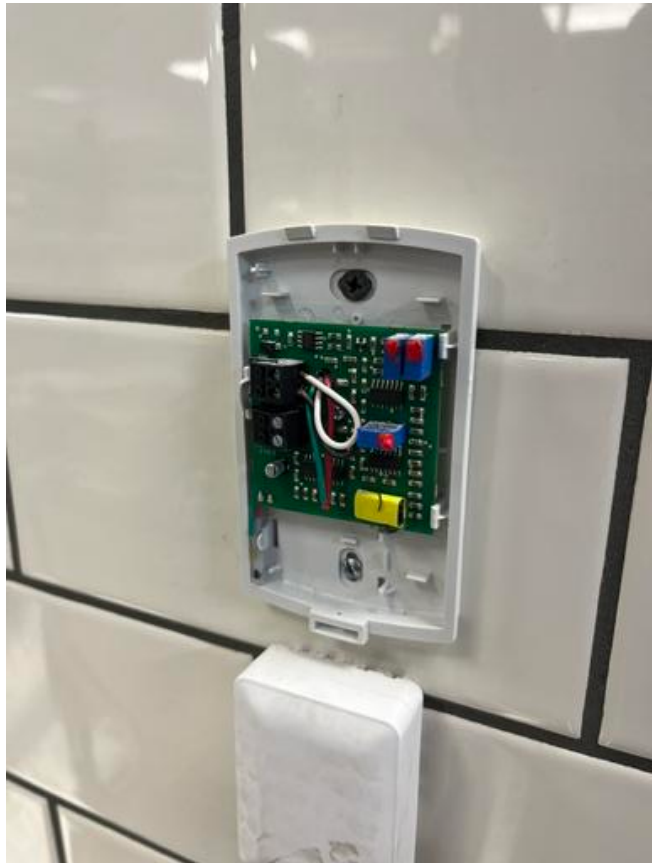
#51 [CNTL 003][NEW] CRITICAL - Wiring Specifications

Humidity Sensor cable does not meet spec and is not Connect Air. Readings appear accurate at each sensor: SEEK APPROVAL.

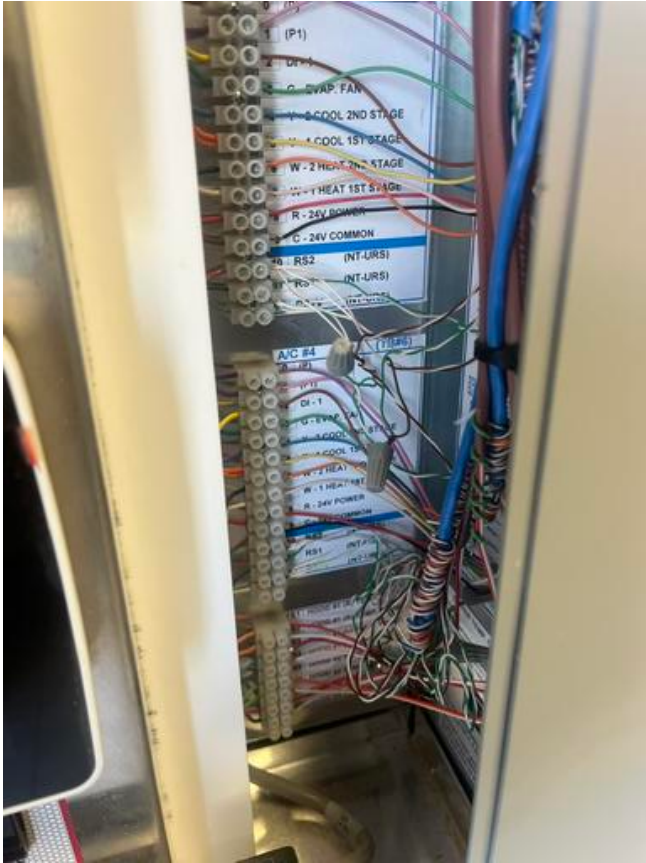
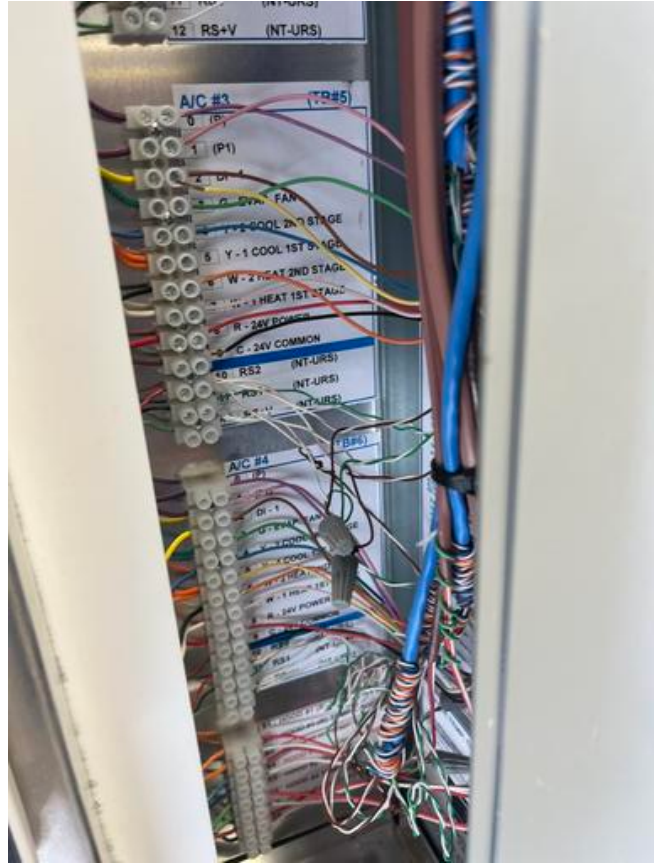
#50 [CNTL 999][NEW] AC-3/4 Temp Sensor Wiring

AC-3 and AC-4 to have averaging sensors. Sensors installed, and operating properly/accurately. However, wire was not routed from sensor to sensor, and instead from each sensor back to SEC panel, where connection was made. Operating correctly: SEEK APPROVAL

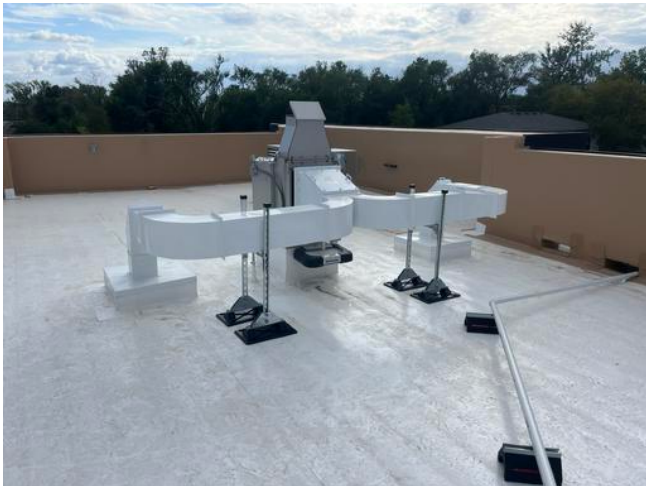
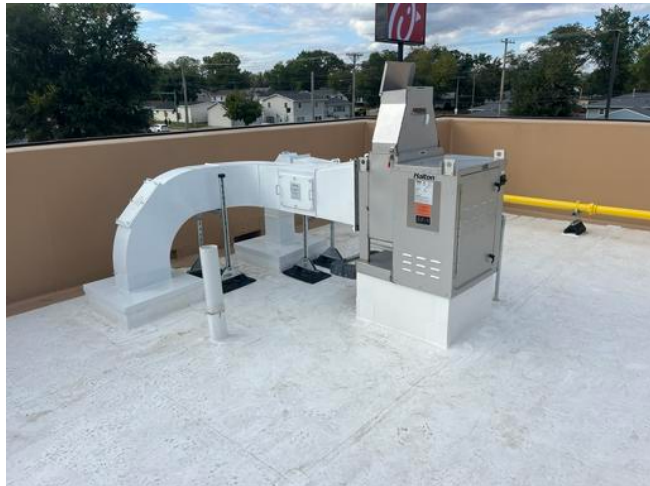
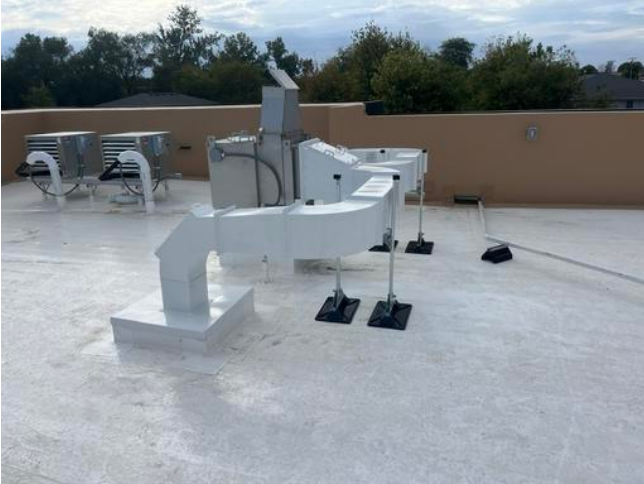
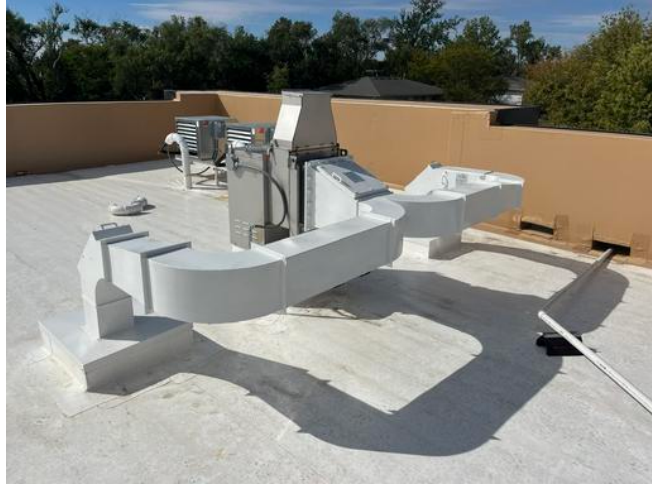
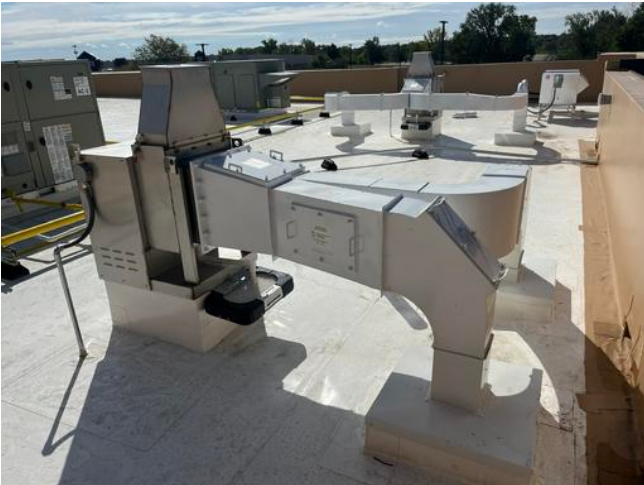
#49 [EXHA 510][NEW] Grease Duct is Not Supported

Exhaust Duct is to be supported per hood exhaust fan detail. Plans indicate supports every 6'0" and at each roof penetration. Recommend support added to roof penetrations in EF-2 per detail.

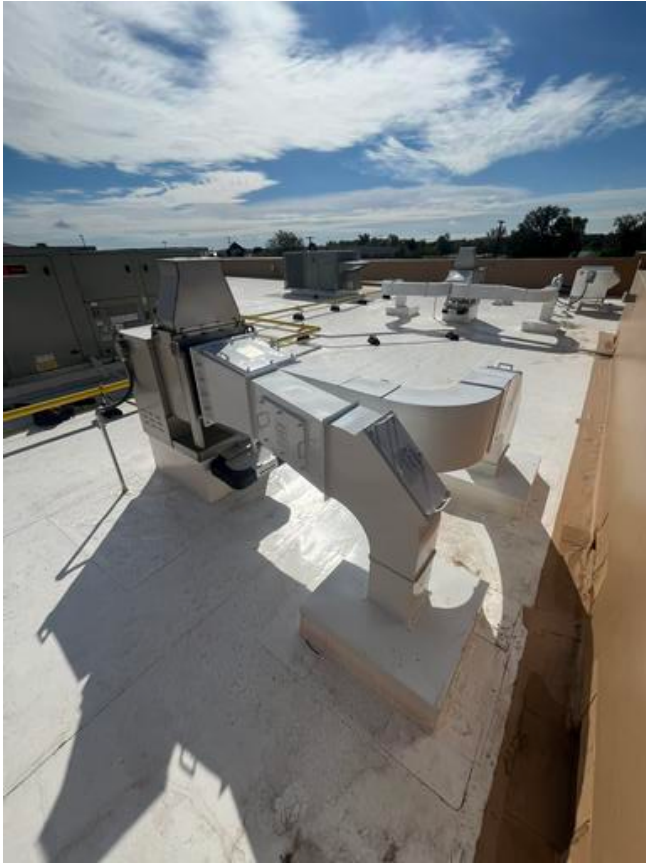
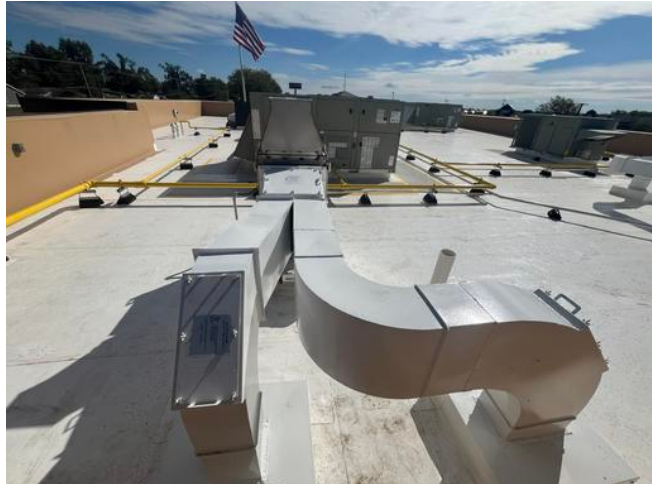
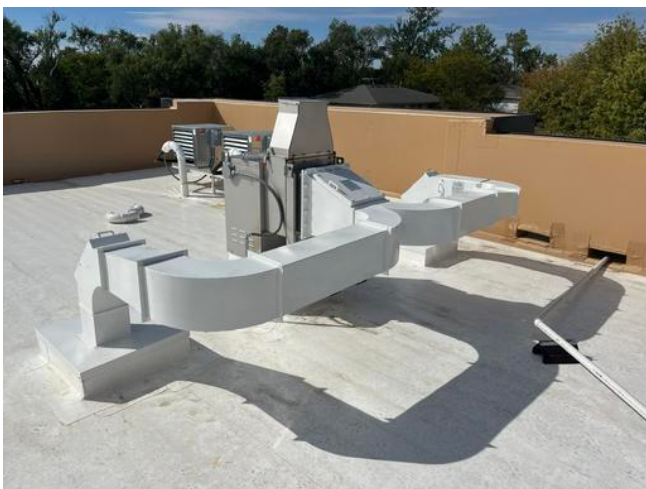
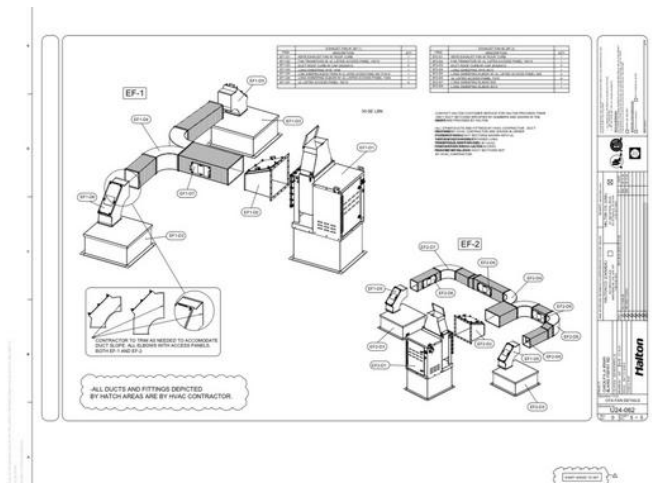
#46 [EXHA 499][NEW] CRITICAL (MISC) Grease Duct Deviates From Plans

Grease duct deviates from plans and is missing sections that were to be field fabricated. They have been omitted. EF-1 position limited by framing. Exhaust hoods performing at design; SEEK APPROVAL

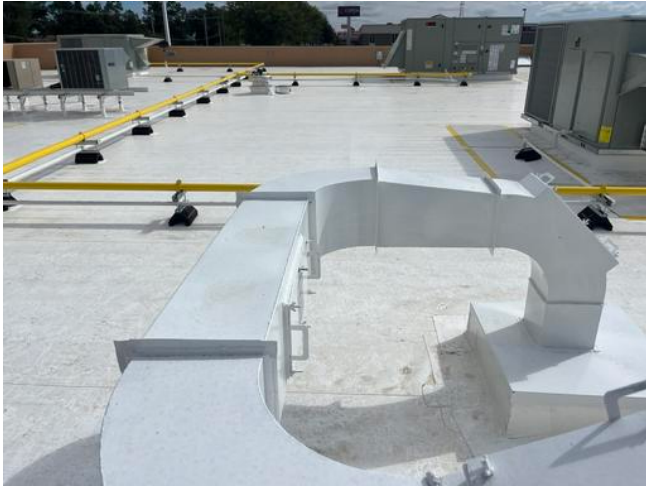
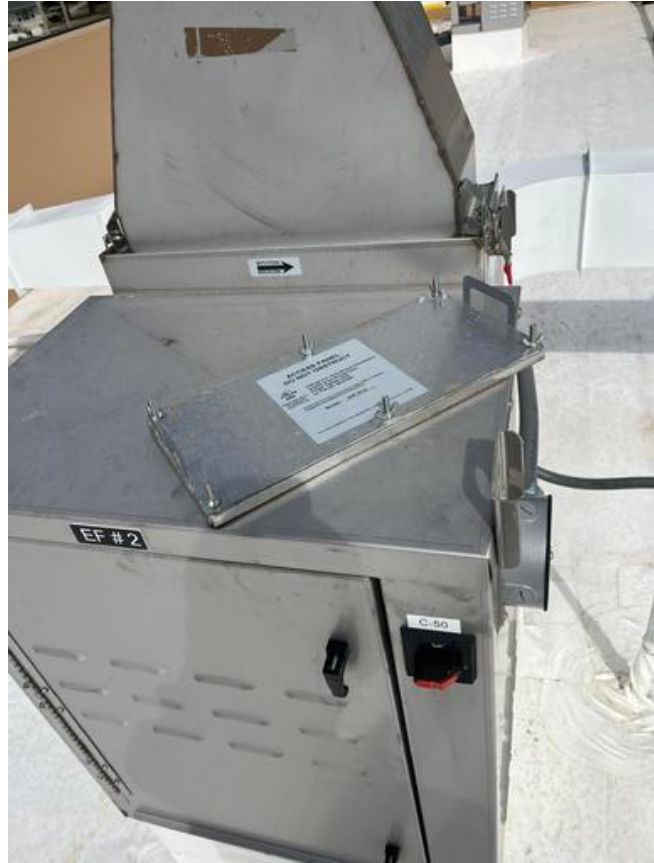
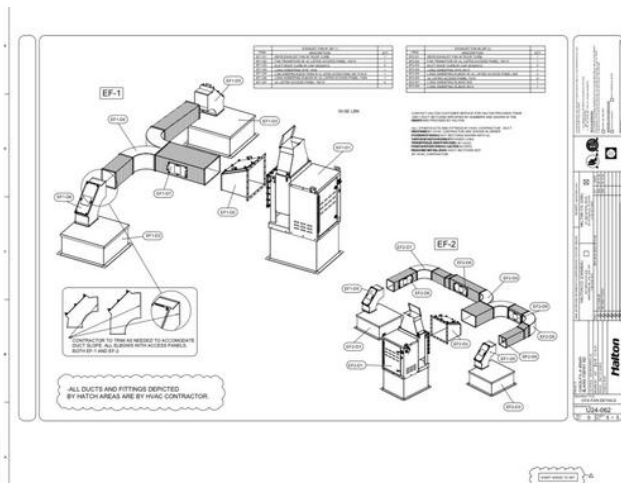
#45 [EXHA 001][NEW] CRITICAL- Grease Duct Access Doors

Access door on EF-2 is not installed.

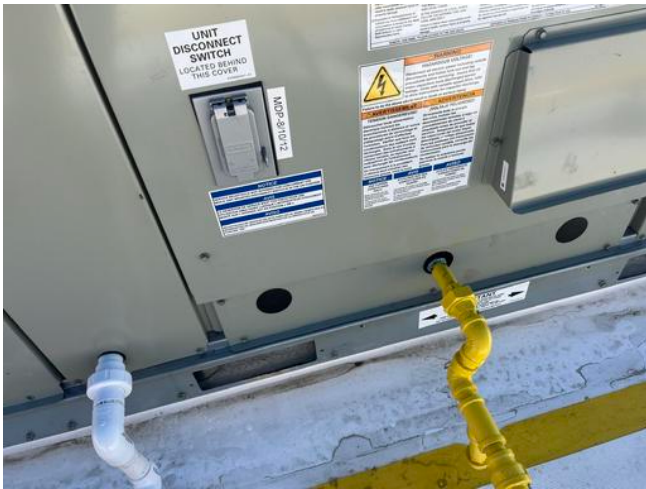
#44 [UNIT 510][NEW] Gas inlet Grommet

AC gas inlet grommet is missing at the penetration point.

TRANE is not sending grommets with every unit. MC was not provided with enough grommets.

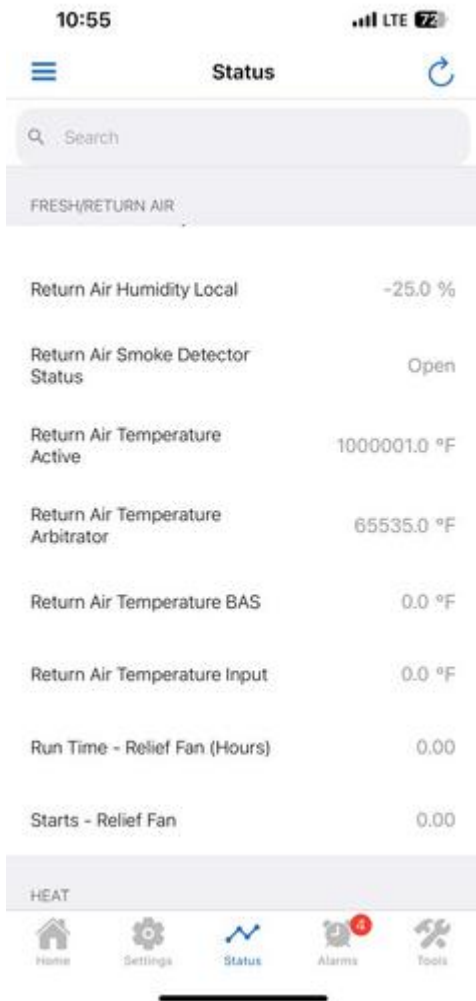
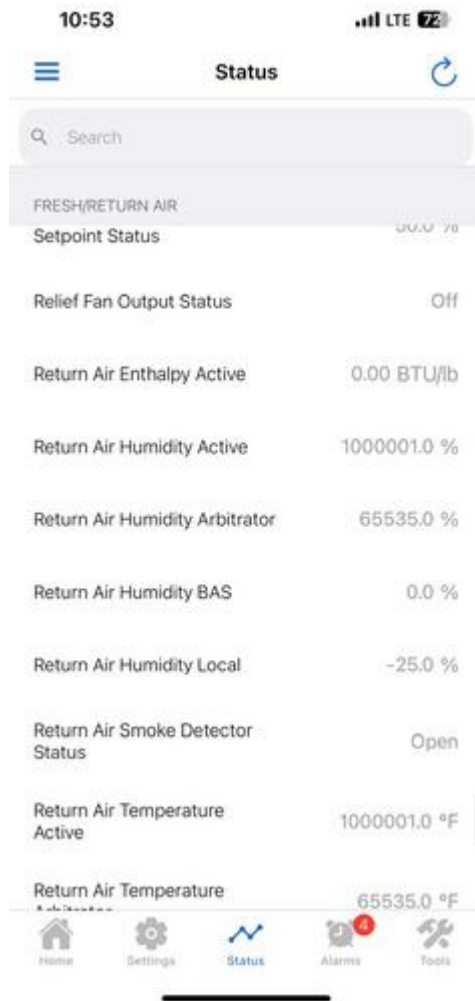
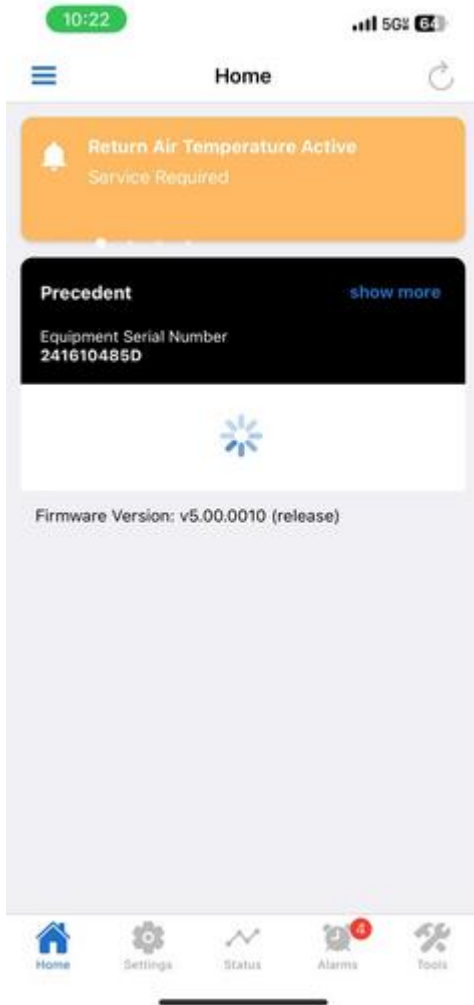
#43 [UNIT 999] [NEW] (MISC) AC-3 Alarmed / Missing Sensors

AC-3 is alarmed for Return air Temperature/ Humidity. Return sensors are not installed on this unit and unit is displaying wild readings. Trane was notified, recommend they are contacted again as to absence of sensors and how this impacts operation.

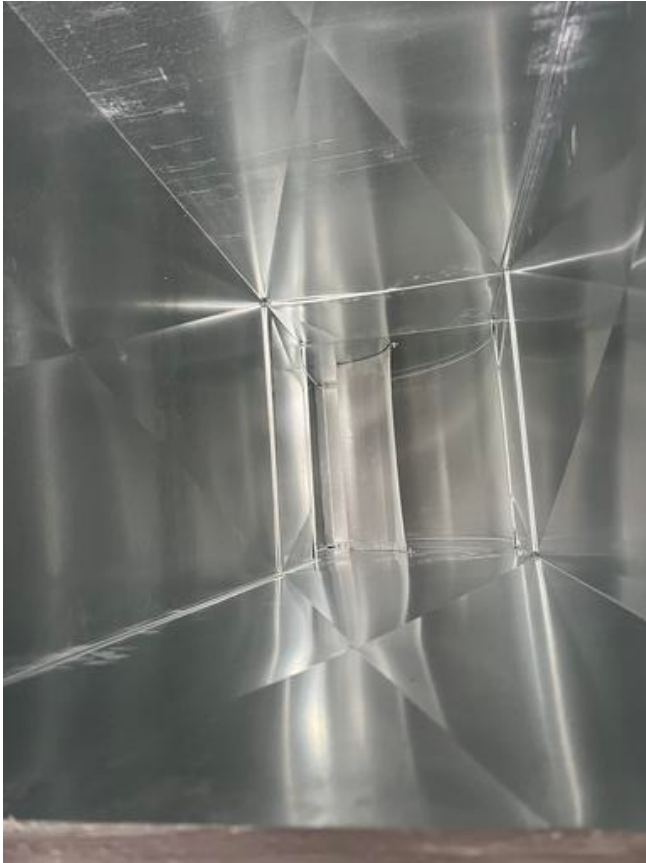
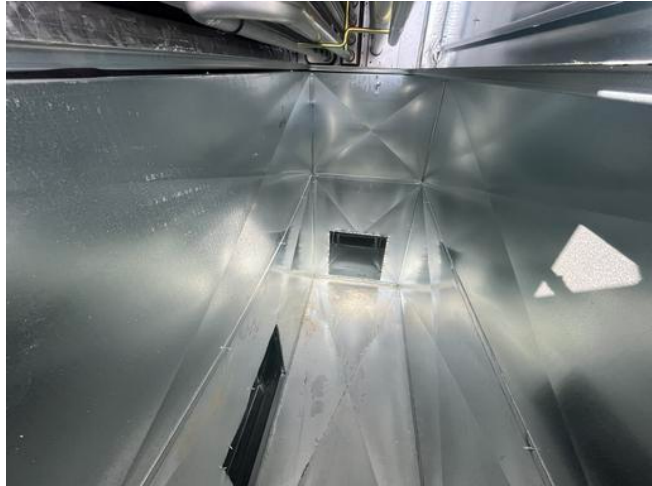
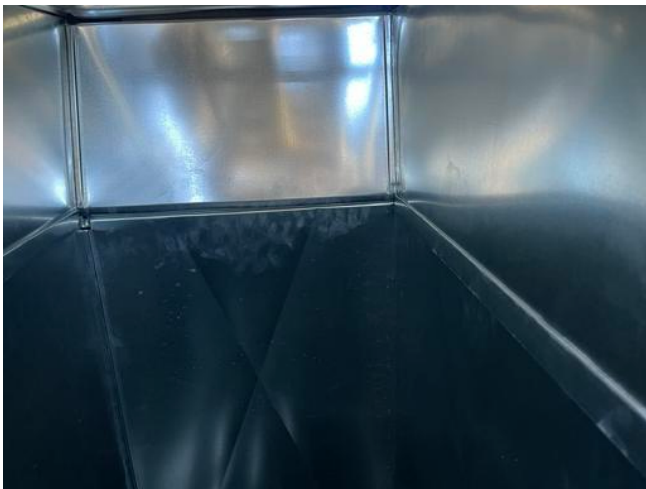
#42 [DUCT 003][NEW] CRITICAL - Canvas Connections

Equipment does not have duct canvas connectors installed at supply or return duct connections. SEEK APPROVAL.

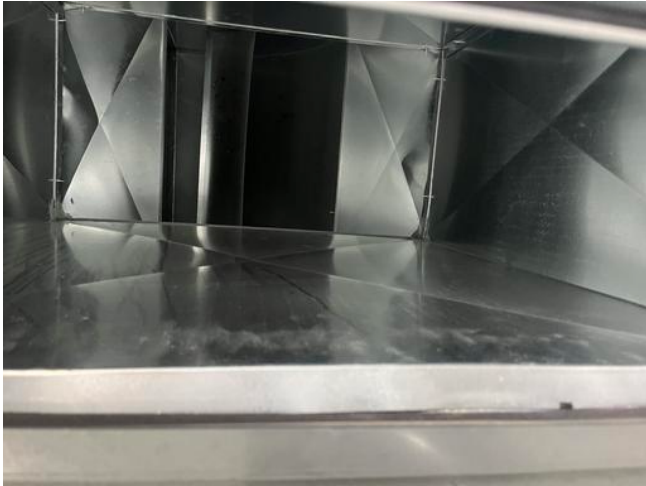
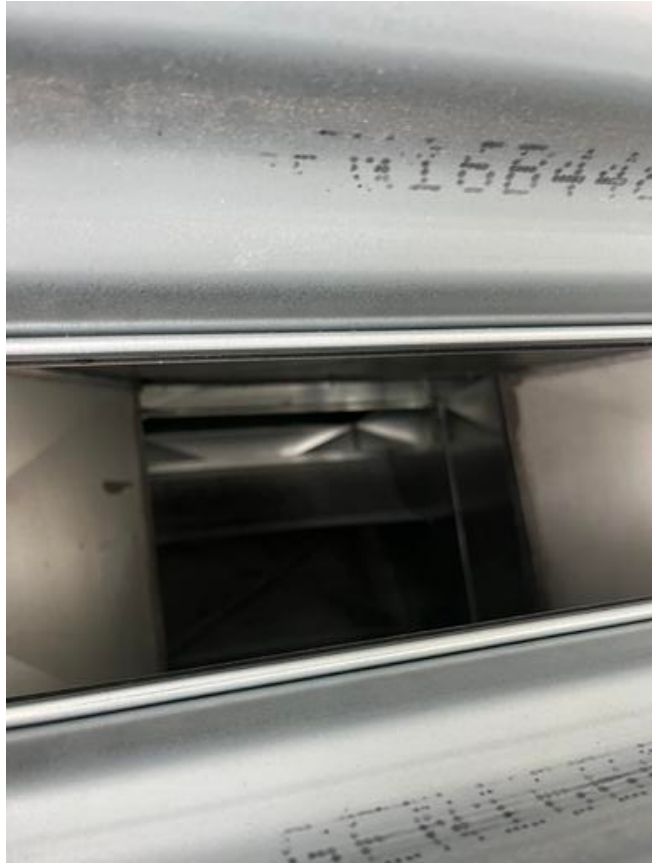
#41 [DUCT 002][NEW] CRITICAL - Turning Vanes in Return Duct

Turning Vanes are present in the return duct on some ACs and need to be removed per specification. MC cannot access vanes to remove: SEEK APPROVAL.

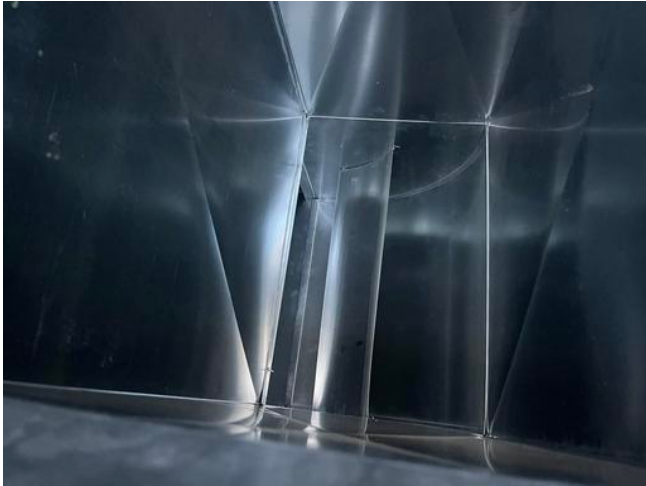
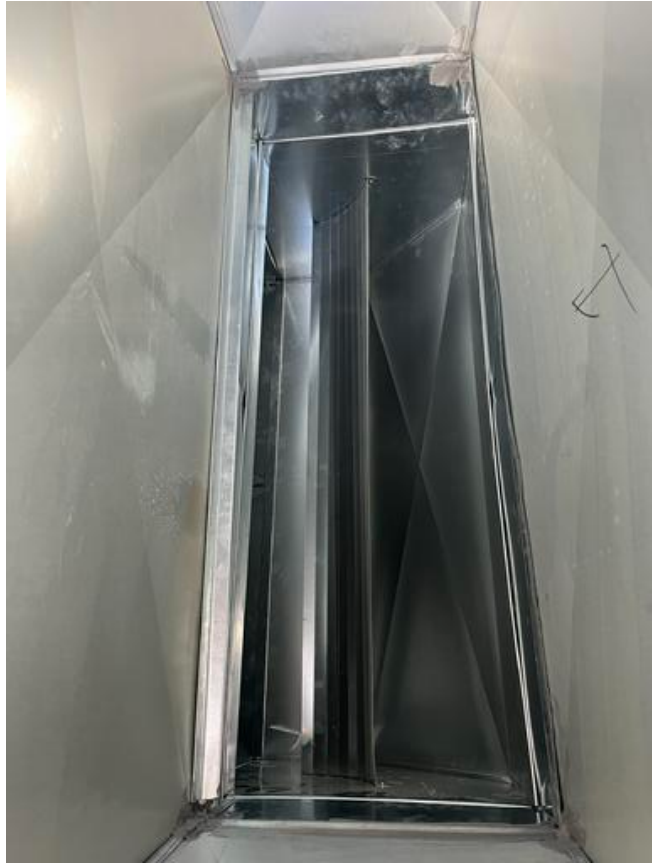
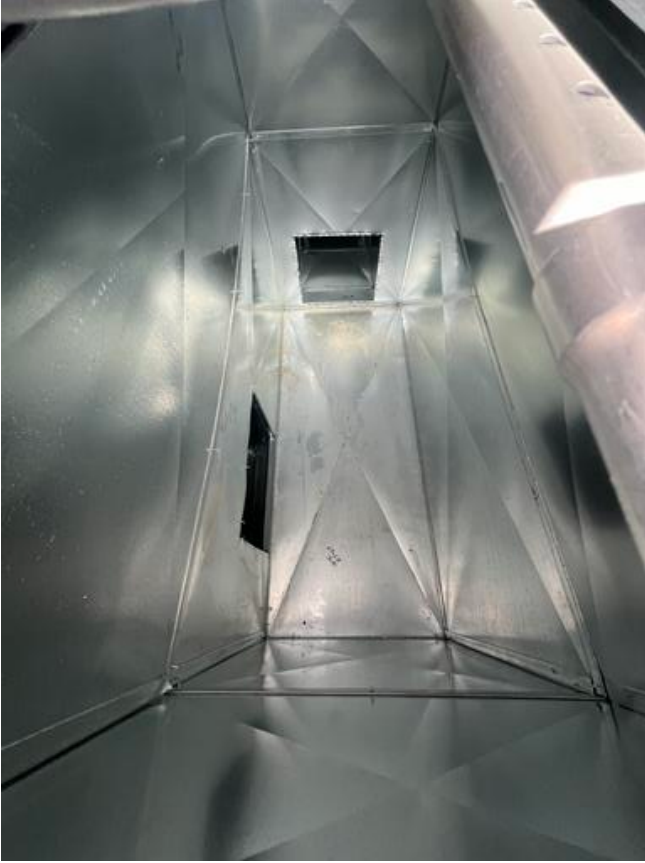
#40 [DUCT 004] [NEW] CRITICAL - Duct Drop Transitions

AC duct drops do not match specification. Single turning vane installed in drops. Drops must meet radius specification or have single thickness turning vanes installed as specified in plans. Units performing at design: SEEK APPROVAL.
