**Report: TAB Report**  
**Function: Test, Adjust, & Balance**  
**Date: 01/12/2026**  
**Completed By: National TAB**

**PROJECT**  
**01-12-26 QT #1412 PHOENIX, AZ**

QUIKTRIP  
4705 SOUTH 129TH EAST AVENUE  
TULSA, OK 74134

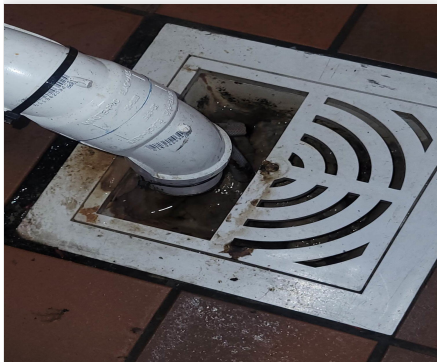
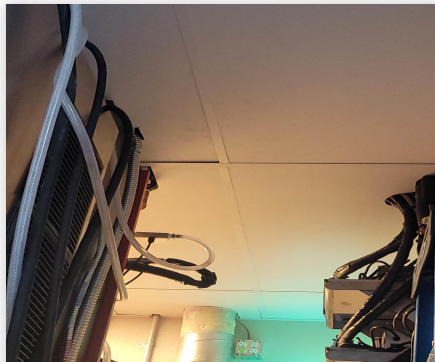
**Issue Name :** BACK AREA NOT BEING CONDITIONED  
**Description :** Duct which should supply damp, humid area behind soda & ice machines is instead atop the ceiling. Problems such as pictured worsen with inadequate air conditioning. Recommend replacing conditioning for the area.  
**Created By :** National TAB                      **Assigned To :** National TAB - Dan Hertenstein  
**Status :** Open  
**Priority :** Medium                                      **Asset Tag :** SGRD5  
**Originated Date :** 01/13/2026 - Christine Weale - National TAB

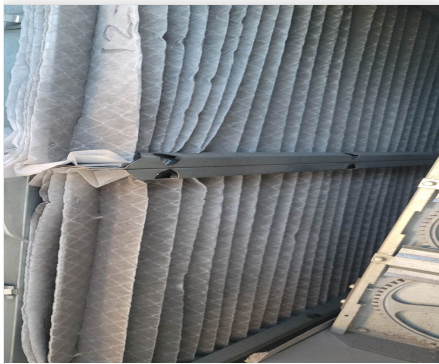
**Issue Name :** DIRTY FILTERS  
**Description :** Filters on all units are dirty, more so than picture shows.  
**Created By :** National TAB                      **Assigned To :** National TAB - Dan Hertenstein  
**Status :** Open  
**Priority :** InfoOnly                                      **Asset Tag :**  
**Originated Date :** 01/16/2026 - Christine Weale - National TAB

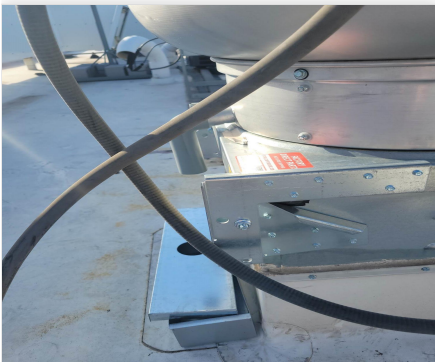
**Issue Name :** EF3 HINGE/GREASE CUP INCORRECT INSTALLATION  
**Description :** Hinge should be installed opposite of the grease conduit/cup.  
**Created By :** National TAB                      **Assigned To :** National TAB - Dan Hertenstein  
**Status :** Open  
**Priority :** Low                                      **Asset Tag :** EF3  
**Originated Date :** 01/13/2026 - Christine Weale - National TAB

Yes, but it's backwards, installed on same side as grease cup/conduit.

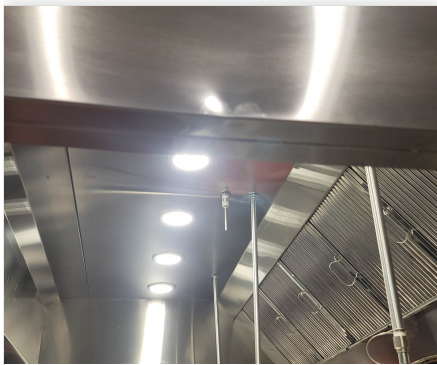
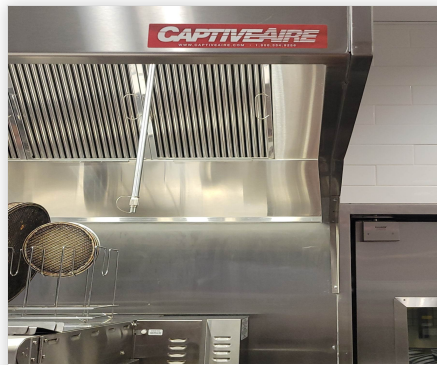
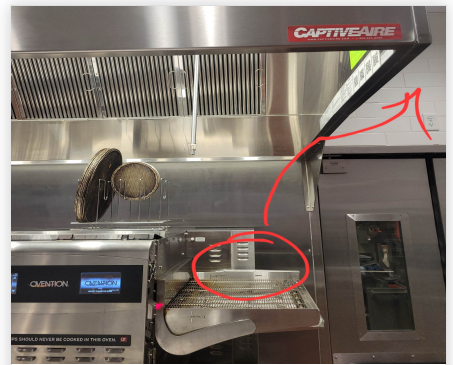
**Issue Name :** HOOD DAMAGED ON OVEN SIDE - 5% LOSS  
**Description :** Large dent on right side of hood has caused right panel to be slightly angled (~174\* i/o 180\*). This also happens to be the same side ~5% smoke loss occurs. Smoke originates from oven surface. Not sure if there is a correlation.  
**Created By :** National TAB                      **Assigned To :** National TAB - Dan Hertenstein  
**Status :** Open  
**Priority :** Medium                                      **Asset Tag :** HD1  
**Originated Date :** 01/13/2026 - Christine Weale - National TAB

**Hood is free of damage?** Fail

95 - oven loss, see 'REMARKS'.

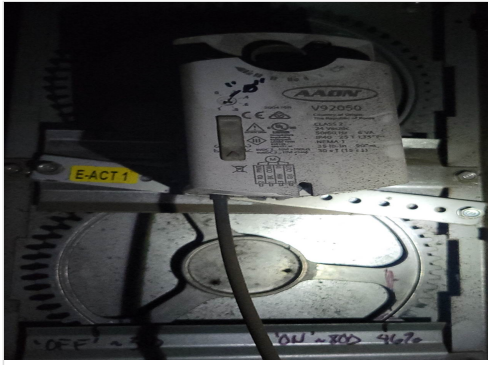
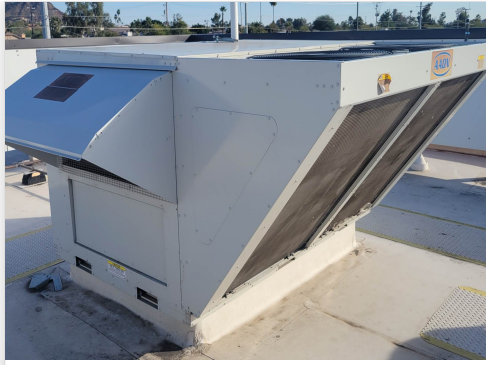
Asset: RT-3

Notes:  
UNIT LEFT ON LOW-SIDE SO KITCHEN AIR FLOW WOULD NOT BE TOO HIGH. REQUIRED DAMPERS INACCESSIBLE.
