**Report: TAB REPORT**  
**Function: Test, Adjust, & Balance**  
**Date: 07/14/2023**

**04-03-23 FREDDY'S - LAREDO, TX  
(INTERNATIONAL)**

Lone Star Custard Holdings

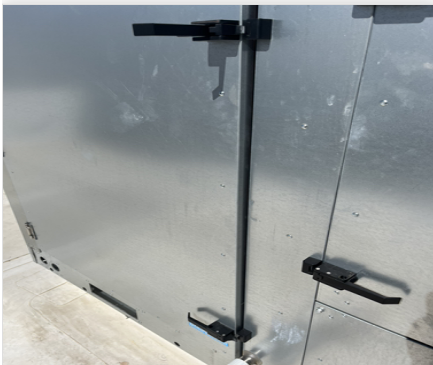
**DOOR**  
**07/11/2023**

**Issue Name :** DOAS filter access door does not close all the way  
**Description :** The door for the filter access does not close all the way and does not latch.  
**Created By :** National TAB                      **Assigned To :** National TAB - Jacob Davidson  
**Status :** Open  
**Originated Date :** 07/11/2023 - Jacob Davidson - National TAB

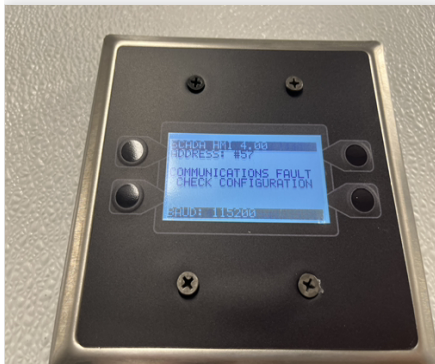
**HMIconfig  
07/11/2023**

**Issue Name :** DOAS HMI config error  
**Description :** DOAS HMI have an error “communications fault check configuration” and DOAS is not functioning as a result. Mike from Captive Aire is going to call tech in the morning and we will go over troubleshooting the addresses to resolve.  
**Created By :** National TAB                      **Assigned To :** National TAB - Jacob Davidson  
**Status :** Open  
**Originated Date :** 07/11/2023 - Jacob Davidson - National TAB

- **07/12/2023 National TAB - Jacob Davidson**
  - On the phone with CA, we determined there is a problem with the CAT5 cable coming from the roof to the HMIs downstairs for the DOAS unit. The CA tech will be here tomorrow to inspect

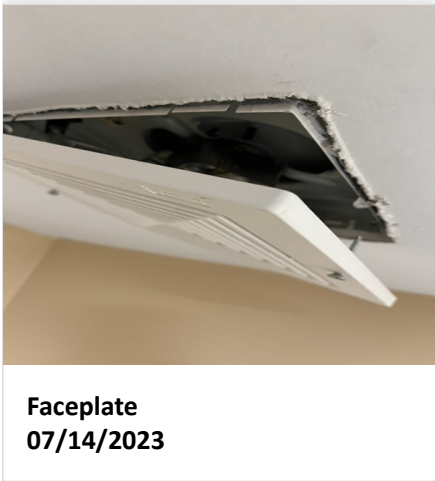
Faceplate  
07/14/2023

**Issue Name :** EF2 face plate isn't secured  
**Description :** EF2 restroom faceplate was screwed directly into drywall with no fastener and not secured. Tech is unable to attach to fan.  
**Created By :** National TAB                      **Assigned To :** National TAB - Jacob Davidson  
**Status :** Open  
**Originated Date :** 07/14/2023 - Jacob Davidson - National TAB

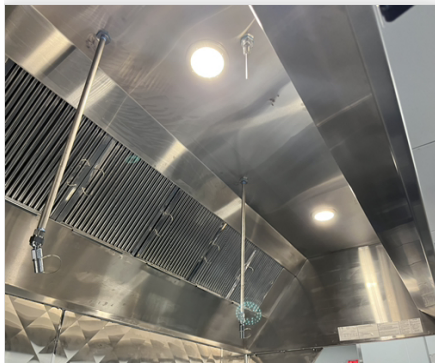
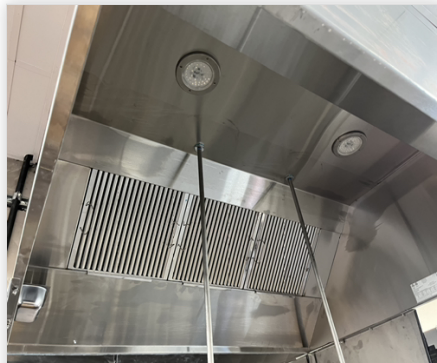
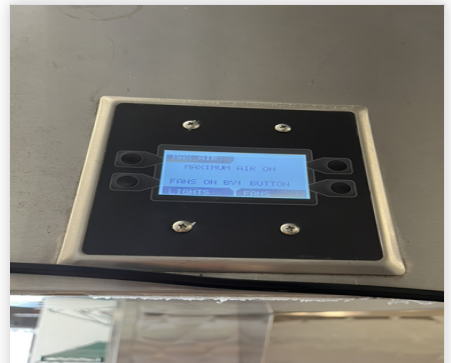
**Issue Name :** HD2 lights don't come on  
**Description :** Lights turn on for HD1 but they do not turn on for HD2 after turning on the fans at the HMI.  
**Created By :** National TAB                      **Assigned To :** National TAB - Jacob Davidson  
**Status :** Open  
**Originated Date :** 07/11/2023 - Jacob Davidson - National TAB

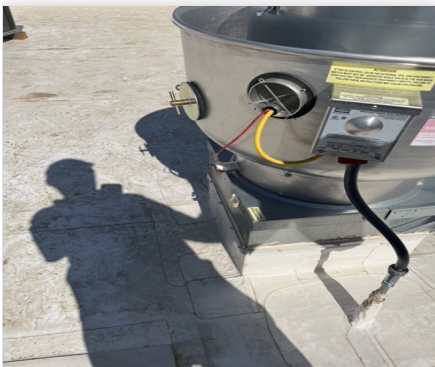
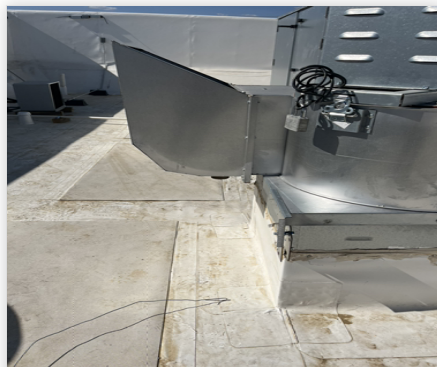
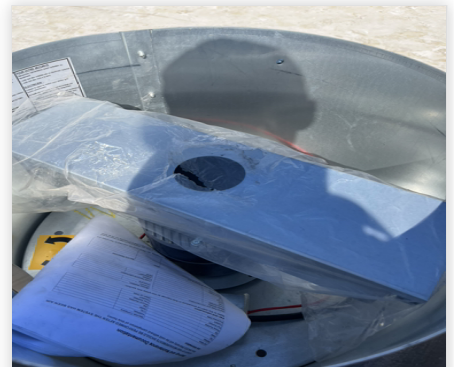
**Issue Name :** KEF1/KEF2 no grease trap in place  
**Description :** Grease traps for both of the fans have not been installed.  
**Created By :** National TAB                      **Assigned To :** National TAB - Jacob Davidson  
**Status :** Open  
**Originated Date :** 07/11/2023 - Jacob Davidson - National TAB

NO, NEED INSTALLED

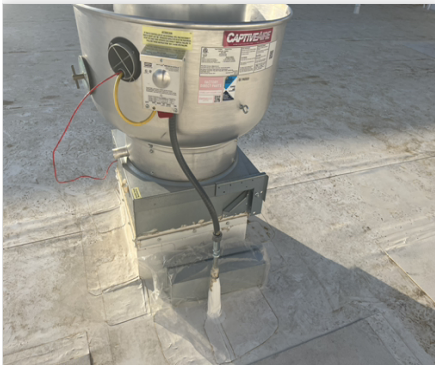
**Flex**  
**07/12/2023**

**Issue Name :** KEF2 flex conduit needs to be longer  
**Description :** Flex conduit is not long enough to tilt fan completely back.  
**Created By :** National TAB                      **Assigned To :** National TAB - Jacob Davidson  
**Status :** Open  
**Originated Date :** 07/12/2023 - Jacob Davidson - National TAB

NO, FLEX CONDUIT NEEDS TO BE LONGER

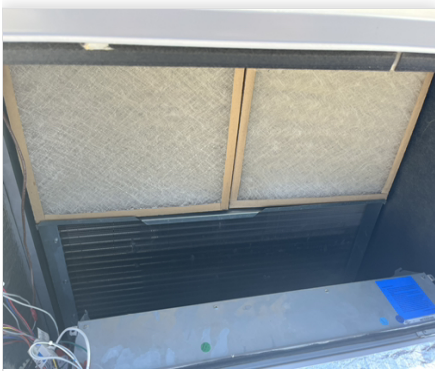
**Filters**  
**07/11/2023**

**Issue Name :** RTU1 not all filters installed  
**Description :** RTU1 only has 2 construction filters installed of the 4 20x20x2 filters it needs  
**Created By :** National TAB                      **Assigned To :** National TAB - Jacob Davidson  
**Status :** Open  
**Originated Date :** 07/11/2023 - Jacob Davidson - National TAB

General		
	Design	Actual
Fan Rotation Correct	-	YES
Unit Filters Clean	-	NO, NEED NEW FILTERS
Condensate Drain Installed	-	YES

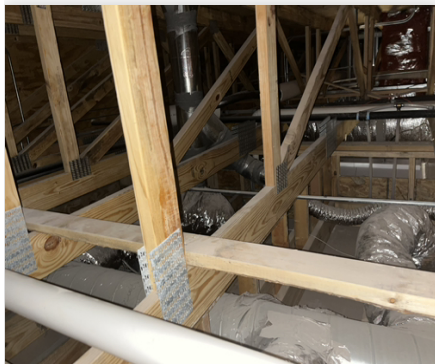
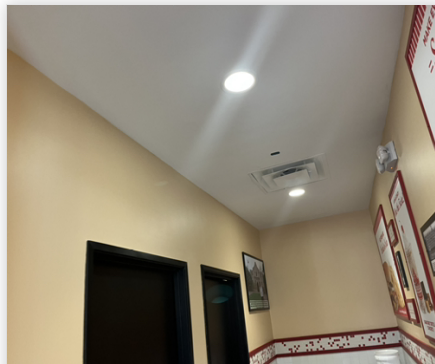
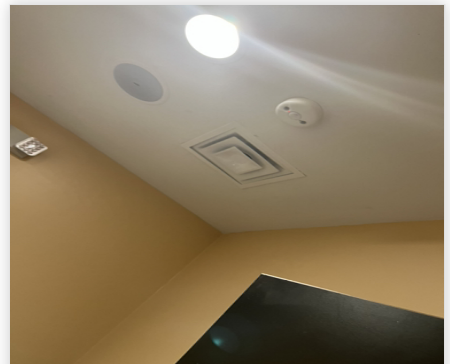
**Issue Name :** RTU1 restroom and hallway dampers not accessible  
**Description :** The dampers for the restroom and hallways supply diffusers on RTU1 are at the take off of the duct above hard ceiling where tech is unable to safely access. MC is not currently on site to assist. The restroom diffusers are high and the hallway diffuser is low.  
**Created By :** National TAB                      **Assigned To :** National TAB - Jacob Davidson  
**Status :** Open  
**Originated Date :** 07/12/2023 - Jacob Davidson - National TAB

Diffusers for the restrooms and hallway are unable to be balanced due to tech not being able to safely access dampers. Unit total and all other diffusers are balanced within design tolerance.

Asset	Notes	Date	Written By
RTU1-SGRD11	Damper is above hard ceiling at the takeoff of the duct and tech is unable to safely access.	07/12/2023	Jacob Davidson
RTU1-SGRD12	Damper is above hard ceiling at the takeoff of the duct and tech is unable to safely access.	07/12/2023	Jacob Davidson
RTU1-SGRD13	Damper is above hard ceiling at the takeoff of the duct and tech is unable to safely access.	07/12/2023	Jacob Davidson

- **07/14/2023 National TAB - Will Turnbough**
  - Recommend installing face dampers for the restroom diffusers and closing approximately 25% to ensure the restroom will have negative pressure.
