Report: TAB REPORT
Function: Test, Adjust, & Balance
Date: 07/14/2023

**04-03-23 FREDDY'S - LAREDO, TX
(INTERNATIONAL)**

Lone Star Custard Holdings

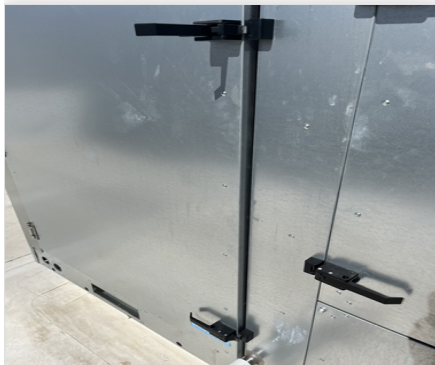
DOOR
07/11/2023

Issue Name : DOAS filter access door does not close all the way
Description : The door for the filter access does not close all the way and does not latch.
Created By : National TAB **Assigned To :** National TAB - Jacob Davidson
Status : Open
Originated Date : 07/11/2023 - Jacob Davidson - National TAB

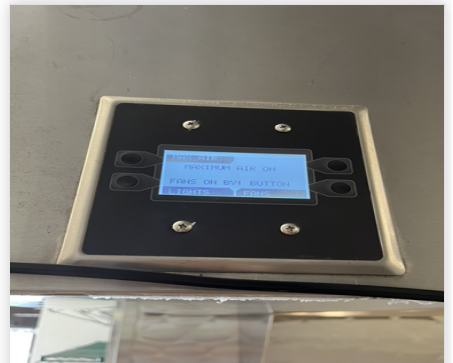
Issue Name : HD2 lights don't come on
Description : Lights turn on for HD1 but they do not turn on for HD2 after turning on the fans at the HMI.
Created By : National TAB **Assigned To :** National TAB - Jacob Davidson
Status : Open
Originated Date : 07/11/2023 - Jacob Davidson - National TAB

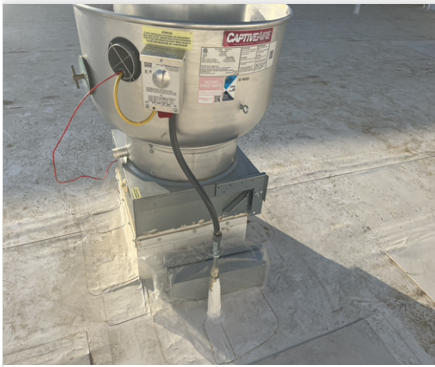
Flex
07/12/2023

Issue Name : KEF2 flex conduit needs to be longer
Description : Flex conduit is not long enough to tilt fan completely back.
Created By : National TAB **Assigned To :** National TAB - Jacob Davidson
Status : Open
Originated Date : 07/12/2023 - Jacob Davidson - National TAB

NO, FLEX CONDUIT NEEDS TO BE LONGER

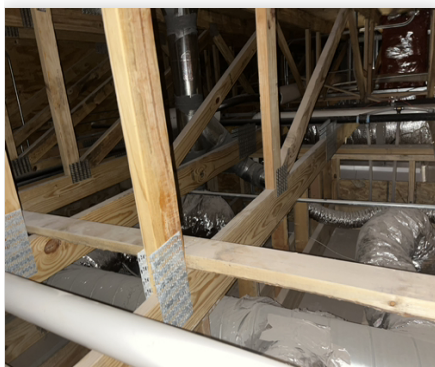
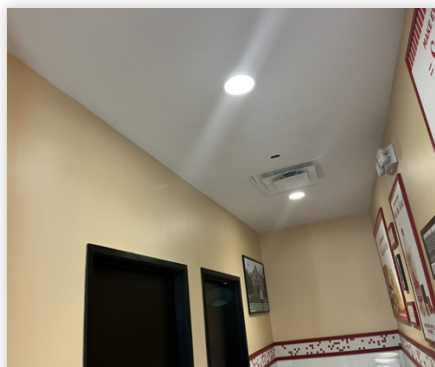
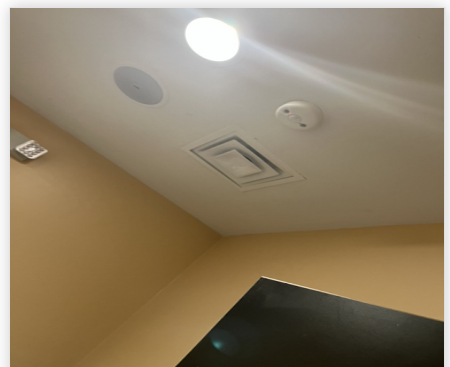
Issue Name : RTU1 restroom and hallway dampers not accessible
Description : The dampers for the restroom and hallways supply diffusers on RTU1 are at the take off of the duct above hard ceiling where tech is unable to safely access. MC is not currently on site to assist. The restroom diffusers are high and the hallway diffuser is low.
Created By : National TAB **Assigned To :** National TAB - Jacob Davidson
Status : Open
Originated Date : 07/12/2023 - Jacob Davidson - National TAB

Diffusers for the restrooms and hallway are unable to be balanced due to tech not being able to safely access dampers. Unit total and all other diffusers are balanced within design tolerance.

Asset	Notes	Date	Written By
RTU1-SGRD11	Damper is above hard ceiling at the takeoff of the duct and tech is unable to safely access.	07/12/2023	Jacob Davidson
RTU1-SGRD12	Damper is above hard ceiling at the takeoff of the duct and tech is unable to safely access.	07/12/2023	Jacob Davidson
RTU1-SGRD13	Damper is above hard ceiling at the takeoff of the duct and tech is unable to safely access.	07/12/2023	Jacob Davidson

- **07/14/2023 National TAB - Will Turnbough**
 - Recommend installing face dampers for the restroom diffusers and closing approximately 75% to ensure the restroom will have negative pressure.
