Report: TAB Report
Function: Test, Adjust, & Balance
Date: 07/31/2025
Completed By: National TAB

PROJECT
07-28-25 WAWA #7400 GREENFIELD, IN

Project: 07-28-25 WAWA #7400 GREENFIELD, IN

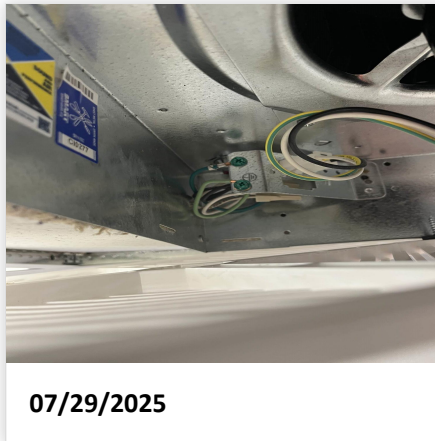
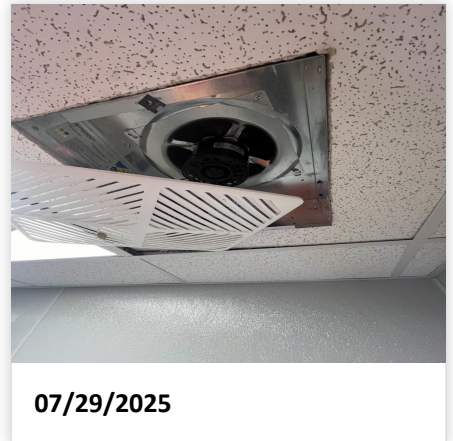
Issue Name : EF-3 low on flow
Description : EF-3 is low on flow at 127/200CFM. unable to change speeds as the fan is missing the speed controller. Per plans it should have a speed controller installed for speed adjustment. Recommend installing speed controller so it can be sped up.
Created By : National TAB **Assigned To :** National TAB - Dylan Crisman
Status : Open
Priority : High **Asset Tag :**
Originated Date : 07/29/2025 - Dylan Crisman - National TAB

Fan is low on flow at 127/200CFM. Fan is missing speed controller, unable to adjust speeds. Issue created.

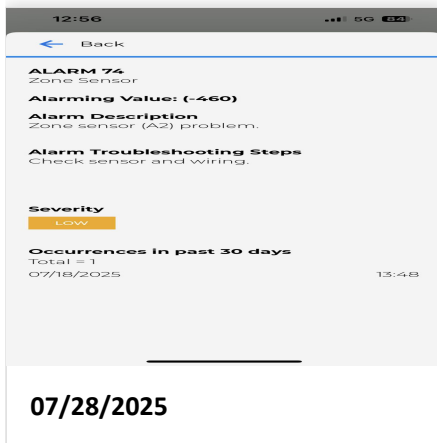
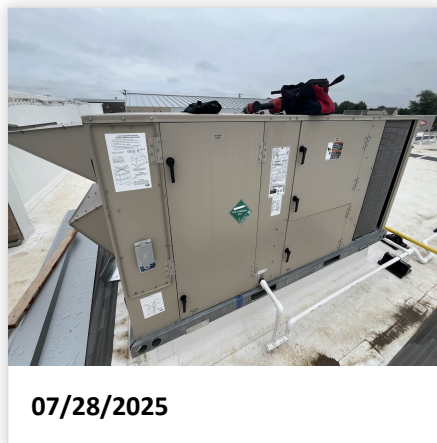
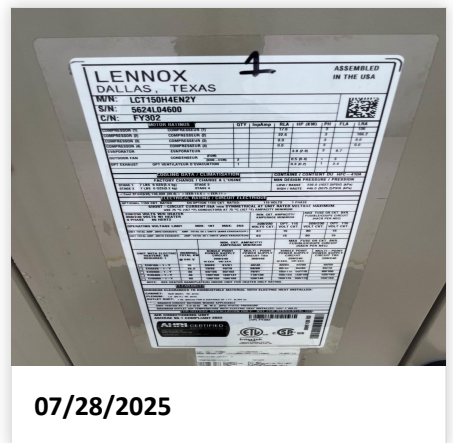
Issue Name : RTU-1 Zone sensor Alarm
Description : RTU-1 has an alarm for zone sensor, recommend inspecting wiring at space sensor and confirm wires are landed properly from the sensor to wiring at the units electric panel.
Created By : National TAB **Assigned To :** National TAB - Dylan Crisman
Status : Open
Priority : High **Asset Tag :**
Originated Date : 07/28/2025 - Dylan Crisman - National TAB

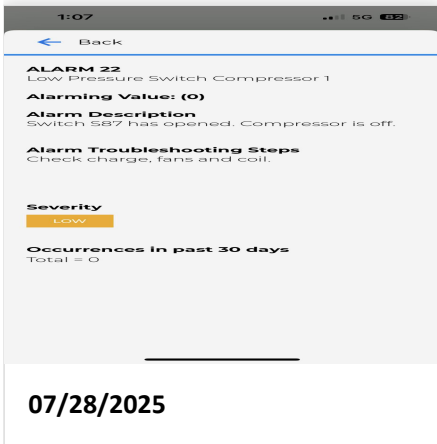
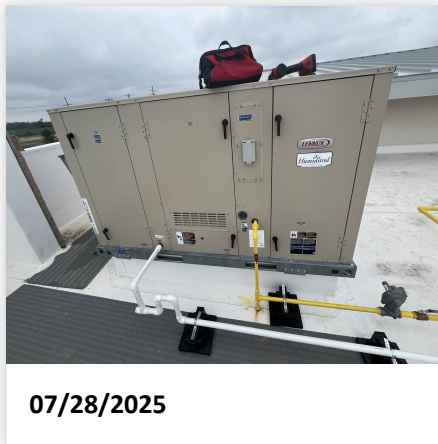
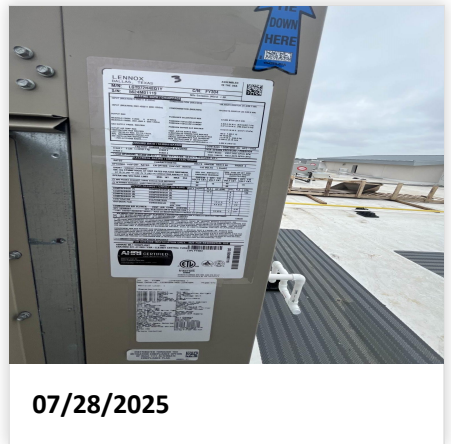
Issue Name : RTU-2 alarm low pressure switch
Description : RTU-2 shows alarm for “low pressure switch compressor 1 recommend mechanical service to correct issue with compressor.
Created By : National TAB **Assigned To :** National TAB - Dylan Crisman
Status : Open
Priority : High **Asset Tag :**
Originated Date : 07/28/2025 - Dylan Crisman - National TAB

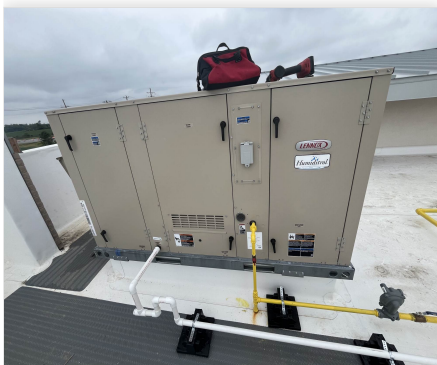
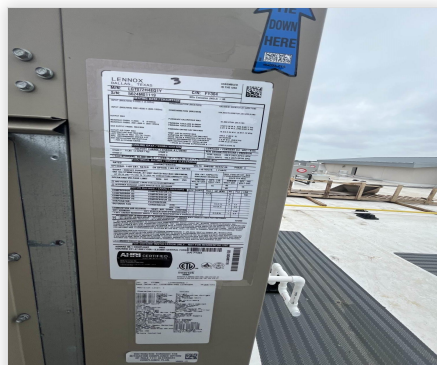
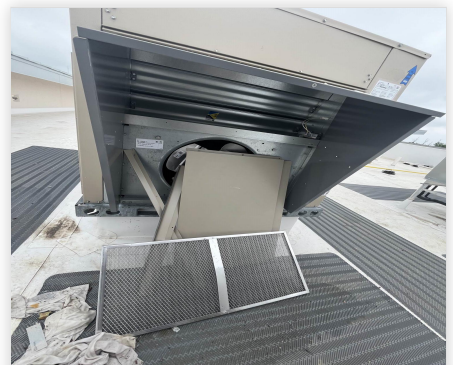
Issue Name : RTU-3 OA hood assembly
Description : RTU-3 components for the OA hood is not fully installed. Recommend mechanical install OA hood for proper functionality of OA intake and avoid debris getting into the mixed air compartment.
Created By : National TAB **Assigned To :** National TAB - Dylan Crisman
Status : Open
Priority : Urgent **Asset Tag :**
Originated Date : 07/28/2025 - Dylan Crisman - National TAB
