Report: Deficiency Report
Function: Test, Adjust, & Balance
Date: 01/24/2025
Completed By: National TAB

PROJECT
01-20-25 CULVERS AVON PARK, FL

01-20-25 CULVERS AVON PARK, FL

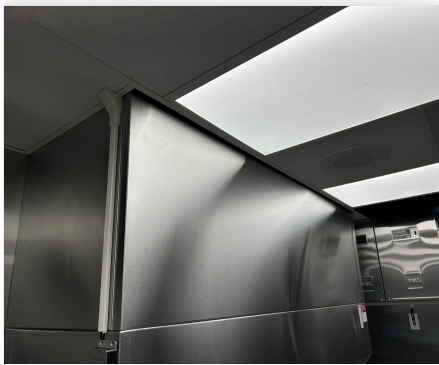
Issue Name : Hoods - Not Sealed At Ceiling
Description : All hoods have a small gap between the top enclosures and ceiling grid. Recommend sealing.
Created By : National TAB **Assigned To :** National TAB - Will Turnbough
Status : Open
Priority : Low **Asset Tag :** HD1
Originated Date : 01/24/2025 - Mark Johnson - National TAB
