PlanGrid Task Report - Feb 14, 2024

L04916_Princeton Woods FSU (Dumfries, VA)

3350 Pine Bluff Drive, Dumfries, Virginia

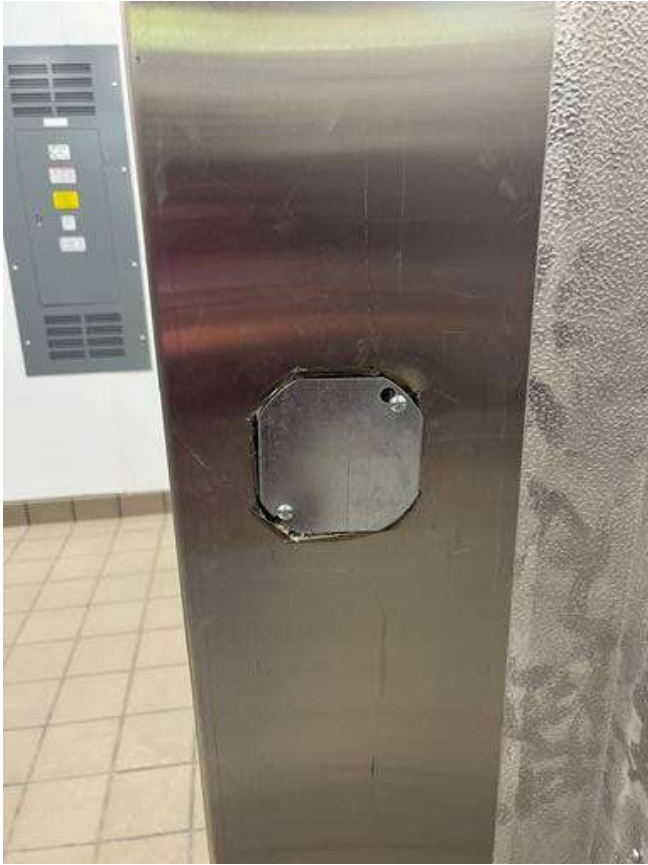
#123 [CNTL 098] Ansul pull labeling.

Missing Ansul Label

Label all Ansul pull stations
for which hoods they serve.

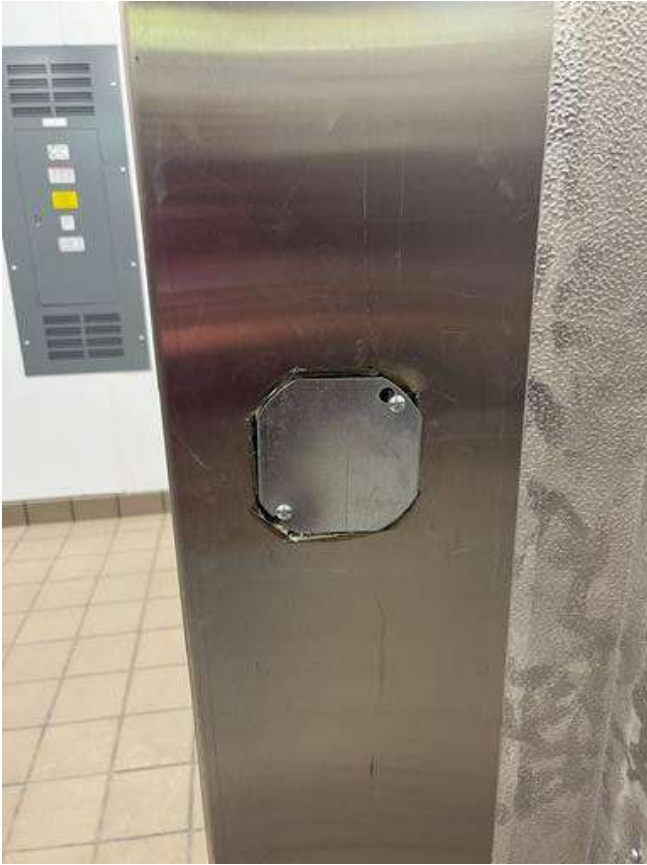
Ansul pull stations are not yet installed at locations designated

Missing Ansul 1

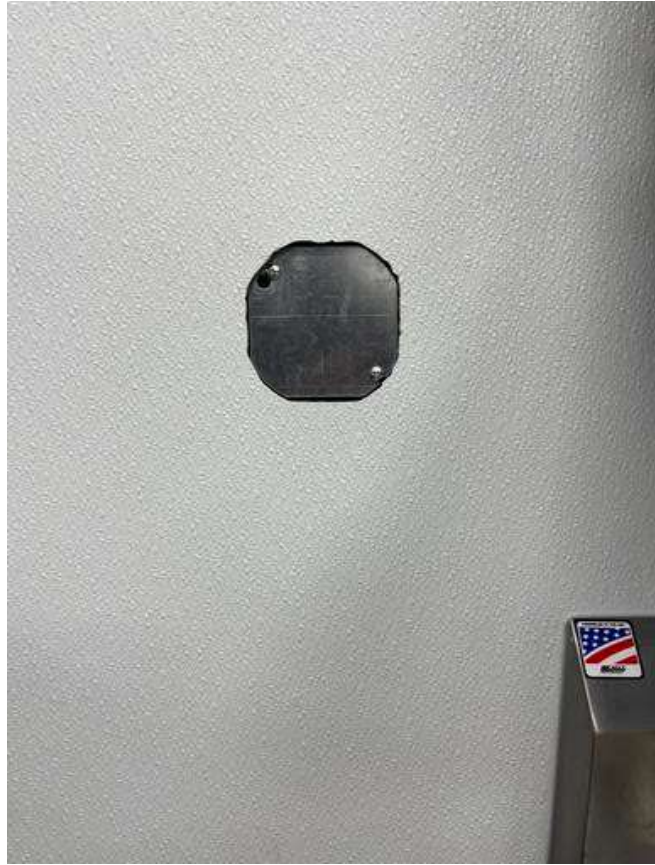
Missing Ansul 2

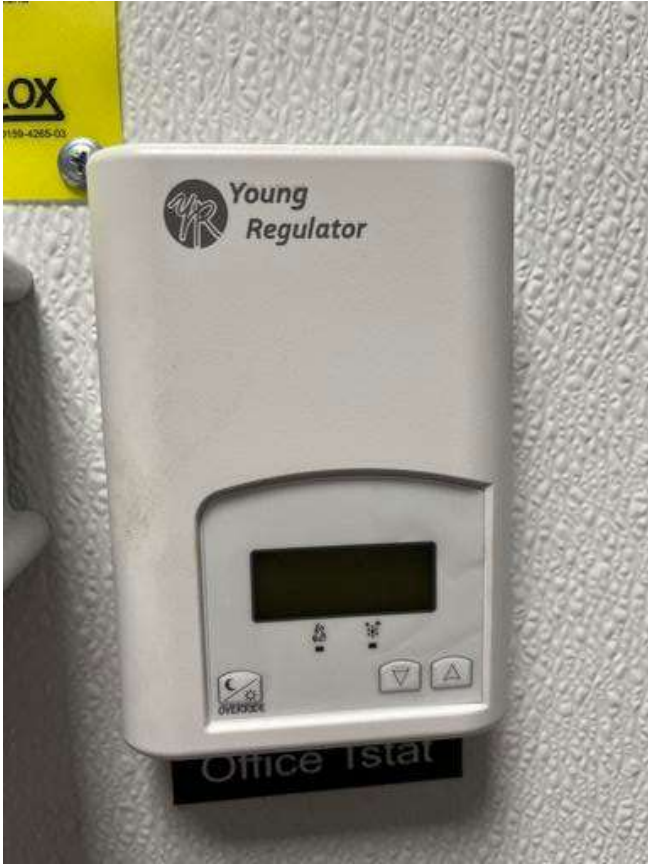
IMG_6512

#121 [CNTL 107] (MISC) Zone Damper Thermostats do not have power

Description
Thermostat controlling zone dampers need transformer installed in order to power thermostats

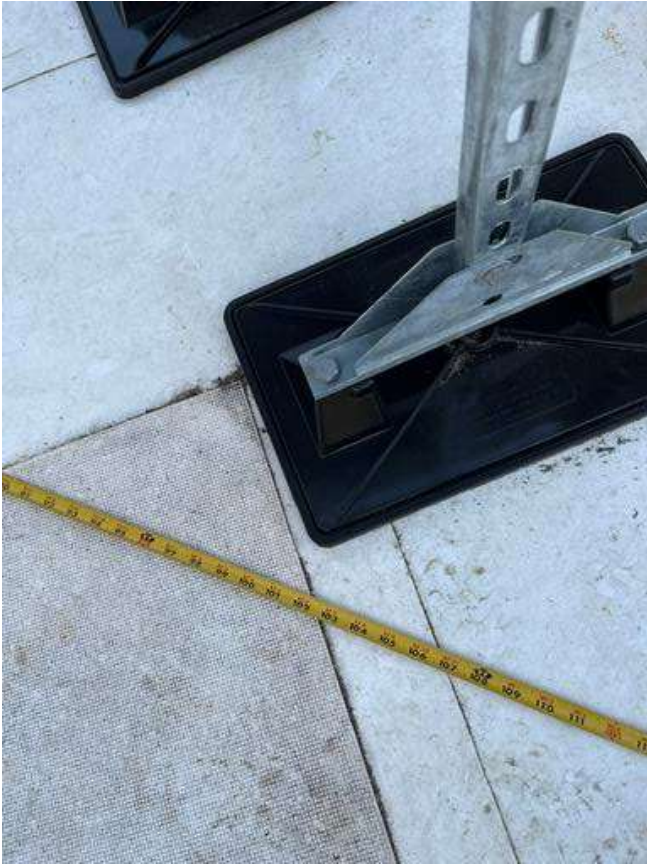
#120 [EXHA 127] Grease exhaust duct is not supported.

Duct Support Spacing

Exhaust duct for EF#1 is to be supported per kitchen hood exhaust fan detail on 6'0" centers.

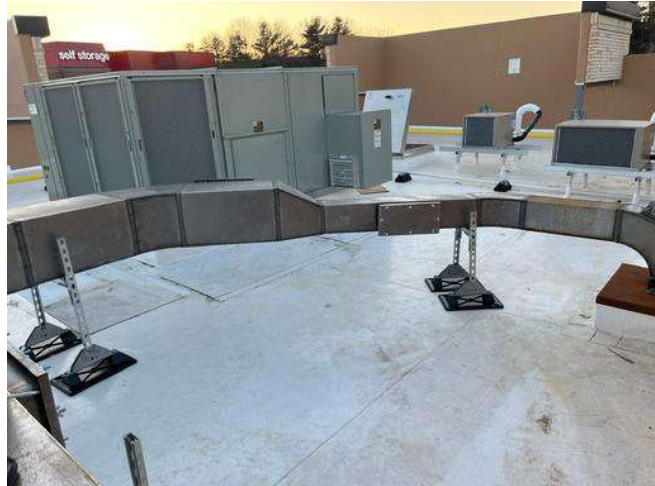
Grease Duct Supports

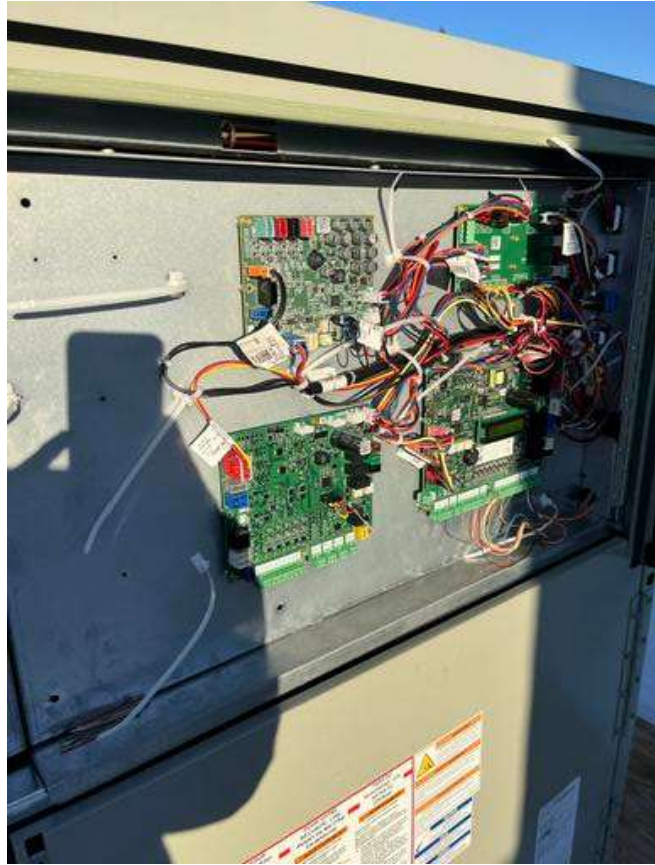
Trane equipment does not have additional manufacturer supplied, field installed relays, delay timer, or discharge temperature controller with FAT scheduled in design.

Missing Delay Timer and Temperature Controller

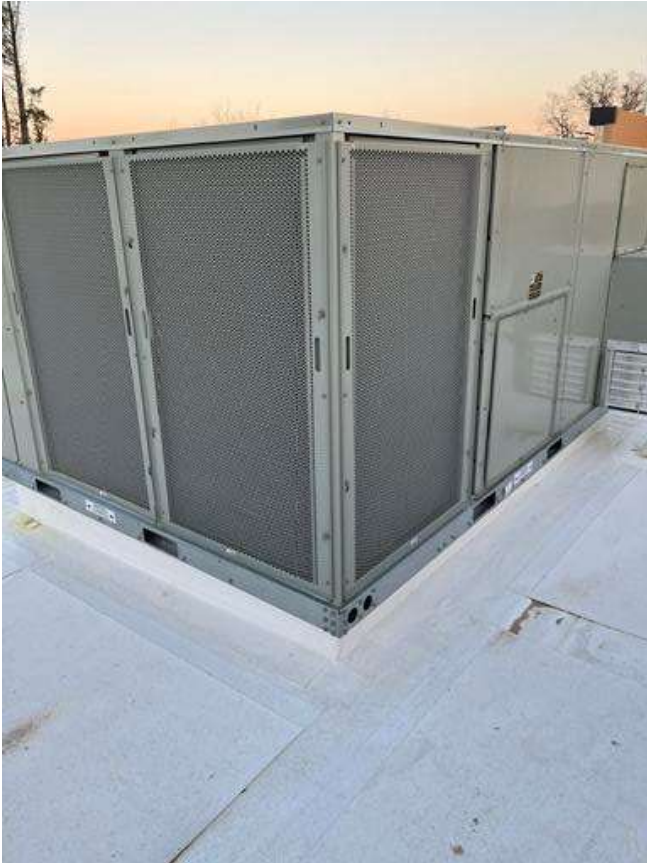
Equipment not secured properly to curb, high wind/ seismic clips not installed. Mechanical stated that unit package did not come with seismic clips.

Missing Seismic Clips
