**Report: Deficiency Report**

**Function: Test, Adjust, & Balance**

**Date: 08/20/2025**

**08-18-25 WAWA #6620 ELKTON, VA**

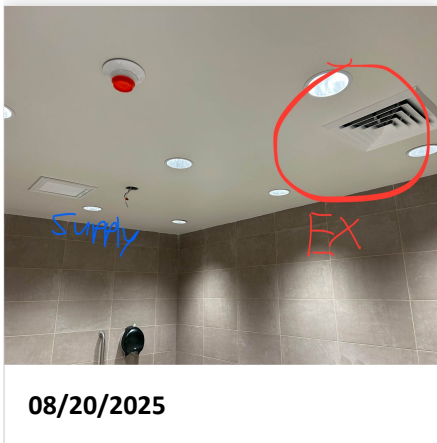
**Issue Name :** Diffuser EF1-2 - Wrong Grille Type  
**Description :** Exhaust diffuser EF1-2 (women's restroom) is using a SD-5 supply grille instead of the required EG-1 exhaust grille. The supply and exhaust grilles in the restroom appear to be swapped. Recommend installing correct grille.  
**Created By :** National TAB                      **Assigned To :** National TAB - Dan Hertenstein  
**Status :** Open  
**Priority :** Low                                      **Asset Tag :**  
**Originated Date :** 08/20/2025 - Mark Johnson - National TAB

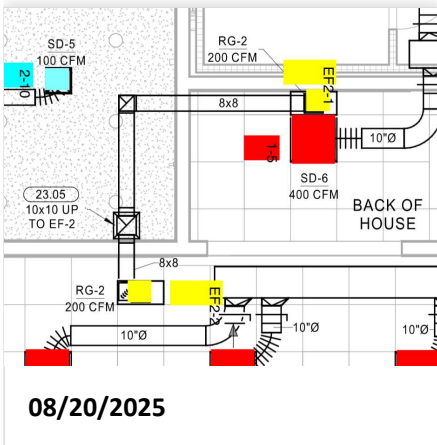
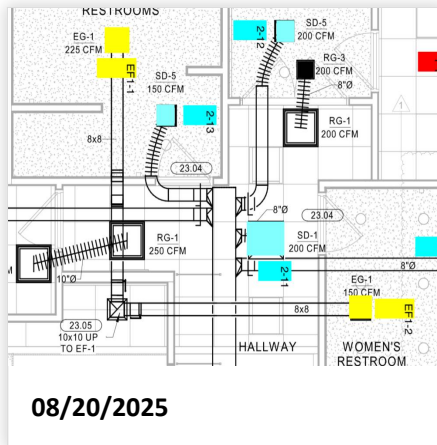
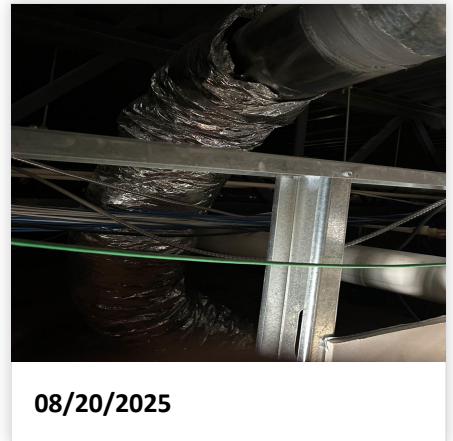
**Issue Name :** Exhaust Ductwork  
**Description :** Exhaust fan ductwork is constructed differently from plans. Mechanical plans specify 8X8 square duct with turning vanes for both rooftop exhaust fans. Installed is 8" round duct with flex at the diffuser connections. This is a 21% reduction of free area and is restricting flow in both exhaust fans. Recommend mechanical inspection.  
**Created By :** National TAB      **Assigned To :** National TAB - Dan Hertenstein  
**Status :** Open  
**Priority :** High      **Asset Tag :**  
**Originated Date :** 08/20/2025 - Mark Johnson - National TAB

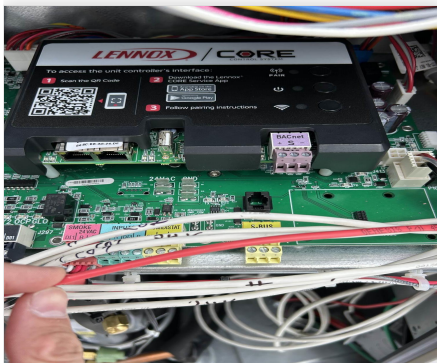
**Issue Name :** RTU 2 - Core Controls  
**Description :** RTU 2's Core control board is not functional. The unit will power on, but the fan remains idle, and parameters cannot be adjusted. Unit cannot be balanced until resolved.  
**Created By :** National TAB                      **Assigned To :** National TAB - Dan Hertenstein  
**Status :** Open  
**Priority :** Urgent                                      **Asset Tag :**  
**Originated Date :** 08/20/2025 - Mark Johnson - National TAB

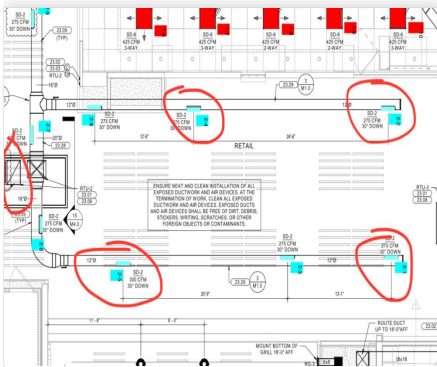
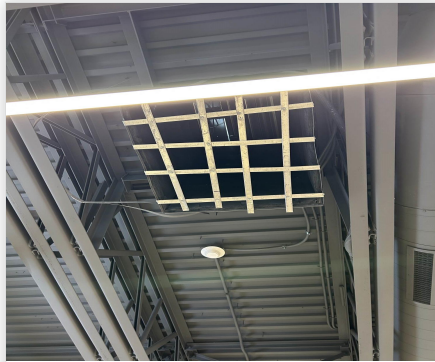
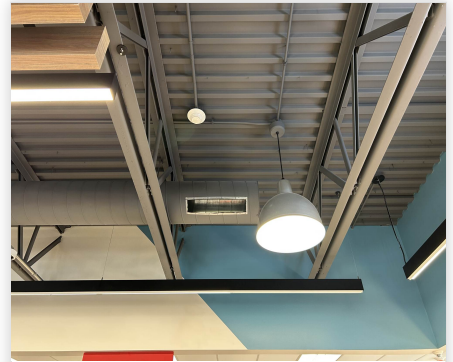
**Issue Name :** RTU 2 - Missing Supply/Return Grilles  
**Description :** RTU 2 is missing several sidewall grilles along the supply duct, and the return grille. Must be installed to balance the individual diffusers.  
**Created By :** National TAB                      **Assigned To :** National TAB - Dan Hertenstein  
**Status :** Open  
**Priority :** High                                      **Asset Tag :**  
**Originated Date :** 08/20/2025 - Mark Johnson - National TAB

- **08/20/2025 National TAB - Mark Johnson**
  - Per GC, missing grilles are on order.

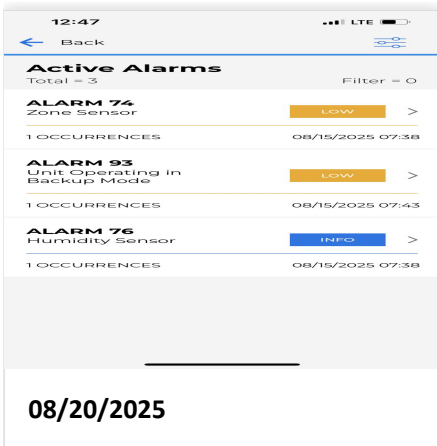
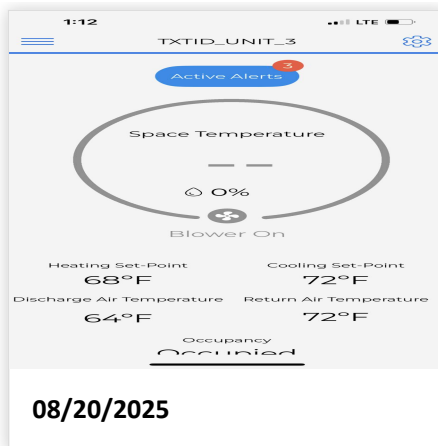
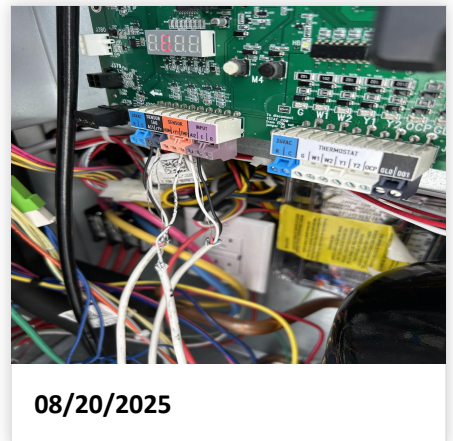
**Issue Name :** RTU 3 - Space Sensor  
**Description :** RTU 3's space sensor is not functional. Unit does not read space temperature/humidity, and the alarms "74 - Zone Sensor", "93 - Unit Operating in Backup Mode", and "76 - Humidity Sensor" are displaying. Recommend service.  
**Created By :** National TAB      **Assigned To :** National TAB - Dan Hertenstein  
**Status :** Open  
**Priority :** High      **Asset Tag :**  
**Originated Date :** 08/20/2025 - Mark Johnson - National TAB
