Report: TAB Report
Function: Test, Adjust, & Balance
Date: 01/26/2026
Completed By: National TAB

PROJECT
08-18-25 WAWA #6620 ELKTON, VA

Project: 08-18-25 WAWA #6620 ELKTON, VA

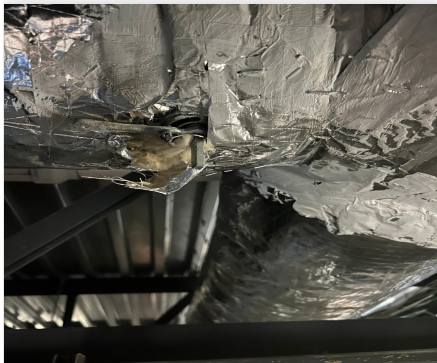
Issue Name : Diffuser 1-1 - Damper Jammed
Description : Diffuser 1-1 (electrical room) is currently at 38% design. Balancing damper is half closed and cannot be opened fully due to jamming. Recommend damper repair.
Created By : National TAB **Assigned To :** National TAB - Dan Hertenstein
Status : Open
Priority : Urgent **Asset Tag :**
Originated Date : 08/21/2025 - Mark Johnson - National TAB

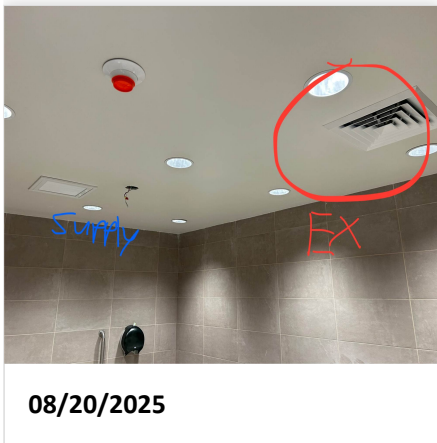
Issue Name : Diffuser EF1-2 - Wrong Grille Type
Description : Exhaust diffuser EF1-2 (women's restroom) is using a SD-5 supply grille instead of the required EG-1 exhaust grille. The supply and exhaust grilles in the restroom appear to be swapped. Recommend installing correct grille.
Created By : National TAB **Assigned To :** National TAB - Dan Hertenstein
Status : Open
Priority : Low **Asset Tag :**
Originated Date : 08/20/2025 - Mark Johnson - National TAB

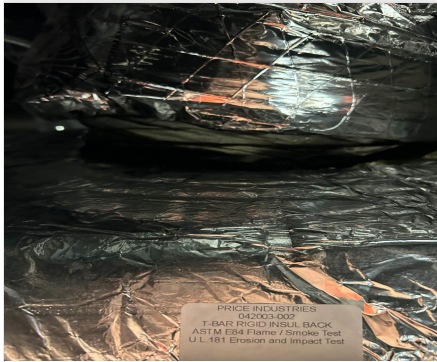
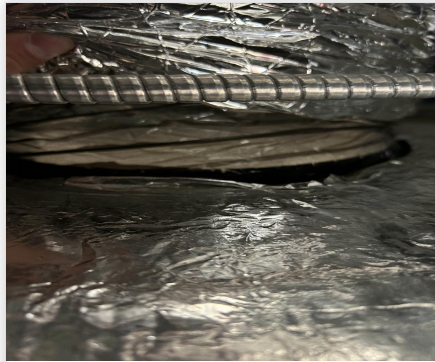
Issue Name : Diffusers 1-7, 1-8 - Duct Connection
Description : Flex duct for supply diffusers 1-6, 1-7 and 1-8 (food service) are fit loosely over the diffuser necks. Recommend securing with zip ties.
Created By : National TAB **Assigned To :** National TAB - Dan Hertenstein
Status : Open
Priority : Medium **Asset Tag :**
Originated Date : 08/21/2025 - Mark Johnson - National TAB

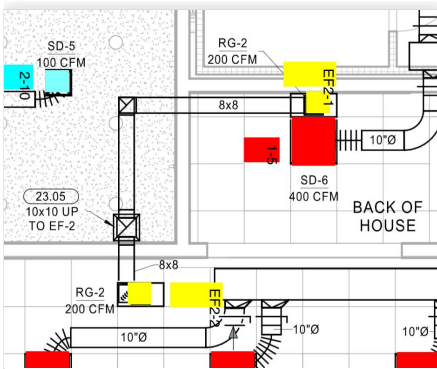
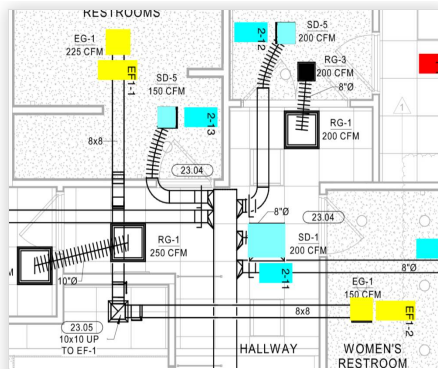
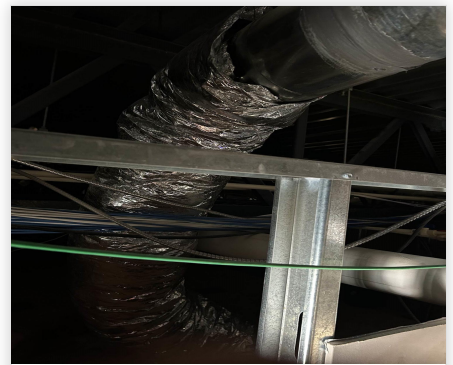
Issue Name : Exhaust Ductwork
Description : Exhaust fan ductwork is constructed differently from plans. Mechanical plans specify 8X8 square duct for both rooftop exhaust fans. Installed is 8" round duct with flex at the diffuser connections.
Created By : National TAB **Assigned To :** National TAB - Dan Hertenstein
Status : Open
Priority : InfoOnly **Asset Tag :**
Originated Date : 08/20/2025 - Mark Johnson - National TAB

- **08/22/2025 National TAB - Mark Johnson**
 - Exhaust fans are fully balanced and are running below FLA and design static pressure.

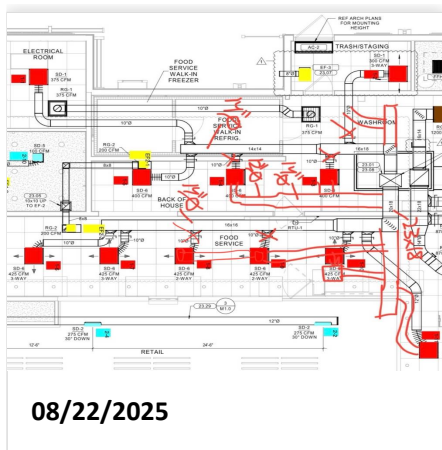
Issue Name : RTU 1 Ductwork
Description : RTU 1 ductwork is constructed differently from plans. See approximate as-built sketch attached. The unit outputs design airflow while running below FLA.
Created By : National TAB **Assigned To :** National TAB - Dan Hertenstein
Status : Open
Priority : InfoOnly **Asset Tag :**
Originated Date : 08/22/2025 - Mark Johnson - National TAB

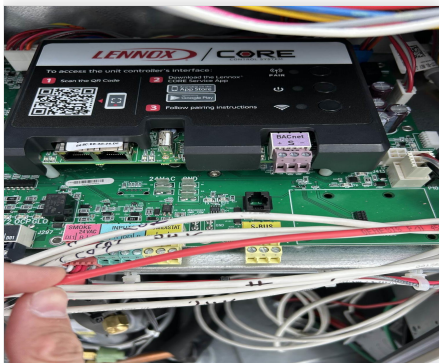
Issue Name : RTU 2 - Core Controls
Description : RTU 2's Core control board is not functional. The unit will power on, but the fan remains idle, and parameters cannot be adjusted. Unit cannot be balanced until resolved.
Created By : National TAB **Assigned To :** National TAB - Dan Hertenstein
Status : Open
Priority : Urgent **Asset Tag :**
Originated Date : 08/20/2025 - Mark Johnson - National TAB

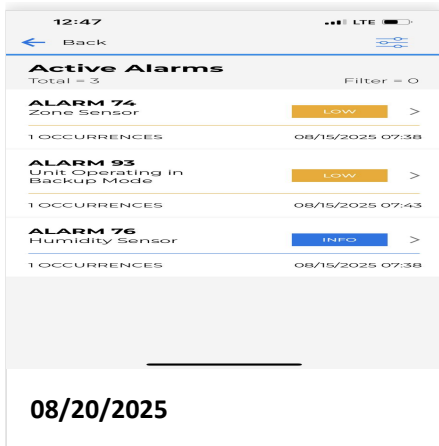
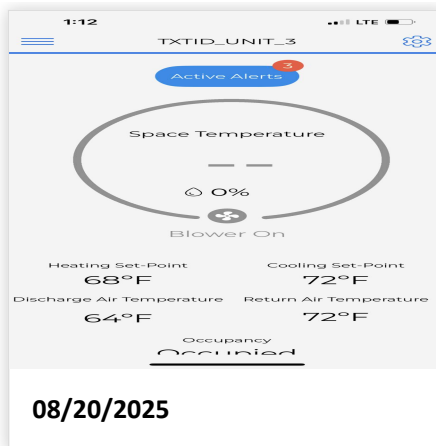
Issue Name : RTU 3 - Space Sensor
Description : RTU 3's space sensor is not functional. Unit does not read space temperature/humidity, and the alarms "74 - Zone Sensor", "93 - Unit Operating in Backup Mode", and "76 - Humidity Sensor" are displaying. Recommend service.
Created By : National TAB **Assigned To :** National TAB - Dan Hertenstein
Status : Open
Priority : High **Asset Tag :**
Originated Date : 08/20/2025 - Mark Johnson - National TAB

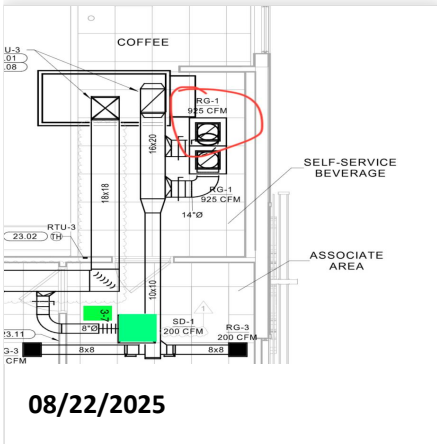
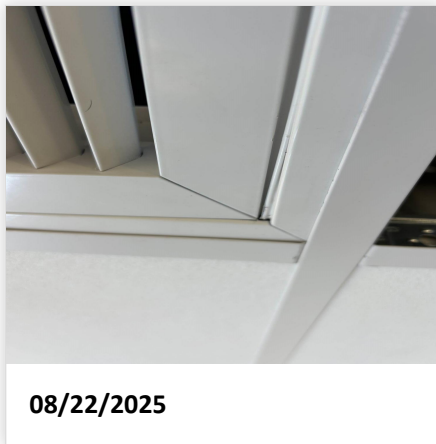
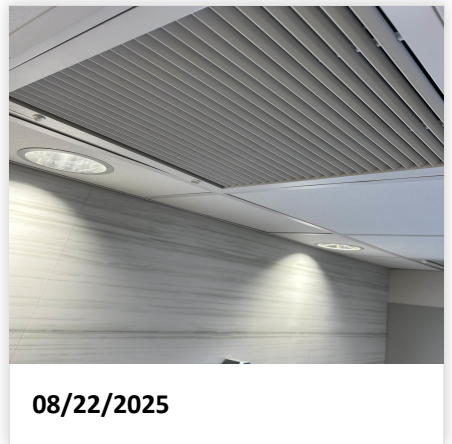
Issue Name : RTU 3 Return Grille Open
Description : A return grille for RTU 3 is stuck partially open. It appears that the hinge is damaged on one side. Recommend repair.
Created By : National TAB **Assigned To :** National TAB - Dan Hertenstein
Status : Open
Priority : Low **Asset Tag :**
Originated Date : 08/22/2025 - Mark Johnson - National TAB
