Report: Remodel Inspection  
Function: Construction Manager  
Date: 12/20/2023

**PROJECT**  
**Sarpinos NLW inspection**

135 AND MISSION

LEAWOOD, KS

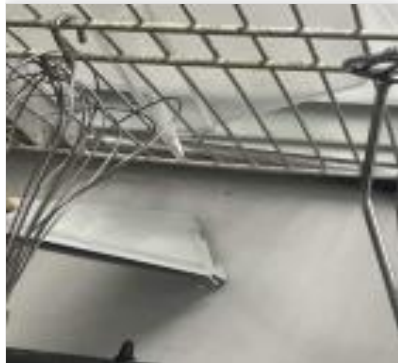
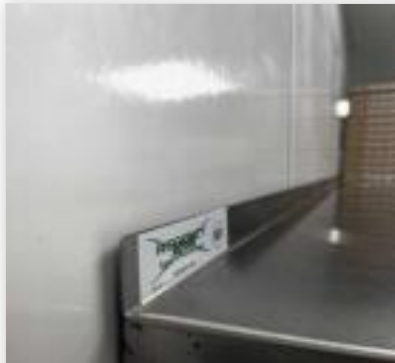
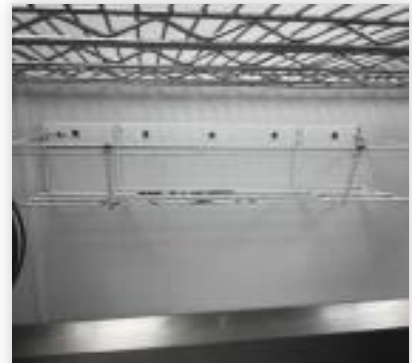
Brackets and Shelf Supports

1: Middle support bracket not installed. 2: s/s shelf not secured to the wall. 3: bracket under the wire shelf needs to be mounted under the triple sink

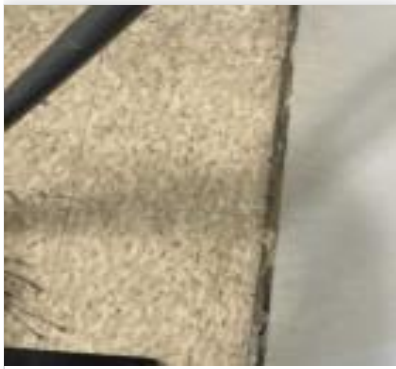
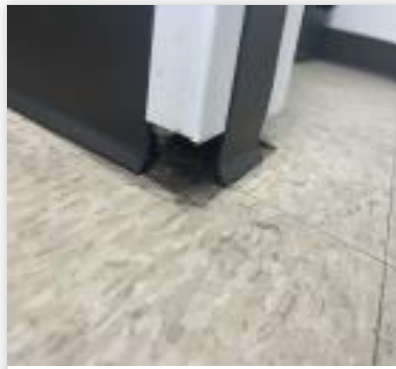
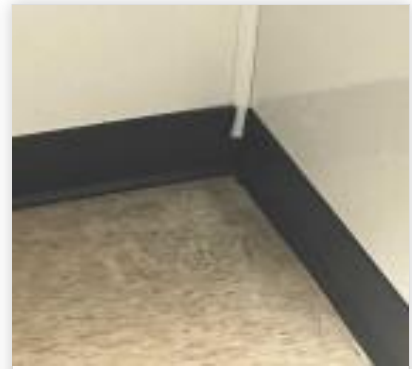
Cove Base & Seal

1: Cove base not complete. 2: Cove base not complete 3. all cove bases need to be sealed especially in triple sink and mop sink area

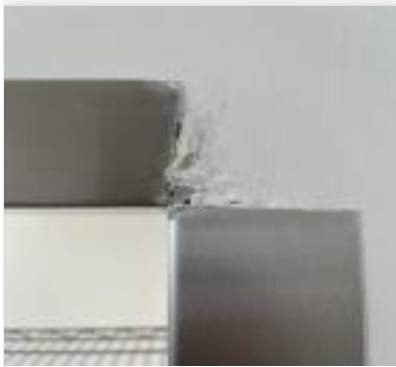
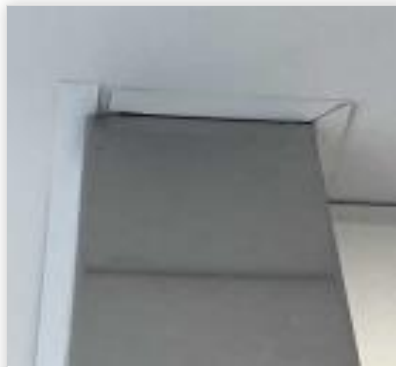
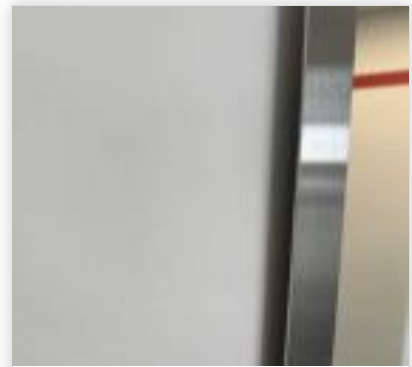
S/S Trim

1: Corner trim is not professionally terminated. 2: Ceiling grid around trip is not professionally terminated. 3: end wall caps have large gaps

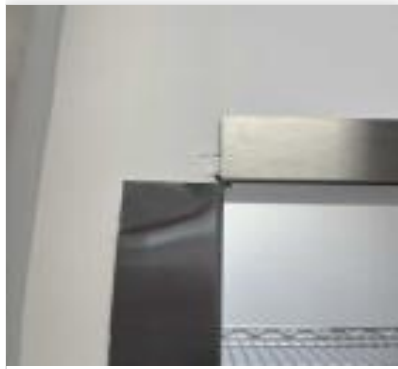
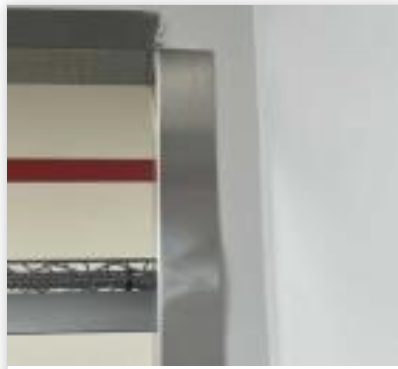
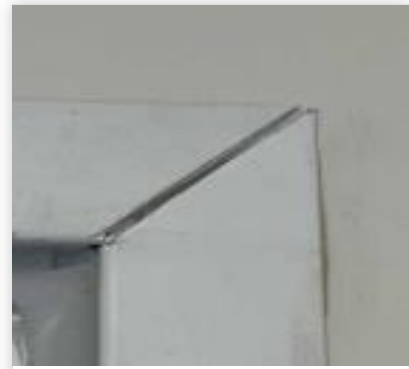
SS Trim

1: Corner trim is not professionally terminated. 2: s/s trim is bent. 3: Door trim not sealed

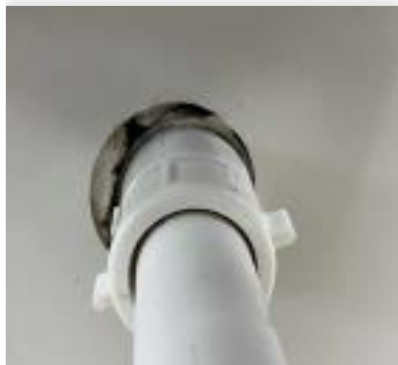
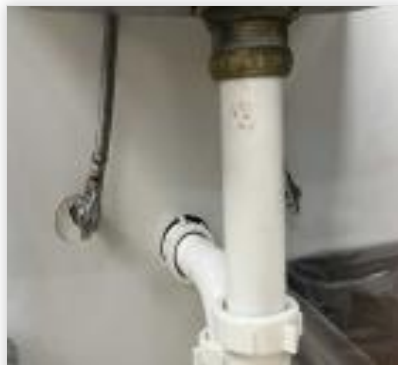
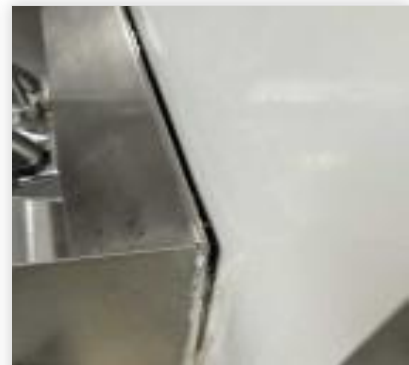
Sinks / Caulk

1: Oversized FRP holes cut for sink drain and not sealed. 2: Oversized FRP holes cut for water lines and not sealed 3: Sinks not caulked to wall

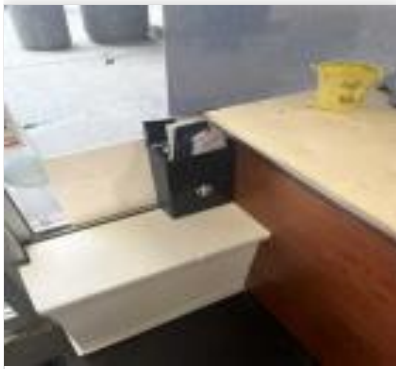
Window Seal and S/S end cap seal

1: Window seal gap needs to be sealed

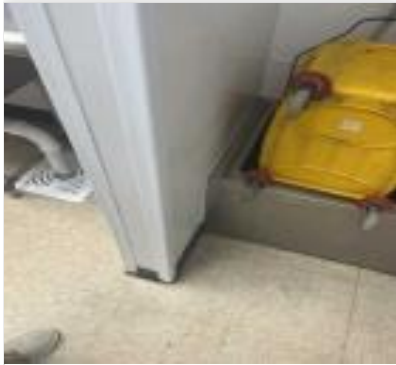
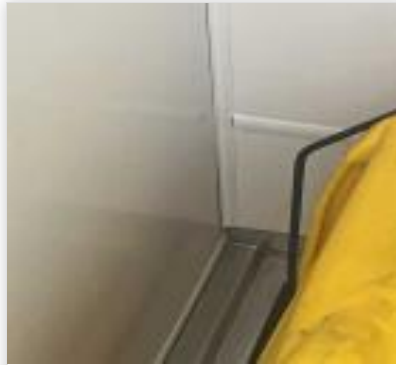
Mop Sink Area

All FRP and Base cove areas around wet areas need to be sealed

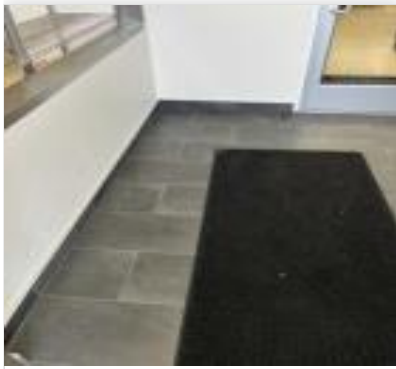
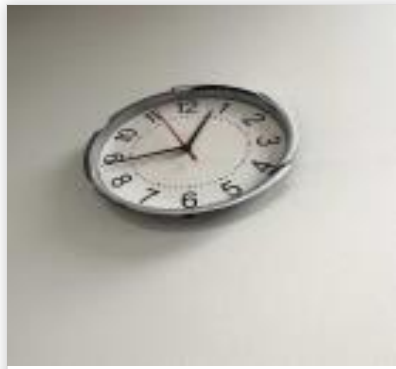
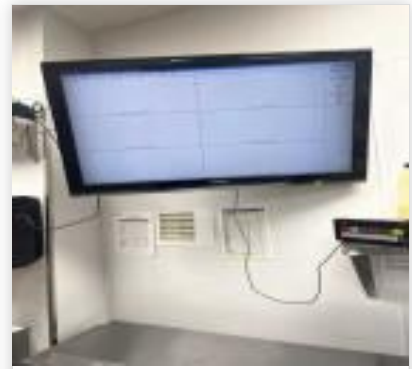
Mislaneous

1: Is front tile sealed? 2: Clock needs to be replaced (owner) 3: Monitor should be moved down 6 inches

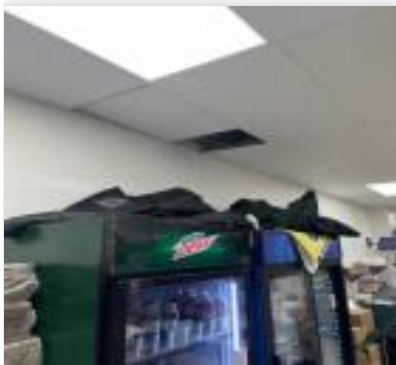
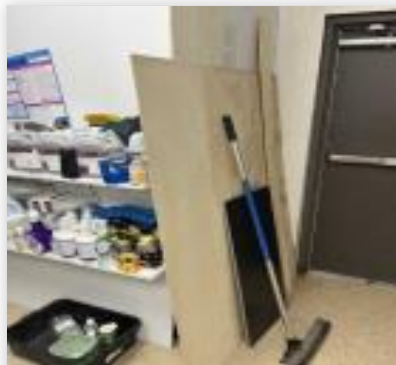
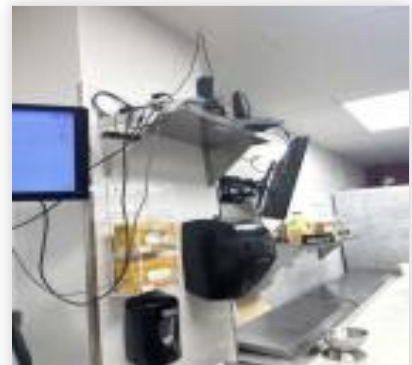
Mislaneous

1: Pizza bags on top of soda machines should be removed (owner) - Ceiling tile replaced 2: Construction debris needs to be removed from the site 3: Wires need to be organized

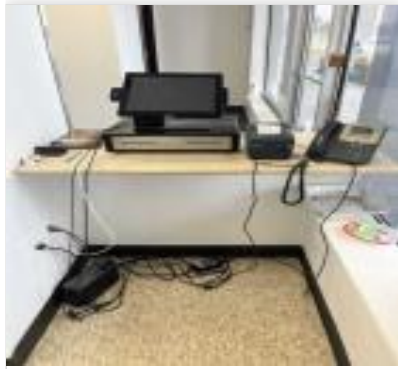
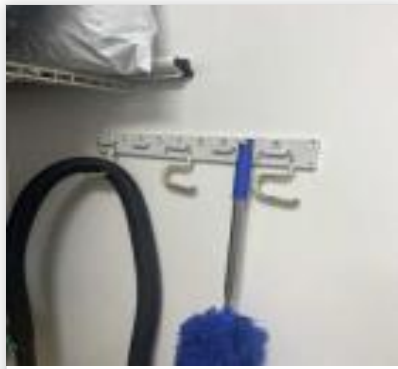
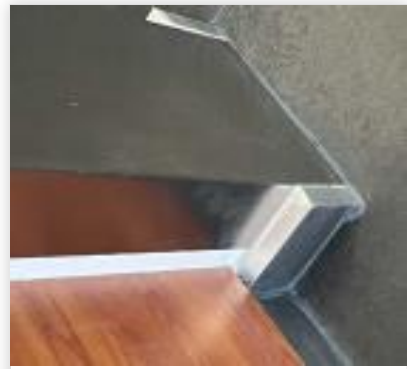
Mislaneous

1: Counter not installed (owner) 2: Mop bracket is hung to low 3: Cove base is not complete
