Report: Punch List
Function: Test, Adjust, & Balance
Date: 12/09/2025
Completed By: National TAB

PROJECT
12-08-25 FREDDYS MIDDLETOWN, DE

Project: 12-08-25 FREDDYS MIDDLETOWN, DE

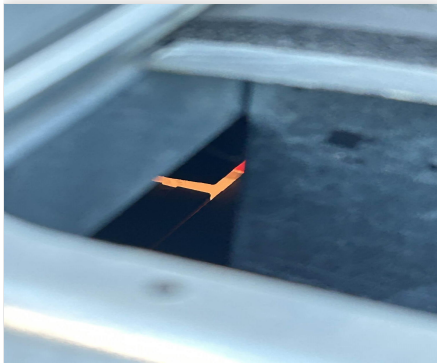
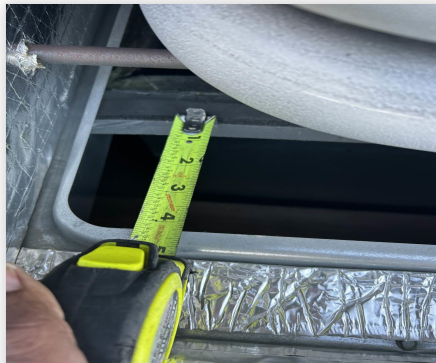
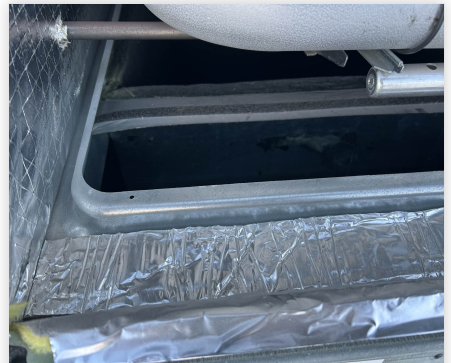
Issue Name : RTU 1 low flow
Description : RTU 1 supply drop has a 4" opening and is not properly attached to discharge. Unit is losing air inside the ceiling.
Created By : National TAB **Assigned To :** National TAB - Dan Hertenstein
Status : Open
Priority : Urgent **Asset Tag :** RTU1
Originated Date : 12/09/2025 - Jearod Ferrette - National TAB
