**Report: TAB Report**  
**Function: Test, Adjust, & Balance**  
**Date: 10/10/2025**  
**Completed By: National TAB**

**PROJECT**  
**10-06-25 CHIPOTLE #5285 CLAYMONT, DE**  
**NEED**  
**CLAYMONT, DE 19703**

Project: 10-06-25 CHIPOTLE #5285 CLAYMONT, DE

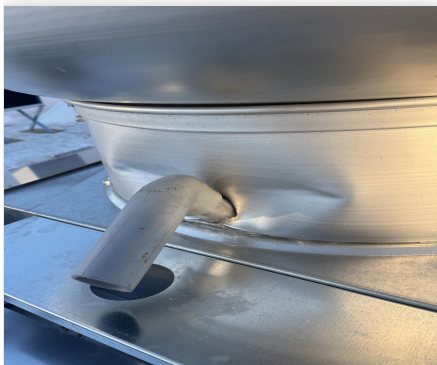
**Issue Name :** EF-1 Grease drain damaged  
**Description :** EF-1 Grease drain is damaged. Grease will not be able to drain from the fan and cause buildup.  
**Created By :** National TAB                      **Assigned To :** National TAB - Dan Hertenstein  
**Status :** Open  
**Priority :** High                                      **Asset Tag :**  
**Originated Date :** 10/09/2025 - Tyler Youells - National TAB

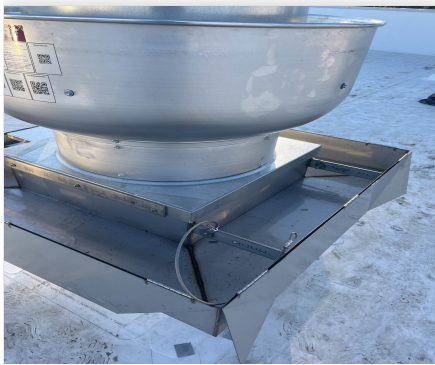
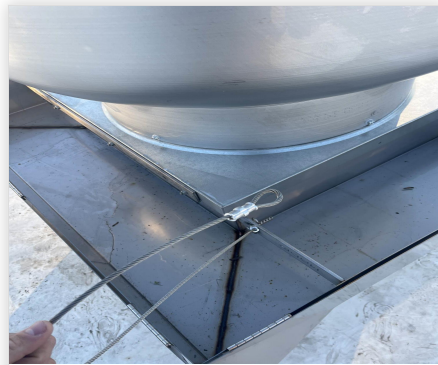
**Issue Name :** EF-1 hinge restraints  
**Description :** Hinge restraints have not been connected for KEF-1 Fan will lean all the way back and likely flip and get damaged  
**Created By :** National TAB                      **Assigned To :** National TAB - Dan Hertenstein  
**Status :** Open  
**Priority :** Low                                      **Asset Tag :**  
**Originated Date :** 10/09/2025 - Tyler Youells - National TAB

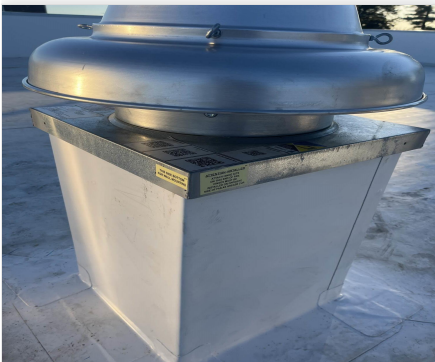
**Issue Name :** EF-2 Not secured to the curb  
**Description :** Secure EF-2 to the curb at each corner  
**Created By :** National TAB                      **Assigned To :** National TAB - Dan Hertenstein  
**Status :** Open  
**Priority :** Low                                      **Asset Tag :**  
**Originated Date :** 10/09/2025 - Tyler Youells - National TAB

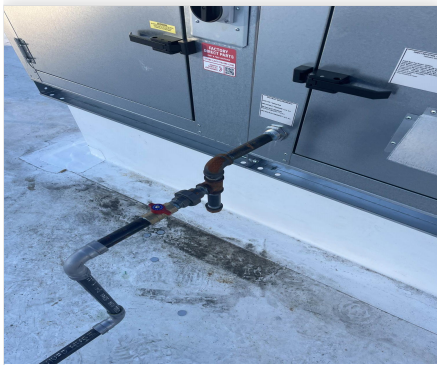
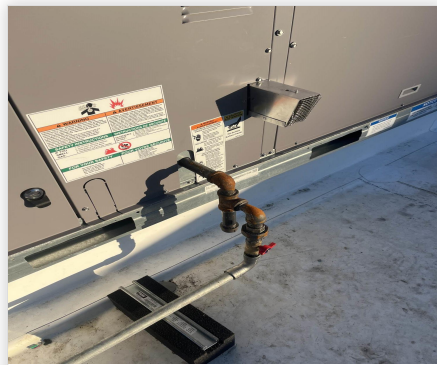
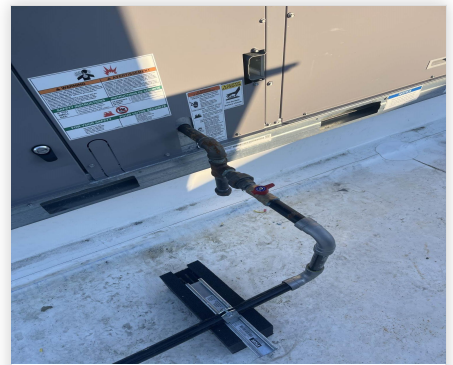
**Issue Name :** HVAC gas Valves  
**Description :** HVAC gas valves not turned on at time of tab. Once gas is on ensure proper heater startups have been completed  
**Created By :** National TAB                      **Assigned To :** National TAB - Dan Hertenstein  
**Status :** Open  
**Priority :** Medium                                      **Asset Tag :**  
**Originated Date :** 10/09/2025 - Tyler Youells - National TAB

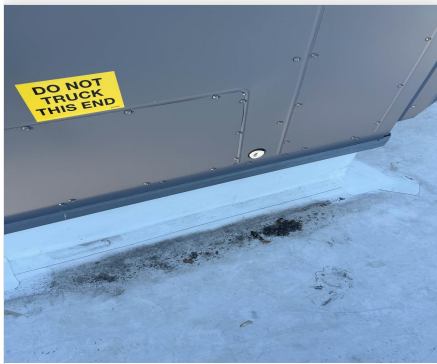
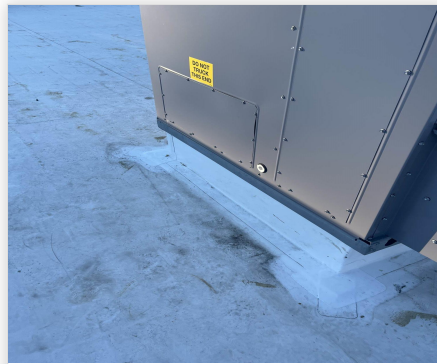
**Issue Name :** RTU- Condensate drains  
**Description :** Install condensate drains  
**Created By :** National TAB                      **Assigned To :** National TAB - Dan Hertenstein  
**Status :** Open  
**Priority :** Low                                      **Asset Tag :**  
**Originated Date :** 10/09/2025 - Tyler Youells - National TAB

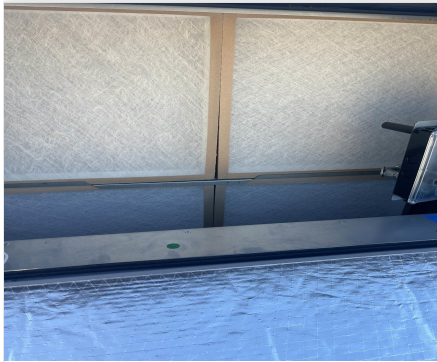
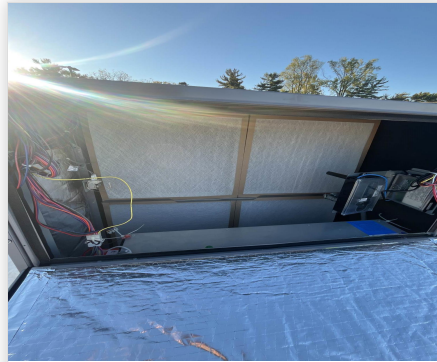
**Issue Name :** RTU-Filters  
**Description :** Construction filters still installed at time of TAB. Replace with Correct MERV rated filters prior to turnover.  
**Created By :** National TAB                      **Assigned To :** National TAB - Dan Hertenstein  
**Status :** Open  
**Priority :** Low    **Asset Tag :**  
**Originated Date :** 10/09/2025 - Tyler Youells - National TAB
