**Report: TAB Report**  
**Function: Test, Adjust, & Balance**  
**Date: 03/30/2026**  
**Completed By: National TAB**

**PROJECT**  
**01-25-26 QT #1182 COLUMBIA, SC**

580 JAMIL RD

QUIKTRIP  
4705 SOUTH 129TH EAST AVENUE  
TULSA, OK 74134

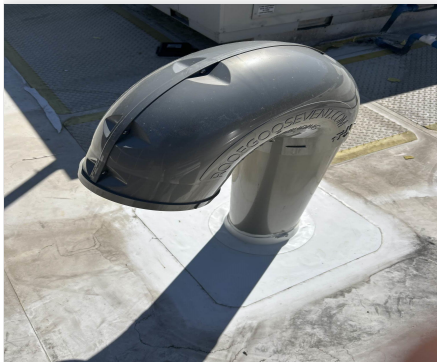
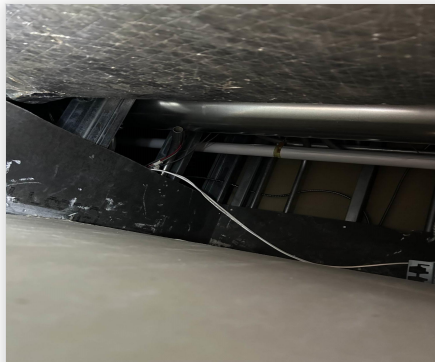
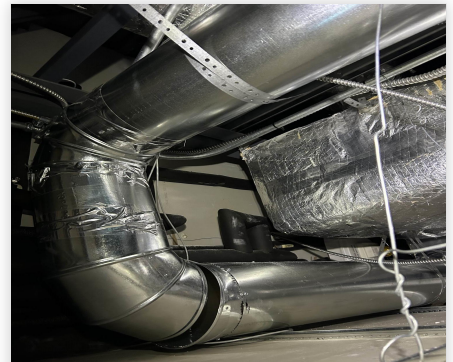
**Issue Name :** EF-1 combo-oven grille/ no access  
**Description :** EF-1 does not serve the combo-oven grille as planned. New asset was installed with an inline fan. Unable to access motor assembly. The unit is powered off and ductwork not connected. Install needs to be completed and a speed controller installed.  
**Created By :** National TAB                      **Assigned To :** National TAB - Dan Hertenstein  
**Status :** Open  
**Priority :** High                                      **Asset Tag :** EF2  
**Originated Date :** 03/17/2026 - Jearod Ferrette - National TAB

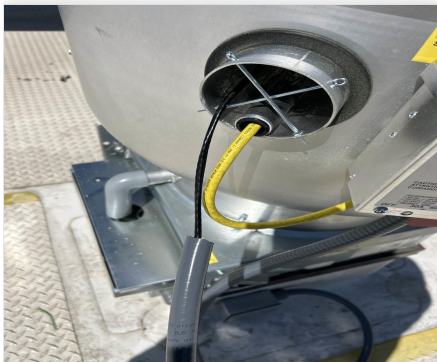
**Issue Name :** Expose wires  
**Description :** Cat 5 cable exposed from conduit  
**Created By :** National TAB                      **Assigned To :** National TAB - Dan Hertenstein  
**Status :** Open  
**Priority :** Medium                                      **Asset Tag :** EF3  
**Originated Date :** 03/17/2026 - Jearod Ferrette - National TAB

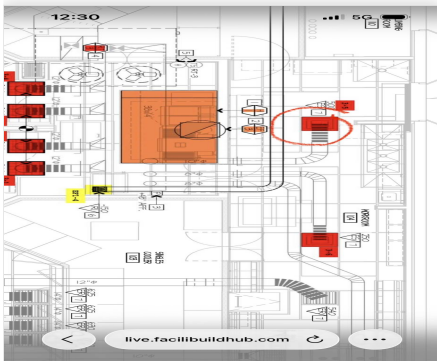
**Issue Name :** RTU 3 damper  
**Description :** SGRD 3-5 non-functioning damper. Change direction of damper handle and no change to airflow. unable to proportionally balance unit due air forced to back 3 diffusers.  
**Created By :** National TAB                      **Assigned To :** National TAB - Dan Hertenstein  
**Status :** Open  
**Priority :** Medium                                      **Asset Tag :** SGRD5  
**Originated Date :** 03/17/2026 - Jearod Ferrette - National TAB

Asset	Notes	Date	Written By
SGRD5	NON-FUNCTIONING DAMPER	03/17/2026	Jearod Ferrette

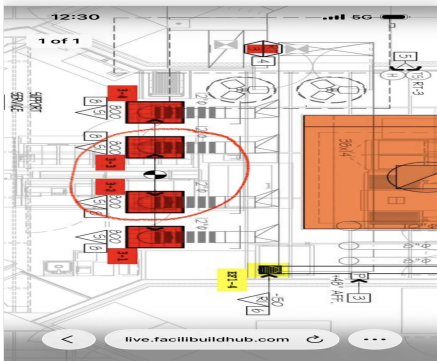
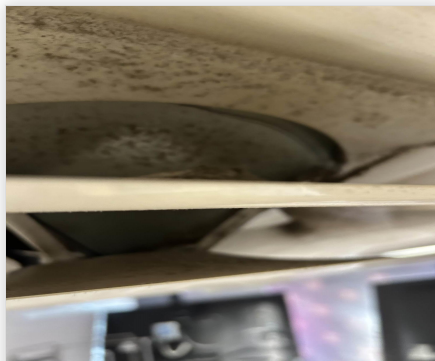
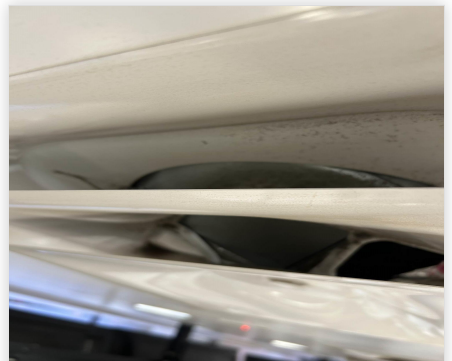
**Issue Name :** RTU 3 restricted air flow  
**Description :** SGRD 3-2/3-3 has a face damper which is restricting flow and putting the RTU at a high static pressure. Dampers from the trunk are 100% open, but the face dampers are restricting the air.  
**Created By :** National TAB                      **Assigned To :** National TAB - Dan Hertenstein  
**Status :** Open  
**Priority :** High                                      **Asset Tag :** RT-3  
**Originated Date :** 03/17/2026 - Jearod Ferrette - National TAB

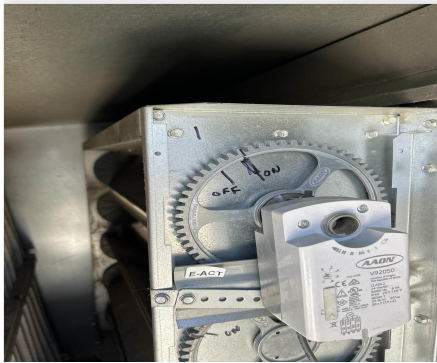
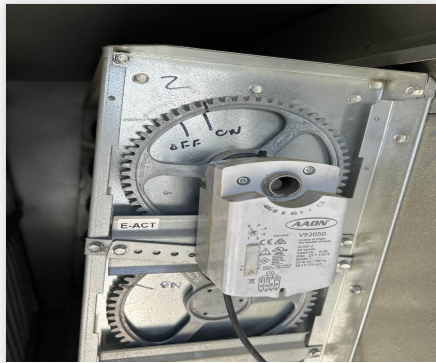
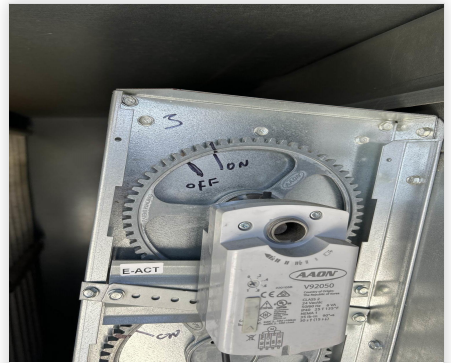
**Issue Name :** RTU OA wiring  
**Description :** It seems the dampers are wired / operating in reverse. Set point for hood on at 46%, normally 26% would close the damper but it's actually opening them more. Manually set and marked on units.  
**Created By :** National TAB                      **Assigned To :** National TAB - Dan Hertenstein  
**Status :** Open  
**Priority :** High                                      **Asset Tag :** HVAC EQUIPMENT1  
**Originated Date :** 03/17/2026 - Jearod Ferrette - National TAB

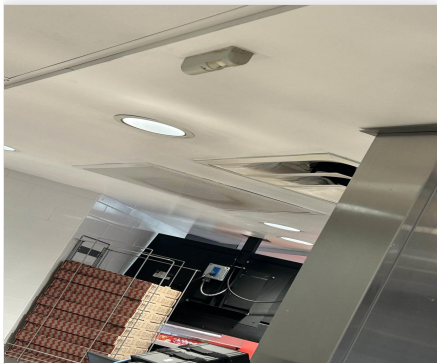
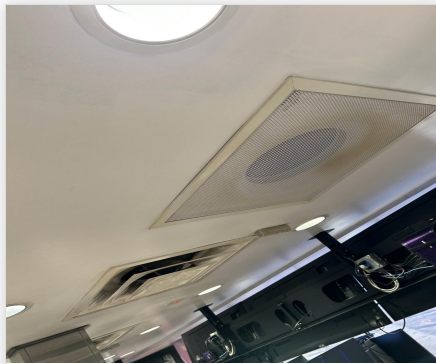
**Issue Name :** Specified diffusers not installed  
**Description :** Specified diffusers not installed  
**Created By :** National TAB                      **Assigned To :** National TAB - Dan Hertenstein  
**Status :** Open  
**Priority :** High                                      **Asset Tag :** RT-3  
**Originated Date :** 03/17/2026 - Jearod Ferrette - National TAB
