08/29 SHAKE SHACK #1356 - HINGHAM, MA (TAB + IAQ)**CheckList Information**

Name : TECH - IAQ INSTALL **Status :** NotSubmitted
Assigned Organization : National TAB **Asset :**
Requesting Organization : National TAB

INDOOR AIR QUALITY - PHI TECHNOLOGY SYSTEM

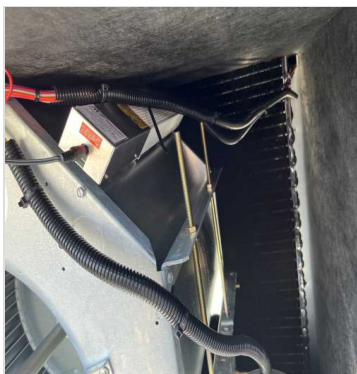
Image_85_.jpeg

Picture of the Package PHI Installed?

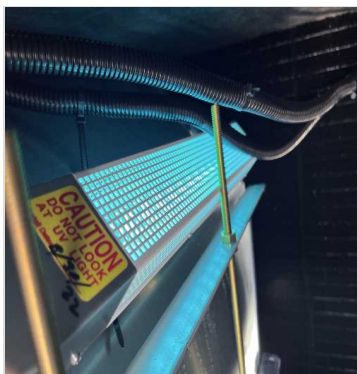
Image_86_.jpeg

Picture of the Package PHI on (if safely accessible)?
