**08/29 SHAKE SHACK #1356 - HINGHAM, MA (TAB + IAQ)****CheckList Information**

**Name :** TECH - IAQ INSTALL **Status :** NotSubmitted  
**Assigned Organization :** National TAB **Asset :**  
**Requesting Organization :** National TAB

RTU# / Area Served	RTU-2 / DINING
Model # of Unit	48HCFD09A2Q6A6U1M0
S/N of Unit	2922P79614

**INDOOR AIR QUALITY - PHI TECHNOLOGY SYSTEM**

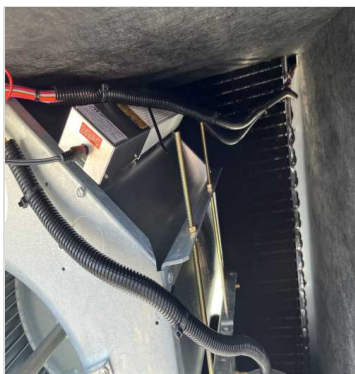
Image\_85\_.jpeg

Picture of the Package PHI Installed?

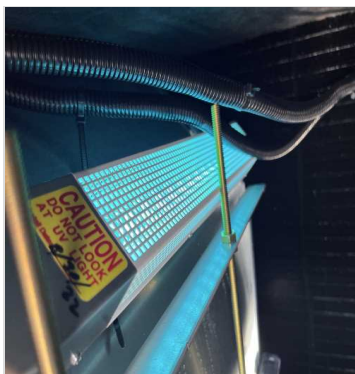
Image\_86\_.jpeg

Picture of the Package PHI on (if safely accessible)?

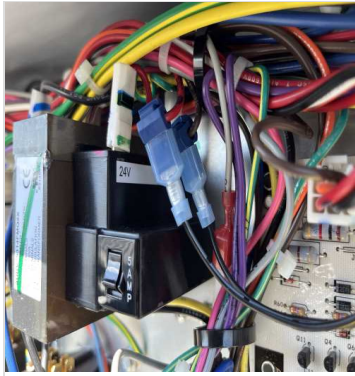
Image\_88\_.jpeg

Picture of where the wires are landed at the transformer or inside the RTU?

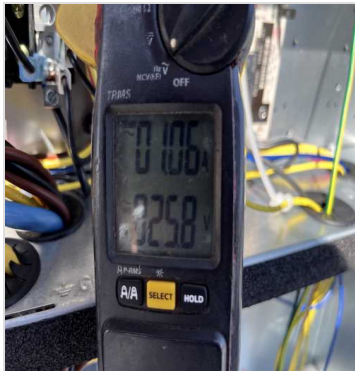
Image\_87\_.jpeg

Measure Voltage reading to PHI units	25.8 V
--------------------------------------	--------

Picture of clamp meter showing correct voltage and amperage?
