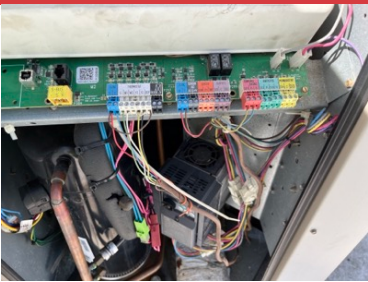
RTU 1 CONTROLS WIRING

OCP jumper installed. Y1 & Y2 jumpered.

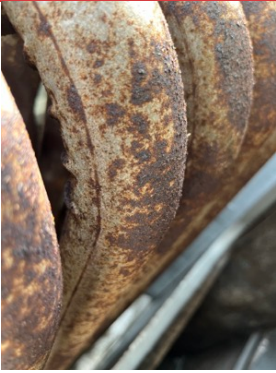
RTU 1 HEAT EXCHANGER TUBES RUSTY

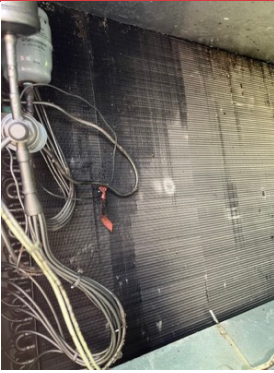
RTU 1 DX COIL DIRTY

Blower side

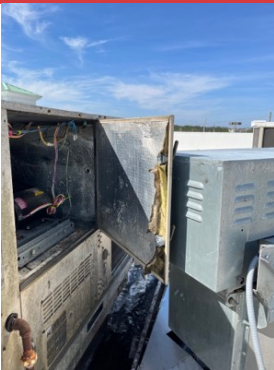
RTU 1 DOOR INTERFERENCE

Blower compartment cannot fully be opened due to kitchen exhaust fan location.

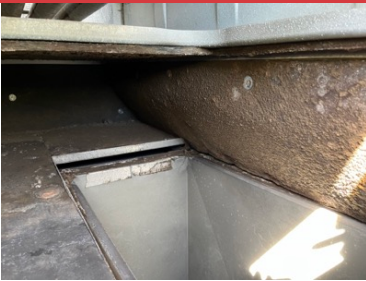
RTU 2 CURB ADAPTER (DISCHARGE SIDE)

Typical of both RTUs.

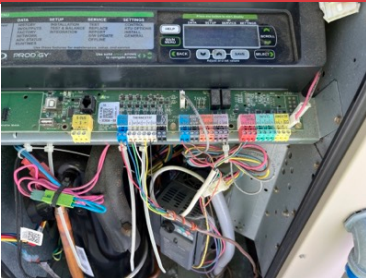
RTU 2 CONTROLS WIRING

OCP jumper installed.
