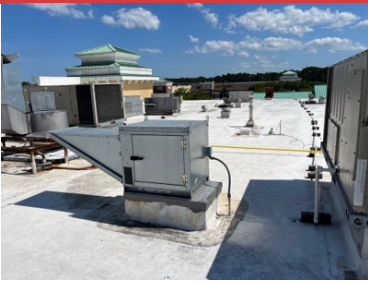
MUA TURNED 180 DEGREES

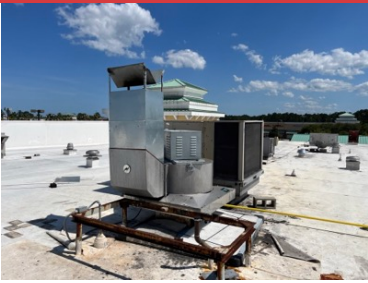
KEF DISCHARGE CORRECTED

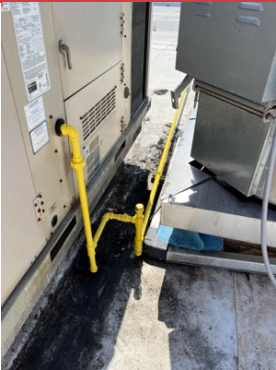
GAS LINES PAINTED

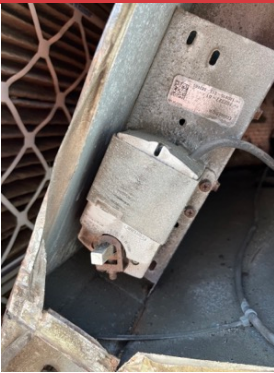
KITCHEN RTU ECON NOT FUNCTIONAL

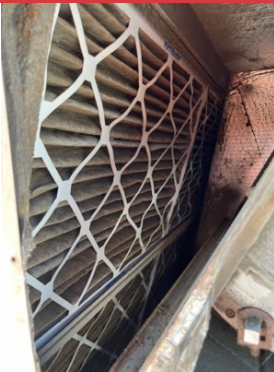
KITCHEN RTU FILTERS DIRTY

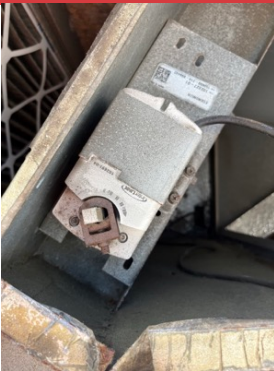
DINING ECON NOT CLOSING FULLY

Set screw rusted. May be able to free with rust penetrant and re-set to fully closed position when unit off.

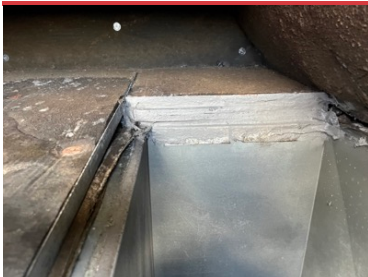
DINING RTU SUPPLY DROP

Leakage mostly resolved but some gaps are still present

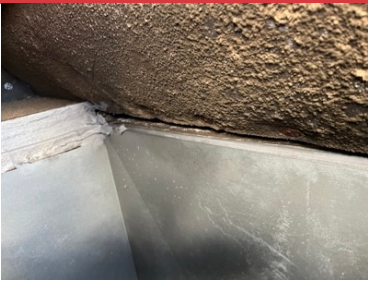
DINING RTU SUPPLY DROP

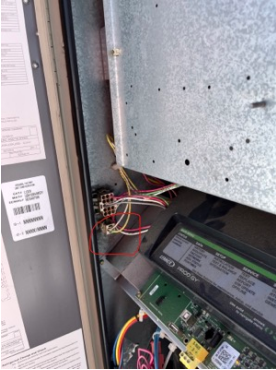
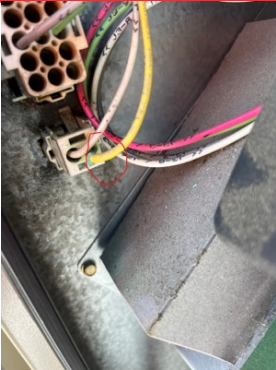
DINING RTU DAMAGED WIRE

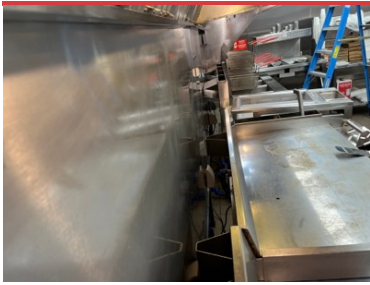
EQUIPMENT SPACING FROM WALL

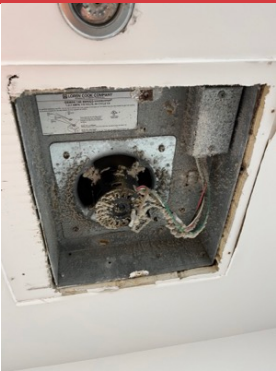
RESTROOM EXHAUST FANS DIRTY AND LOSING PERFORMANCE

Women's restroom seen here.

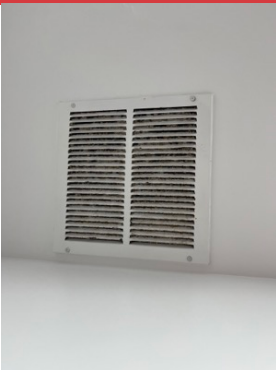
RESTROOM EF GRILLS DIRTY
