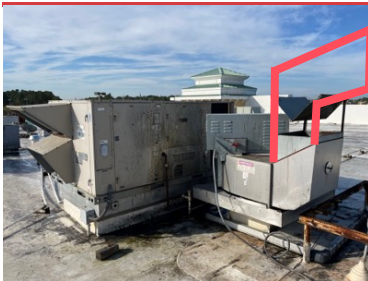
RTU 1 - KITCHEN

Grease discharge is causing maintenance issue for RTU & will degrade life of unit. Recommend installing a galvanized discharge duct on fan. Route 18" vertical before directing 45 degree on low side & go at least 12" to 18" on short side of 45"

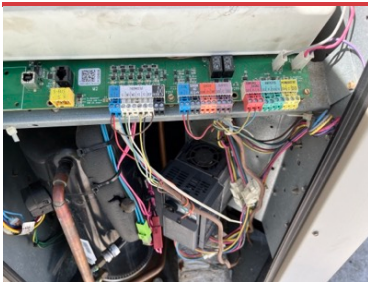
RTU 1 CONTROLS WIRING

OCP jumper installed. Y1 & Y2 jumpered.

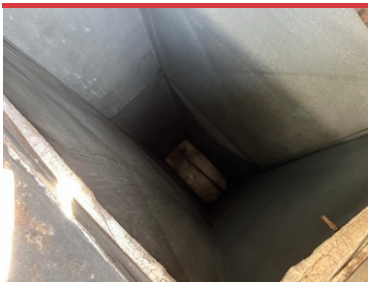
RTU 1 SUPPLY DROP

The inside of the supply ducts in both systems are fairly clean.

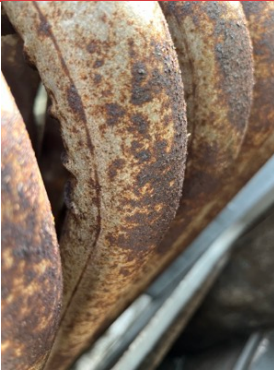
RTU 1 HEAT EXCHANGER TUBES RUSTY

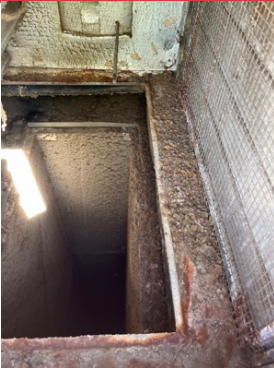
RTU 1 RETURN

Inside Mixed air plenum prior to Dx Coil. Make sure return duct & curb adapter are sealed properly for no leakage

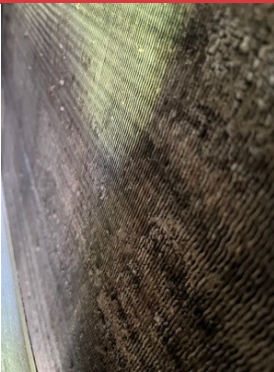
RTU 1 DX COIL

At one time the unit did not have proper size filters installed in unit causing debris to build up on exposed coil. Current filters are adequate size & are covering the coil completely.

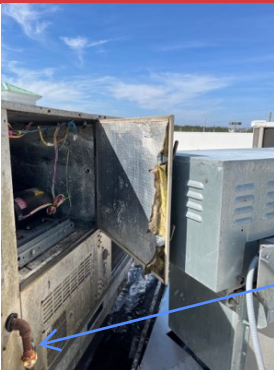
RTU 1 DOOR INTERFERENCE

Blower compartment cannot fully be opened due to kitchen exhaust fan location.

Also, ideal to always paint gas piping on roof for future projects. Existing piping have to be sanded down & then primed & then painted. There is just about 5 or 6 ft for each unit that is not painted at this location.

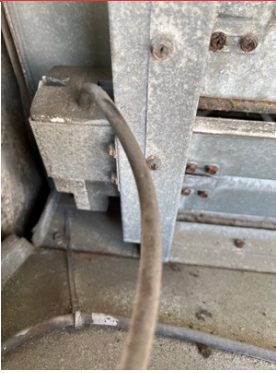
RTU 1 ECONOMIZER NOT FUNCTIONAL

Motor not moving, arm damaged where it attaches to damper.

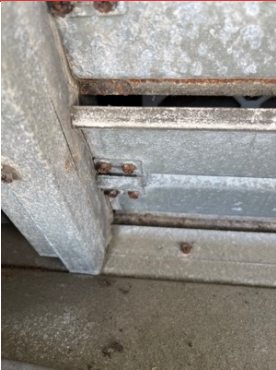
RTU 1 DAMPER POSITION (Outside air damper)

Set manually to 3/4" by NTAB. Damper was previously closed.

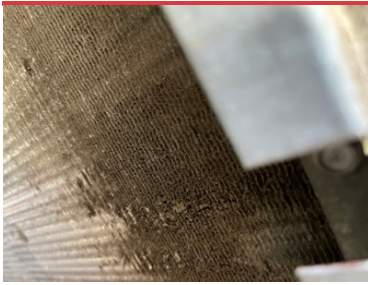
RTU 2 DX COIL

Similar to RTU1. Proper filters are installed now.

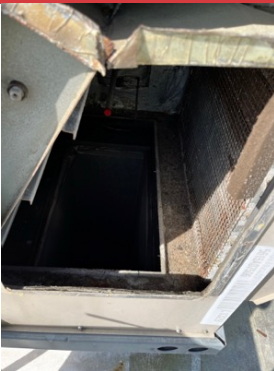
RTU 2 RETURN

Ensure return duct & curb adapters are sealed tightly to prevent leakage

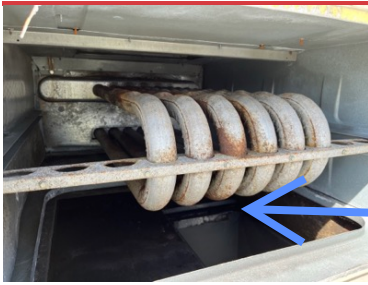
RTU 2 HEAT EXCHANGER TUBES

Return duct is not sealed to adapter, need to seal better to units & ensure adapter to unit is also sealed properly.

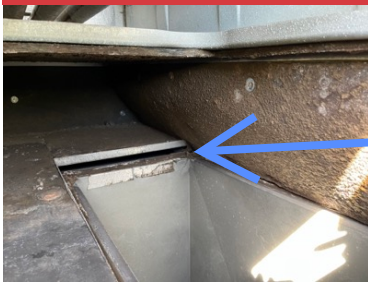
RTU 2 CURB ADAPTER (DISCHARGE SIDE)

Typical of both RTUs.

Both units supply ductwork is not sealed to curb adapter causing leakage directly at unit. This will cause lower airflow readings down in the space.

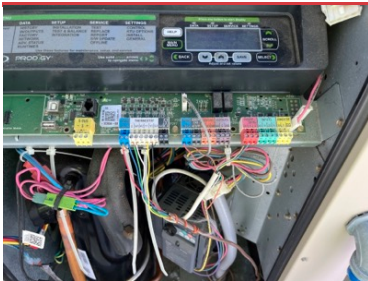
RTU 2 CONTROLS WIRING

OCP jumper installed.

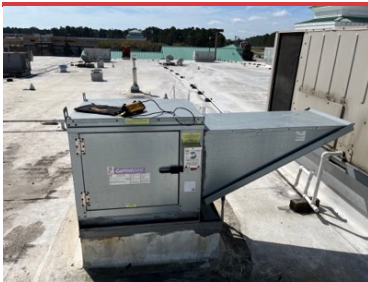
SF 1

Untempered Make up air unit.

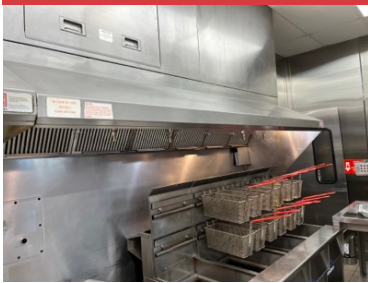
HOOD RIGHT

Hood capture is actually pretty good. It does capture all the affluent. As instructed by other team members, reducing size of standoff mounted on back of equipment to allow equipment to be pushed back further will help a lot on any radiant heat discharge.

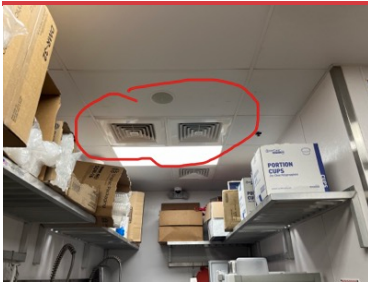
ATYPICAL RETURN GRILLS

These grills are typically used for supply air

No impact on TAB or comfort. Just for FYI so no confusion on location of return grills

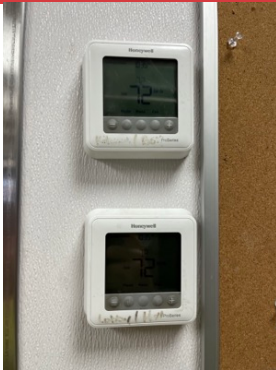
THERMOSTATS

NTAB changed fan function to “Fan ON” to maintain building pressure. Previously set to “Auto”
