National TAB  
1329 E. KEMPER ROAD  
SUITE 4210  
CINCINNATI, OH 45246

**Report: PUNCH**

**Function: Test, Adjust, & Balance**

**01-12-26 BARNES AND NOBLES #2934  
FAYETTEVILLE, NC**

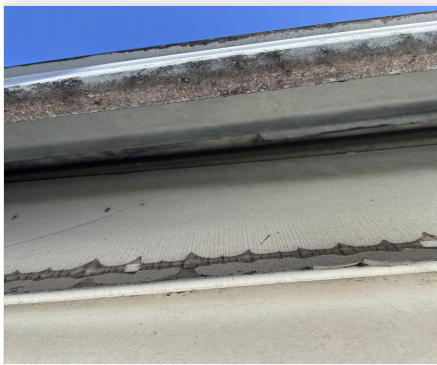
**Issue Name :** RTU3: Discharge panel gap  
**Description :** Significant gap between the curb and unit's discharge panel, heavy airflow leaking from under panel.  
**Created By :** National TAB                      **Assigned To :** National TAB - Dan Hertenstein  
**Status :** Open  
**Priority :** Urgent                                      **Asset Tag :**  
**Originated Date :** 01/16/2026 - Cody Mauro - National TAB

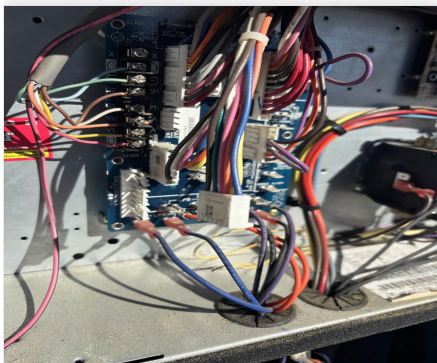
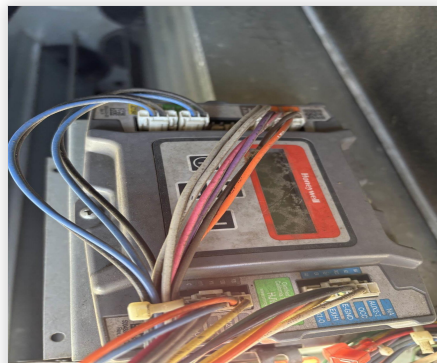
**Issue Name :** RTU3: Honeywell controller  
**Description :** Honeywell controller is not powered, screen is very dirty and not clearly visible. Cable labeled for “DDC HARNES” not connected to board. Unable to open dampers to balnce total supply.  
**Created By :** National TAB                      **Assigned To :** National TAB - Dan Hertenstein  
**Status :** Open  
**Priority :** Urgent                                      **Asset Tag :**  
**Originated Date :** 01/16/2026 - Cody Mauro - National TAB

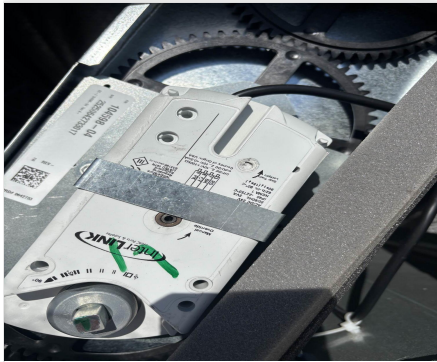
**Issue Name :** RTU5: Economizer  
**Description :** Cannot set OA dampers in core service app. Cannot manually open dampers due to stripped gear lock.  
**Created By :** National TAB                      **Assigned To :** National TAB - Dan Hertenstein  
**Status :** Open  
**Priority :** Urgent                                      **Asset Tag :**  
**Originated Date :** 01/15/2026 - Cody Mauro - National TAB

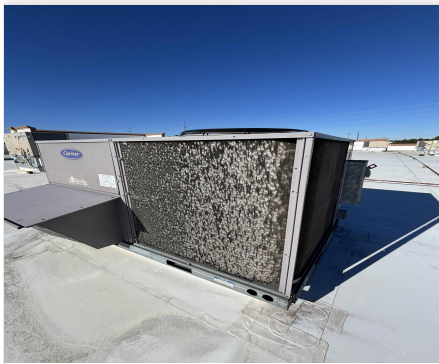
**Issue Name :** RTU6: Coil conditions  
**Description :** Coils very rusted and bent.  
**Created By :** National TAB                      **Assigned To :** National TAB - Dan Hertenstein  
**Status :** Open  
**Priority :** **Medium**                                      **Asset Tag :**  
**Originated Date :** 01/16/2026 - Cody Mauro - National TAB

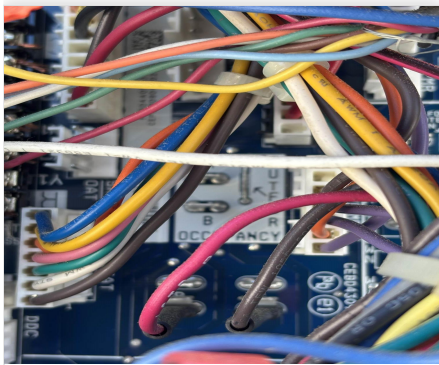
**Issue Name :** RTU6: Occupancy not wired  
**Description :** Dampers cannot be opened due to running in low speed. Occupancy is not wired from A to B.  
**Created By :** National TAB                      **Assigned To :** National TAB - Dan Hertenstein  
**Status :** Open  
**Priority :** **Urgent**                                      **Asset Tag :**  
**Originated Date :** 01/16/2026 - Cody Mauro - National TAB

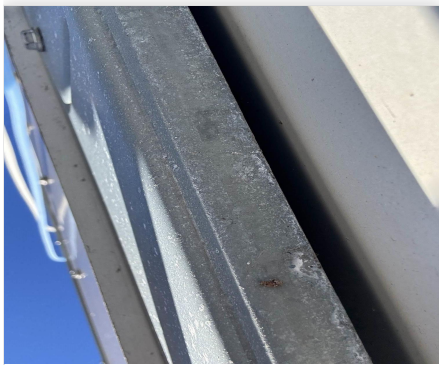
**Issue Name :** RTU9: Discharge panel gap  
**Description :** Decent sized gap between the curb and unit's discharge panel, noticeable airflow leaking from under panel.  
**Created By :** National TAB                      **Assigned To :** National TAB - Dan Hertenstein  
**Status :** Open  
**Priority :** Urgent                                      **Asset Tag :**  
**Originated Date :** 01/16/2026 - Cody Mauro - National TAB

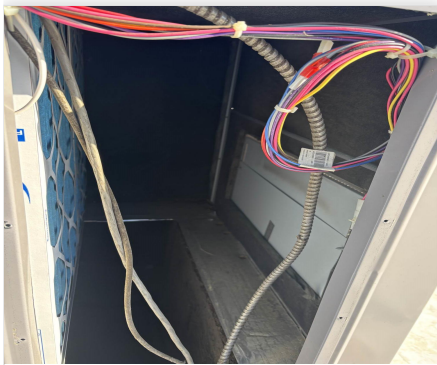
**Issue Name :** RTU9: OA dampers  
**Description :** OA intake is blocked from the inside by a blank canvas. Cannot open/read OA to balance supply total.  
**Created By :** National TAB                      **Assigned To :** National TAB - Dan Hertenstein  
**Status :** Open  
**Priority :** Urgent                                      **Asset Tag :**  
**Originated Date :** 01/16/2026 - Cody Mauro - National TAB
