TAB Punchlist CFA 05435

Oct 30, 2024

L05435_RELO - Polaris Parkway (OH) FSU

1515 Polaris Parkway, Columbus, Ohio

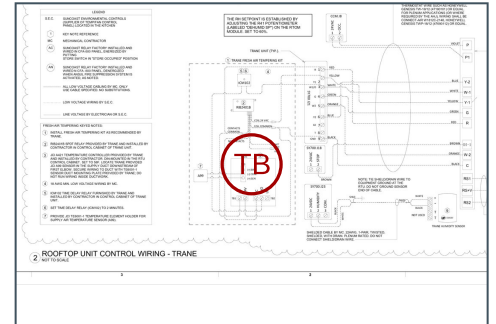
M-701

Units with Fresh Air Tempering kits are to have the discharge sensor routed per specification into the discharge duct via wiring portal. If Trane set turn-on/turn-off temps to 60/65 in Kitchen, 62/67 in Drive-Thru/Serving, 63/68 in Dining/Play Area. Controller missing on AC 4.

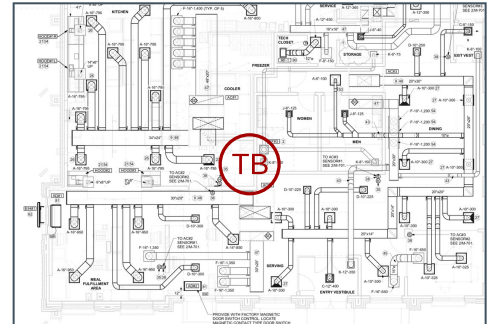
M-101

Control not installed at drawing location. AC-1 Temperature and humidity is not on the correct wall, CFA CM to review and accept or deny.

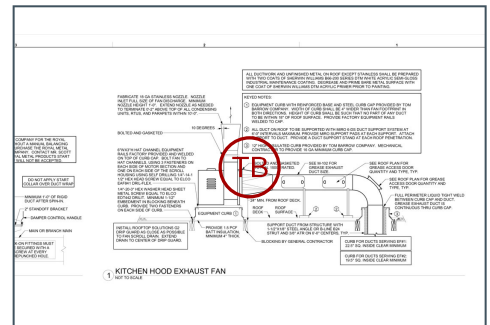
Sheet
M-501

Exhaust fan is missing 1500*F rated field provided/ installed gasketing at intake and/or discharge companion flange connections.

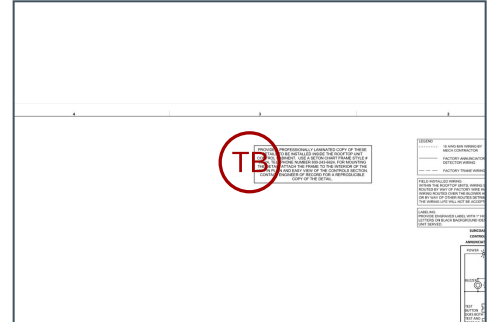
M-701

Equipment missing
laminated copy of controls
detail low voltage wiring
diagrams. As seen on M701

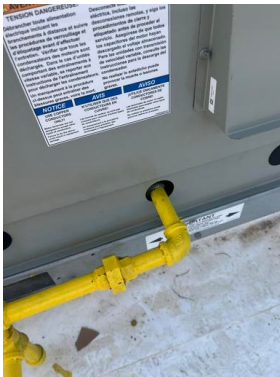
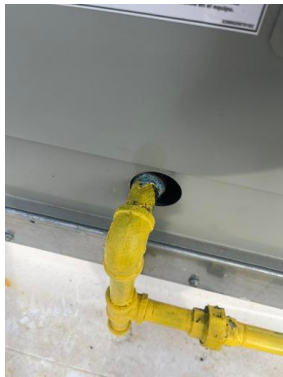
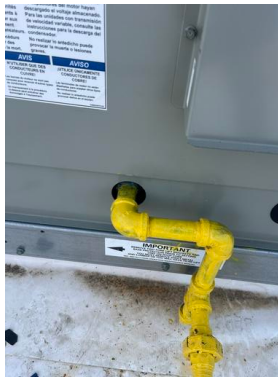
AC gas inlet grommet is missing at the gas line/RTU penetration point per manufacturers recommendations.
Applicable to AC-1/2/3

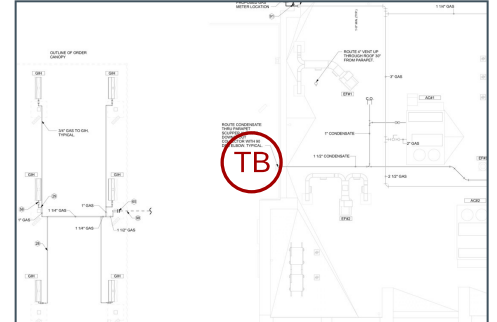
P-105

Equipment condensate piping pitch is not sloped correctly downward away from the unit. Units 2/3/4 are not properly pitched away from the units and main condensate piping is not pitched properly

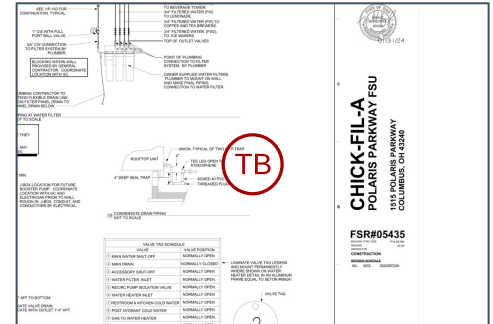
Sheet
P-502

Equipment condensate piping or p-trap is not constructed per normal CFA specifications. Missing union on leaving side

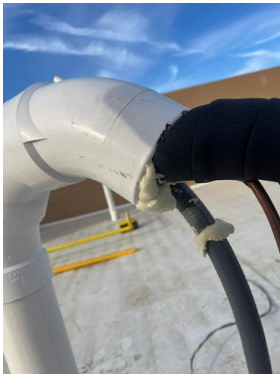
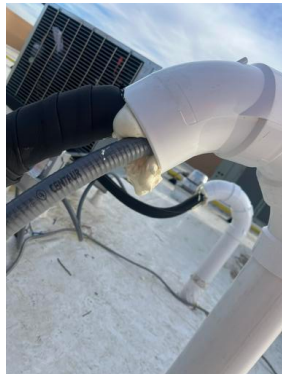
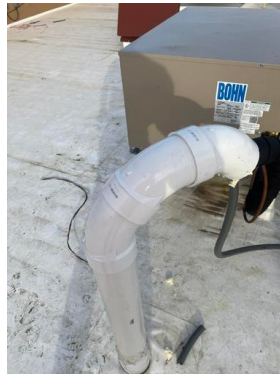
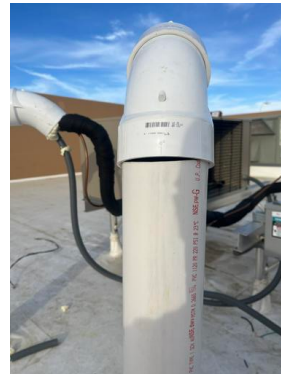
PVC pipe chase risers are not constructed to drawing or is not sealed with spray foam to prevent weather/pest infiltration. Gooseneck pieces need to be glued. 10/28/24 Goosenecks are filled with spray foam but still need glued together.

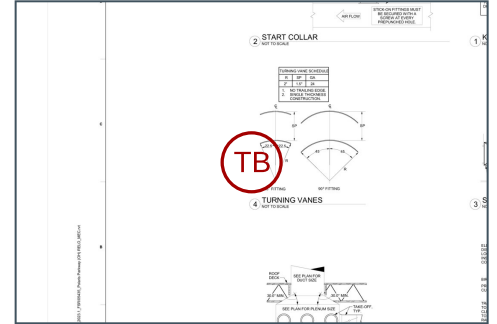
M-501

Turning vanes in supply drop are spaced very far apart. It appears that mounting holes exist for twice the current number of turning vanes to be installed, which would more closely match design.

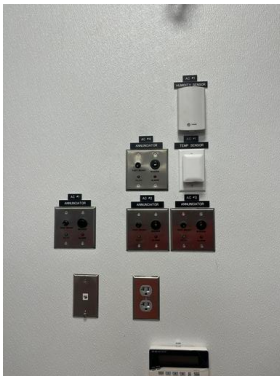
20241028_171432_photo

Annunciators not powered correctly through smoke detector, showing trouble light, or ground shorted.

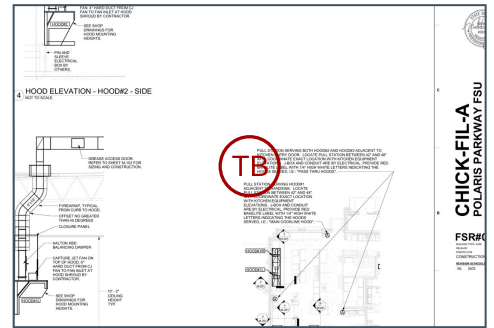
M-201

Label all ansul pull stations for which hoods they serve.

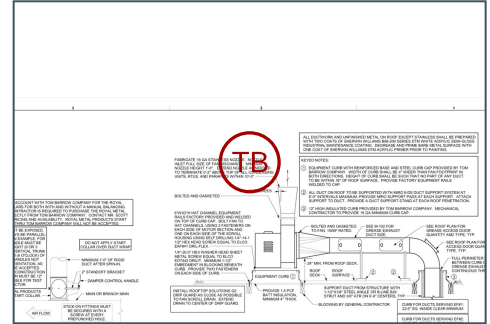
Sheet
M-501

Exhaust Fan 2 nozzle does not reach at least 2" above nearest parapet wall, and will require an extension.

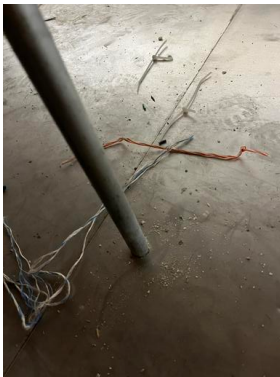
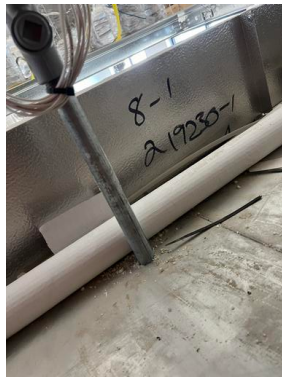
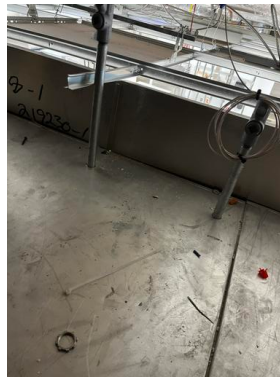
WIF/WIC penetrations are not sealed inside with silicone and above ceiling panel with 2 layers of ¼" foam tape 12" above panel at time of inspection.
