Report: TAB Report
Function: Test, Adjust, & Balance
Date: 01/21/2026
Completed By: National TAB

PROJECT
01-19-26 SEPHORA #672 GLENDALE, CA

Project: 01-19-26 SEPHORA #672 GLENDALE, CA

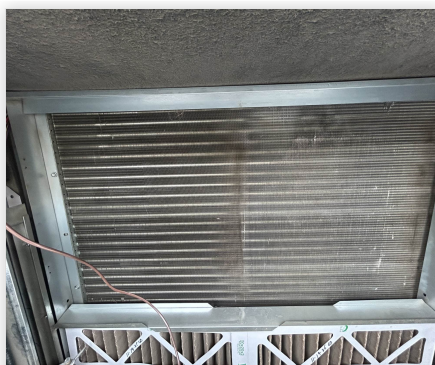
Issue Name : RTU-1 FAN COIL DIRTY
Description : RTU-1 fan coil appears to be dirty. Static pressure drop -0.82" from mixed air compartment to fan blower. Recommend cleaning fan coils and replacing final filters.
Created By : National TAB **Assigned To :** National TAB - Dan Hertenstein
Status : Open
Priority : Medium **Asset Tag :**
Originated Date : 01/27/2026 - David Nicolas Sanchez - National TAB
