**Report: TAB Report**  
**Function: Test, Adjust, & Balance**  
**Date: 01/21/2026**  
**Completed By: National TAB**

**PROJECT**  
**01-19-26 SEPHORA #672 GLENDALE, CA**

Project: 01-19-26 SEPHORA #672 GLENDALE, CA

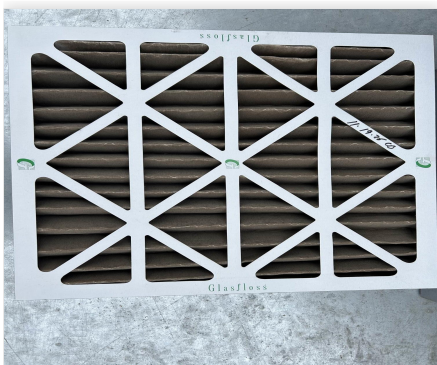
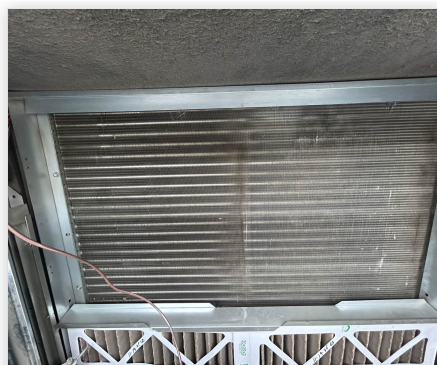
**Issue Name :** RTU-1 FAN COIL DIRTY  
**Description :** RTU-1 fan coil appears to be dirty. Static pressure drop -0.82" from mixed air compartment to fan blower. Recommend cleaning fan coils and replacing final filters.  
**Created By :** National TAB                      **Assigned To :** National TAB - Dan Hertenstein  
**Status :** Open  
**Priority :** Medium                                      **Asset Tag :**  
**Originated Date :** 01/27/2026 - David Nicolas Sanchez - National TAB

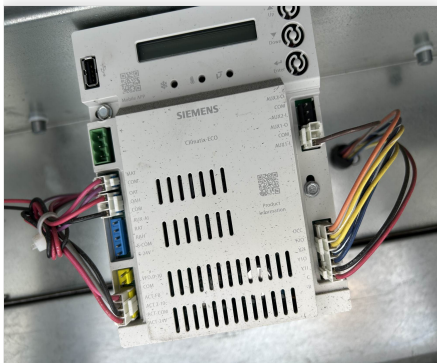
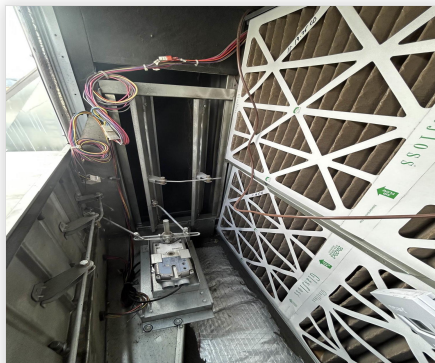
**Issue Name :** RTU'S ECONOMIZER NOT FUNCTIONAL  
**Description :** RTU Economizers are not functional. Economizers have been assembled but not operational. OA dampers have been manually adjusted to design airflow. Recommend getting Economizers operational.  
**Created By :** National TAB                      **Assigned To :** National TAB - Dan Hertenstein  
**Status :** Open  
**Priority :** Medium                              **Asset Tag :**  
**Originated Date :** 01/26/2026 - David Nicolas Sanchez - National TAB

Economizers assemble but not functional.

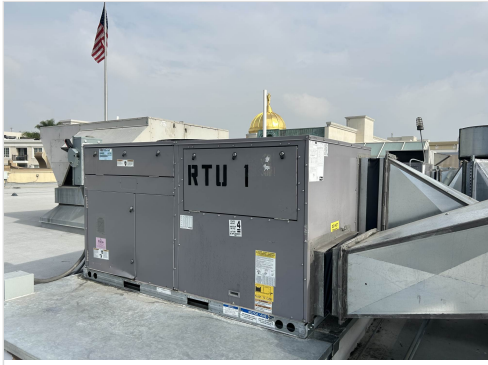
Asset: RTU1

Test Data		
	Design	Actual
SF CFM	4000	4246
SF RPM	-	1973
RA CFM	3400	3608
OA CFM	600	638
RL Voltage	-	483
RL Amperage	-	3.08
SF Rotation	-	CCW
SF System SetPt	-	B
RA Damper Position	-	85%
Min OA Damper Position	-	15%
Min OA Damper Type	-	ECONOMIZER
OA Enthalpy Setpt	-	NA

Performance Data		
	Design	Actual
MA Plenum SP	-	-0.84"
Fan Suction SP	-	-1.66"
Fan Discharge SP	-	0.54"
Total ESP	1.00"	1.38"
Fan Total SP	-	2.2"

General	
	Actual
Fan Rotation Correct	YES
Unit Filters Clean	NO
Condensate Drain Installed	YES

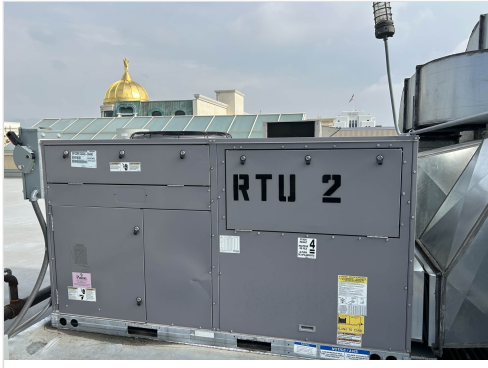
Asset: RTU2

Test Data		
	Design	Actual
SF CFM	4000	4262
SF RPM	-	1966
RA CFM	3400	3608
OA CFM	600	654
RL Voltage	-	486
RL Amperage	-	3.09
SF Rotation	-	CCW
SF System SetPt	-	B
RA Damper Position	-	85%
Min OA Damper Position	-	15%
Min OA Damper Type	-	ECONOMIZER

Performance Data		
	Design	Actual
MA Plenum SP	-	-0.67"
Fan Suction SP	-	-1.45"
Fan Discharge SP	-	0.47"
Total ESP	1.0"	1.14"
Fan Total SP	-	1.92"

General	
	Actual
Fan Rotation Correct	YES
Unit Filters Clean	YES
Condensate Drain Installed	YES
