Report: TAB Report
Function: Test, Adjust, & Balance
Date: 12/17/2025
Completed By: National TAB

12-08-25 WAWA #8695 WOODFORD, VA

Project: 12-08-25 WAWA #8695 WOODFORD, VA

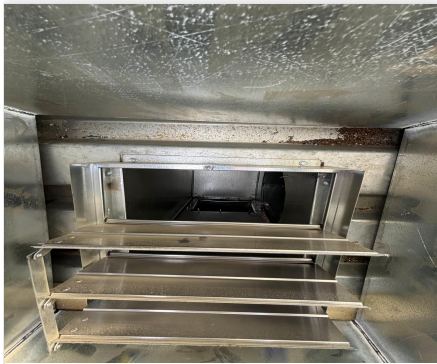
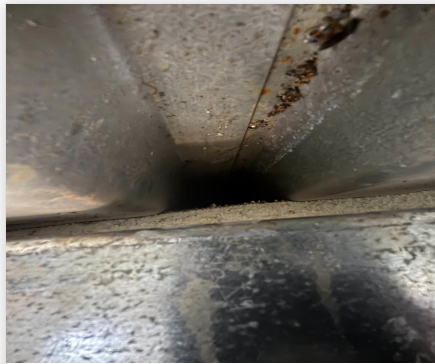
Issue Name : EF-2: Improper riser installation
Description : Riser for EF2 is set on top of the roof. 12x12" duct needs to be extended to the top of the curb. Flange needs to be sealed with the top of the curb.
Created By : National TAB **Assigned To :** National TAB - Brianna Biggs
Status : Open
Priority : Urgent **Asset Tag :**
Originated Date : 02/16/2026 - Cody Mauro - National TAB

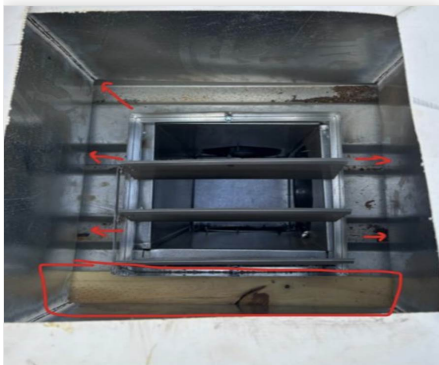
Issue Name : EF-2: Low total exhaust
Description : Total exhaust ~80% of design due to improper riser seating on rooftop.
Created By : National TAB **Assigned To :** National TAB - Brianna Biggs
Status : Open
Priority : High **Asset Tag :**
Originated Date : 02/16/2026 - Cody Mauro - National TAB

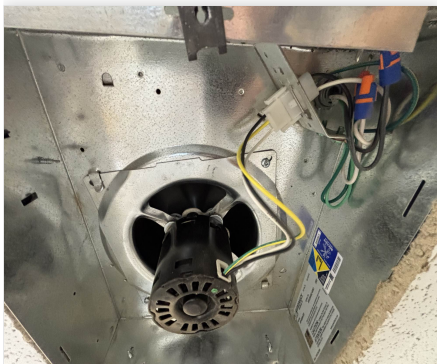
Issue Name : EF-3: High total exhaust
Description : EF3 total exhaust ~15% high of design. Single phase motor, wired at high speed.
Created By : National TAB **Assigned To :** National TAB - Brianna Biggs
Status : Open
Priority : Low **Asset Tag :**
Originated Date : 02/16/2026 - Cody Mauro - National TAB

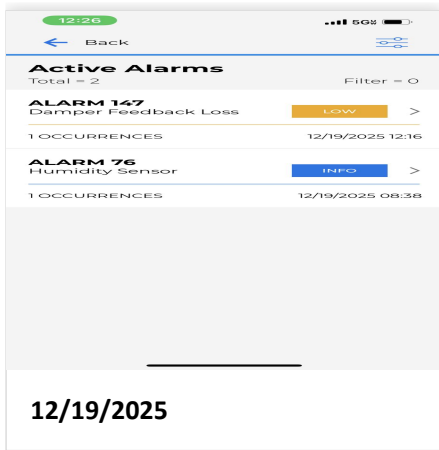
Issue Name : RTU-2 Alarms
Description : Unit is presenting Alarm 147, 76
Created By : National TAB **Assigned To :** National TAB - Brianna Biggs
Status : Closed
Priority : Low **Asset Tag :**
Originated Date : 12/19/2025 - John Barresi - National TAB

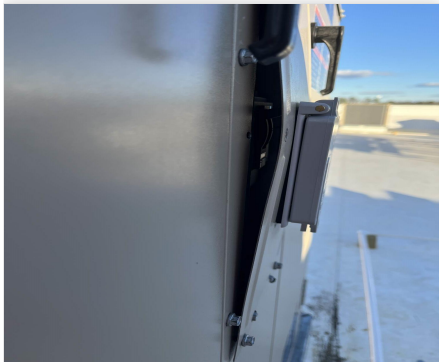
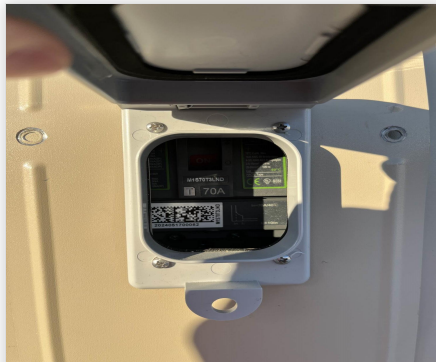
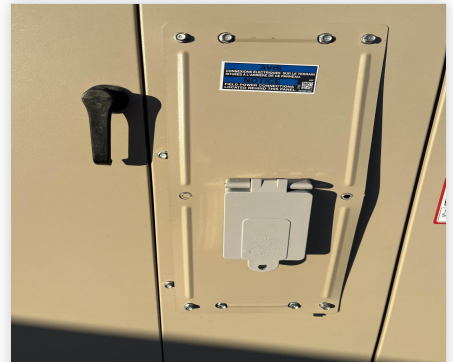
Issue Name : RTU-3 Unit Disconnect
Description : Unit disconnect switch cover is misaligned, unable to access/use switch unless cover is taken off.
Created By : National TAB **Assigned To :** National TAB - Brianna Biggs
Status : Closed
Priority : Low **Asset Tag :**
Originated Date : 12/12/2025 - John Barresi - National TAB

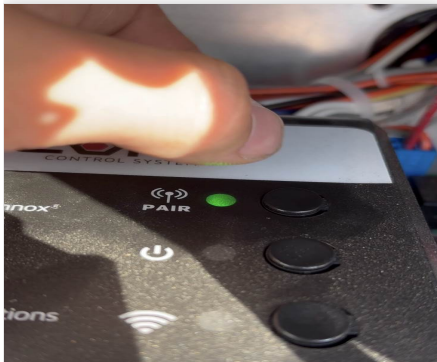
Issue Name : RTU1: CORE board input
Description : The CORE Prodigy board's Bluetooth pairing button is not functional, cannot connect to unit with the CORE app.
Created By : National TAB **Assigned To :** National TAB - Brianna Biggs
Status : Open
Priority : Low **Asset Tag :**
Originated Date : 02/16/2026 - Cody Mauro - National TAB
