Report: Punchlist
Function: Test, Adjust, & Balance
Date: 03/19/2026
Completed By: National TAB

PROJECT
03-16-26 QT #0596 OMAHA, NE

QUIKTRIP
4705 SOUTH 129TH EAST AVENUE
TULSA, OK 74134

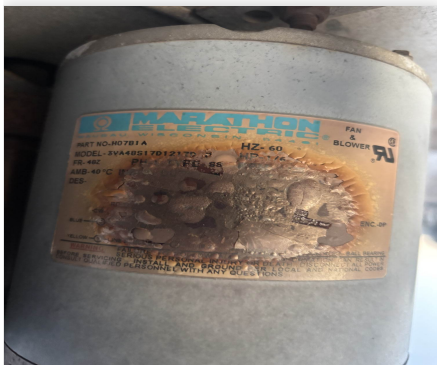
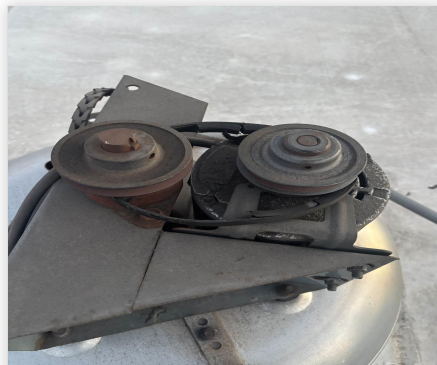
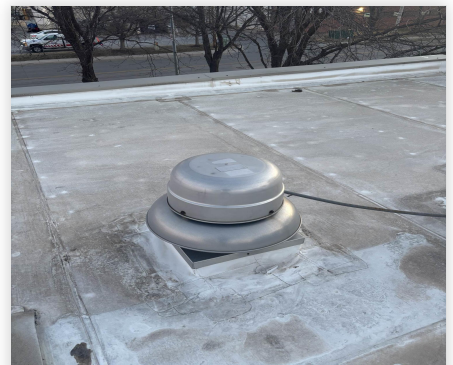
Issue Name : EF-1: Not Running
Description : EF-1 is not running. Drive belt is broken. Motor does not turn on. Noticeable burn marks on the motor. Recommend Service
Created By : National TAB **Assigned To :** National TAB - Dan Hertenstein
Status : Open
Priority : Urgent **Asset Tag :** EF1
Originated Date : 03/19/2026 - Kalen Kemp - National TAB

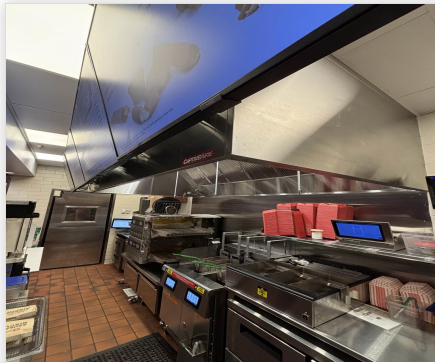
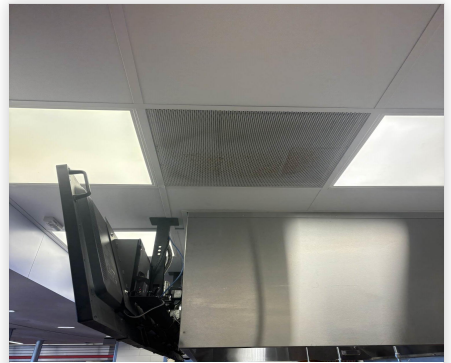
Issue Name : HOOD1: Smoke Capture
Description : The smoke capture was very poor (~70%) along the perimeter. This appears to be due to turbulence caused by the diffusers and minor air leakage at the fan base. Recommend sealing connection at EF-2 and installing rigid risers/elbows at neck of the diffusers.
Created By : National TAB **Assigned To :** National TAB - Dan Hertenstein
Status : Open
Priority : High **Asset Tag :** HD1
Originated Date : 03/19/2026 - Kalen Kemp - National TAB

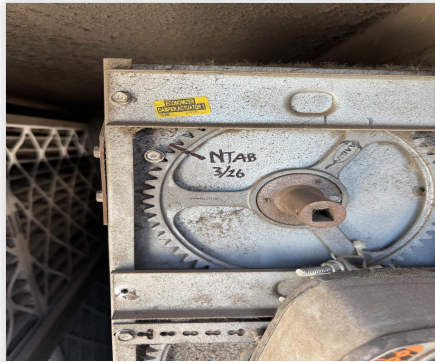
Issue Name : RT-1: Economizer/OA Damper
Description : The Economizer/actuator is not attached to the OA gears. OA damper position set manually and fastened with a screw.
Created By : National TAB **Assigned To :** National TAB - Dan Hertenstein
Status : Open
Priority : Medium **Asset Tag :** RT-1
Originated Date : 03/19/2026 - Kalen Kemp - National TAB

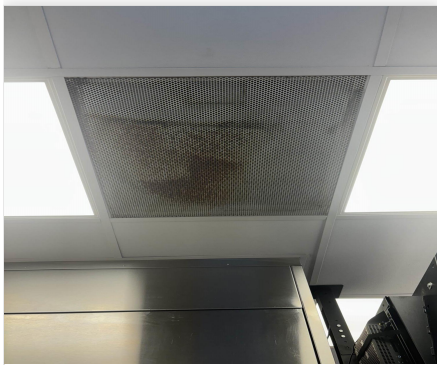
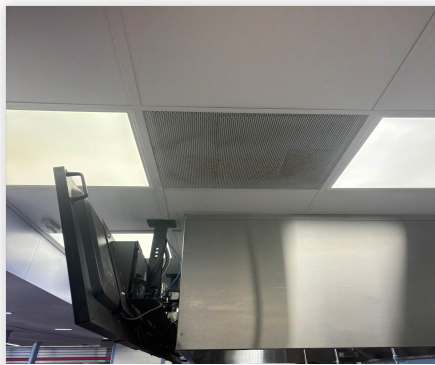
Issue Name : RT-2: Flex Duct
Description : The diffusers for RT-2 have flex duct ran all the way to them. The flex is pinched at the neck of the diffuser causing turbulence at the face of it and at the hood. Recommend installing rigid risers/elbows to neck of the diffusers.
Created By : National TAB **Assigned To :** National TAB - Dan Hertenstein
Status : Open
Priority : Medium **Asset Tag :** RT-2
Originated Date : 03/19/2026 - Kalen Kemp - National TAB

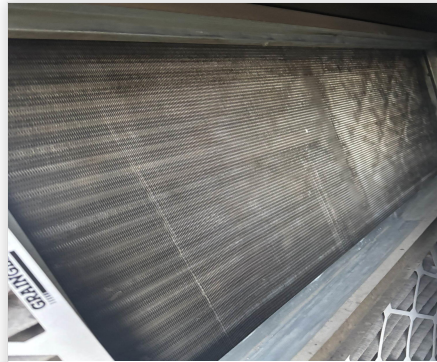
Issue Name : RTs: Dirty Evaporator Coils
Description : The evaporator coils inside the RTUs are dirty. This affects unit performance and efficiency. Recommend cleaning.
Created By : National TAB **Assigned To :** National TAB - Dan Hertenstein
Status : Open
Priority : Low **Asset Tag :**
Originated Date : 03/19/2026 - Kalen Kemp - National TAB
