Report: TAB Report
Function: Test, Adjust, & Balance
Date: 01/20/2026
Completed By: National TAB

PROJECT
03-16-26 QT #0596 OMAHA, NE

Project: 03-16-26 QT #0596 OMAHA, NE

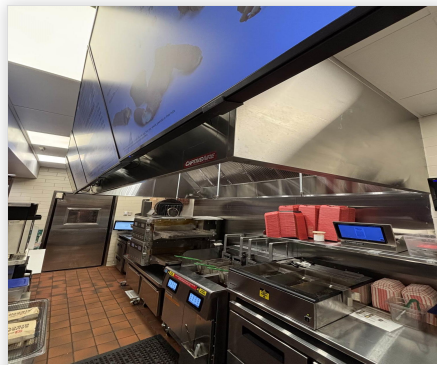
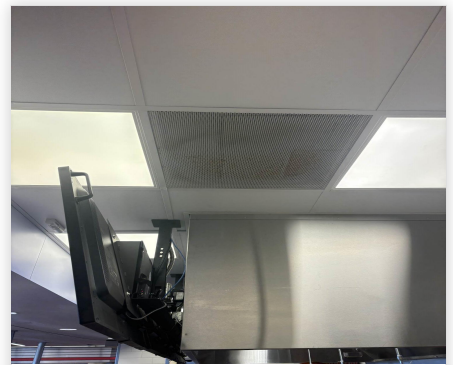
Issue Name : HOOD1: Smoke Capture
Description : The smoke capture was very poor (~70%) along the perimeter. This appears to be due too turbulence caused by the diffusers and minor air leakage at the fan base. Recommend sealing connection at EF-2 and installing rigid risers/elbows at neck of the diffusers.
Created By : National TAB **Assigned To :** National TAB - Dan Hertenstein
Status : Open
Priority : High **Asset Tag :** HD1
Originated Date : 03/19/2026 - Kalen Kemp - National TAB

-HOOD HAS POOR SMOKE CAPTURE ALONG THE PERIMETER. SMOKE CAPTURE IS 100% AT COOKING SURFACE. WE DO NOT ANTICIPATE ANY SMOKE LOSS FROM COOKING SURFACES.

Hood has poor smoke capture along the perimeter. This is due to turbulence being caused by the flex duct in the diffusers. Recommend installing rigid risers/elbows in neck of the diffusers.

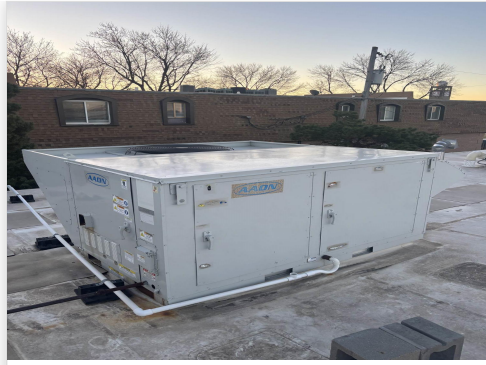
Asset: RT-2

- MOTOR DATA RETRIEVED FROM UNIT TAG.
- FINAL FILTERS ARE DIRTY.
- EVAPORATOR COIL IS DIRTY.
