Report: TAB Report
Function: Test, Adjust, & Balance
Date: 01/20/2026
Completed By: National TAB

PROJECT
03-16-26 QT #0596 OMAHA, NE

QUIKTRIP
4705 SOUTH 129TH EAST AVENUE
TULSA, OK 74134

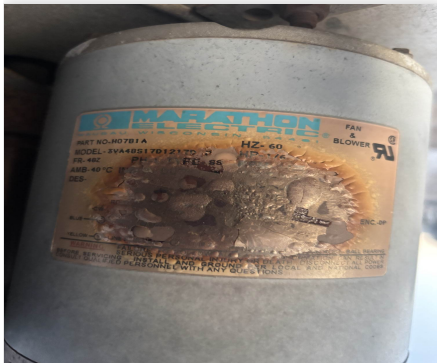
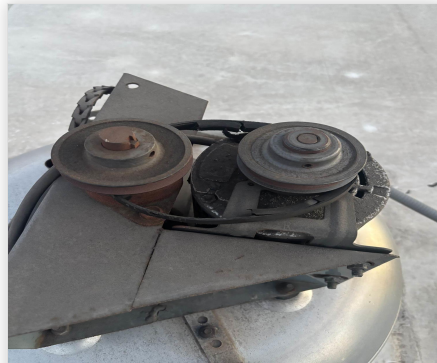
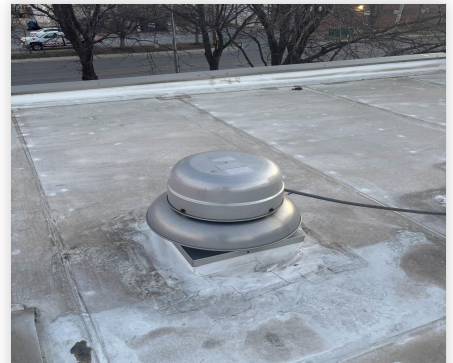
Issue Name : EF-1: Not Running
Description : EF-1 is not running. Drive belt is broken. Motor does not turn on. Noticeable burn marks on the motor. Recommend Service
Created By : National TAB **Assigned To :** National TAB - Dan Hertenstein
Status : Open
Priority : Urgent **Asset Tag :** EF1
Originated Date : 03/19/2026 - Kalen Kemp - National TAB

- FAN NOT RUNNING. DRIVE BELT IS BROKEN. RECOMMEND SERVICE.
- MOTOR NOT RUNNING. HAS NOTICEABLE BURN MARKS ON IT.

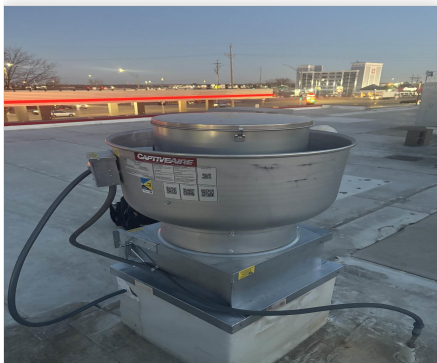
Issue Name : EF-2: Air Leakage
Description : There is minor air leakage observed at the fan base. This is causing the fan speed to be set higher to achieve design airflow. Recommend sealing connection.
Created By : National TAB **Assigned To :** National TAB - Dan Hertenstein
Status : Open
Priority : High **Asset Tag :** EF2
Originated Date : 03/19/2026 - Kalen Kemp - National TAB

Notes:
 -MINOR AIR LEAKAGE OBSERVED AT FAN BASE
 -RPM DATA RETRIEVED FROM MOTOR SPEED CONTROLLER IN MOTOR COMPARTMENT.

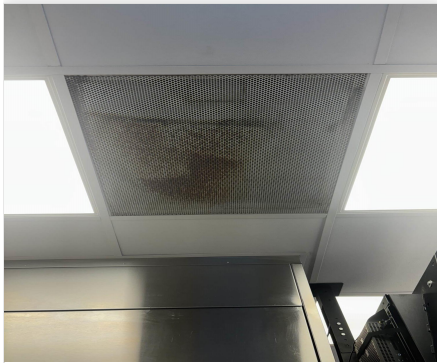
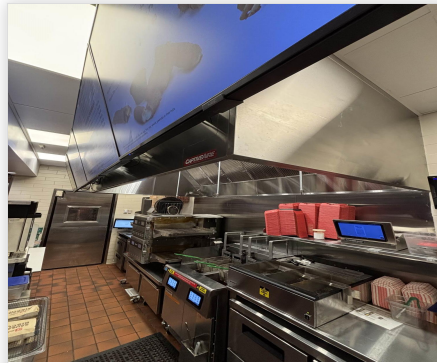
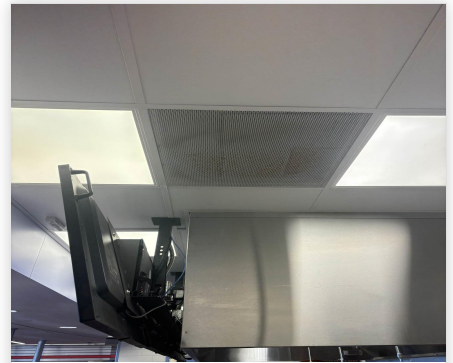
Issue Name : HOOD1: Smoke Capture
Description : The smoke capture was very poor (~70%) along the perimeter. This appears to be due too turbulence caused by the diffusers and minor air leakage at the fan base. Recommend sealing connection at EF-2 and installing rigid risers/elbows at neck of the diffusers.
Created By : National TAB **Assigned To :** National TAB - Dan Hertenstein
Status : Open
Priority : High **Asset Tag :** HD1
Originated Date : 03/19/2026 - Kalen Kemp - National TAB

70% Smoke Capture

-HOOD HAS POOR SMOKE CAPTURE ALONG THE PERIMETER. SMOKE CAPTURE IS 100% AT COOKING SURFACE. WE DO NOT ANTICIPATE ANY SMOKE LOSS FROM COOKING SURFACES.

Hood has poor smoke capture along the perimeter. This is due to turbulence being caused by the flex duct in the diffusers. Recommend installing rigid risers/elbows in neck of the diffusers.

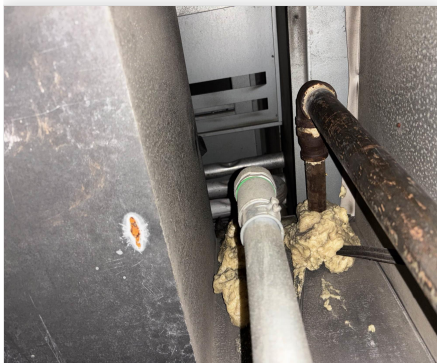
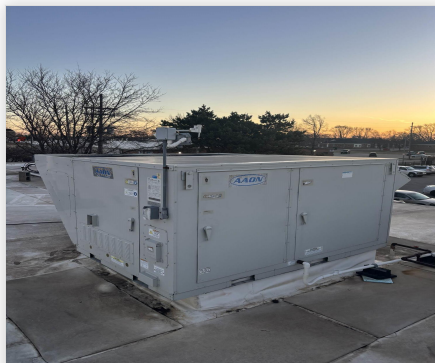
Issue Name : RT-1: Air Leakage
Description : Large amount of air leakage at the supply drop for RT-1. The curb for the unit is not properly aligned. There is approximately 20% loss in airflow. Recommend aligning drop for improved airflow.
Created By : National TAB **Assigned To :** National TAB - Dan Hertenstein
Status : Open
Priority : High **Asset Tag :** RT-1
Originated Date : 03/19/2026 - Kalen Kemp - National TAB

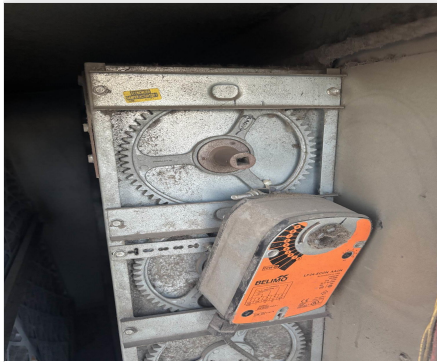
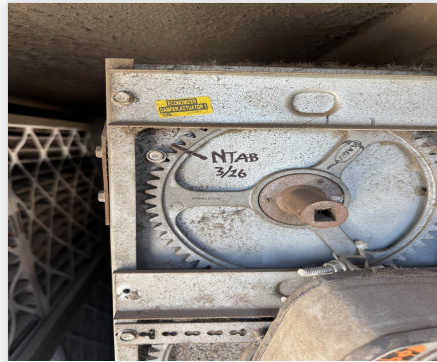
Issue Name : RT-1: Economizer/OA Damper
Description : The Economizer/actuator is not attached to the OA gears. OA damper position set manually and fastened with a screw.
Created By : National TAB **Assigned To :** National TAB - Dan Hertenstein
Status : Open
Priority : Medium **Asset Tag :** RT-1
Originated Date : 03/19/2026 - Kalen Kemp - National TAB

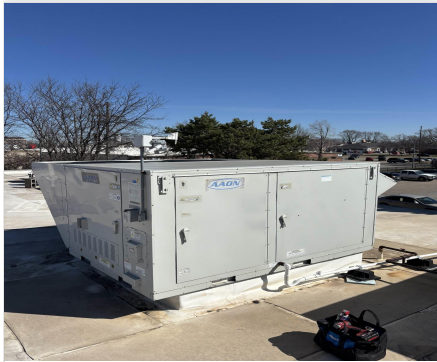
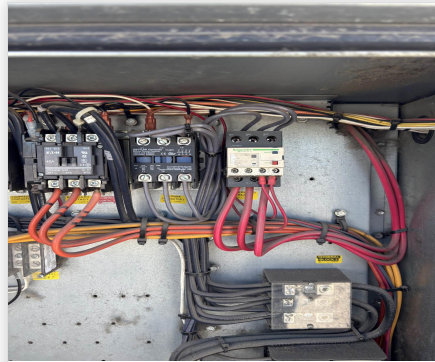
Issue Name : RT-1: Fan Speed
Description : There is no VFD/Speed Controller for RT-1. Unable to adjust fan speed for improved airflow.
Created By : National TAB **Assigned To :** National TAB - Dan Hertenstein
Status : Open
Priority : High **Asset Tag :**
Originated Date : 03/19/2026 - Kalen Kemp - National TAB

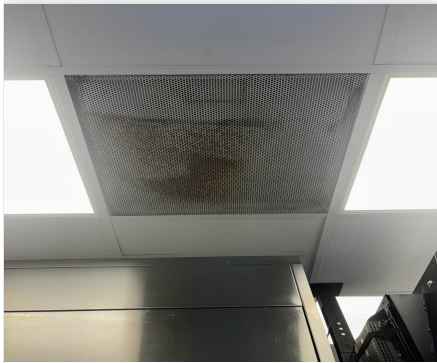
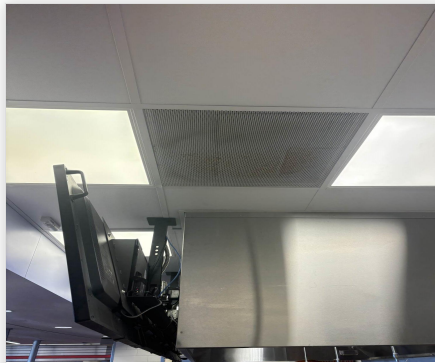
Issue Name : RT-2: Flex Duct
Description : The diffusers for RT-2 have flex duct ran all the way to them. The flex is pinched at the neck of the diffuser causing turbulence at the face of it and at the hood. Recommend installing rigid risers/elbows to neck of the diffusers.
Created By : National TAB **Assigned To :** National TAB - Dan Hertenstein
Status : Open
Priority : Medium **Asset Tag :** RT-2
Originated Date : 03/19/2026 - Kalen Kemp - National TAB

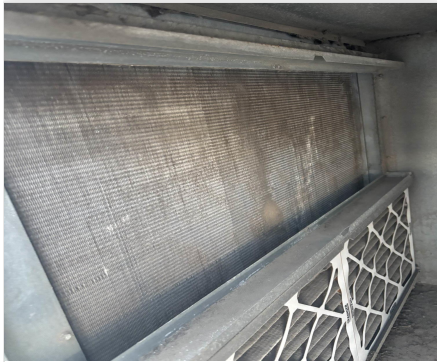
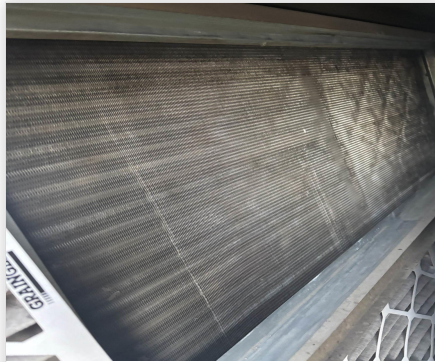
Issue Name : RTs: Dirty Evaporator Coils
Description : The evaporator coils inside the RTUs are dirty. This affects unit performance and efficiency. Recommend cleaning.
Created By : National TAB **Assigned To :** National TAB - Dan Hertenstein
Status : Open
Priority : Low **Asset Tag :**
Originated Date : 03/19/2026 - Kalen Kemp - National TAB

Dirty coils in both RTUs

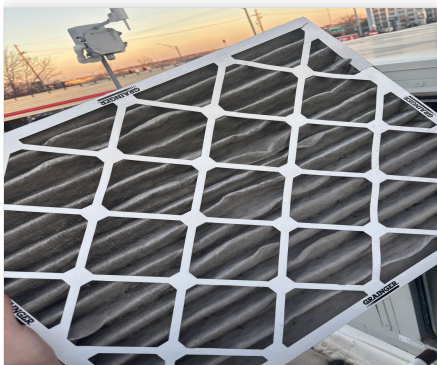
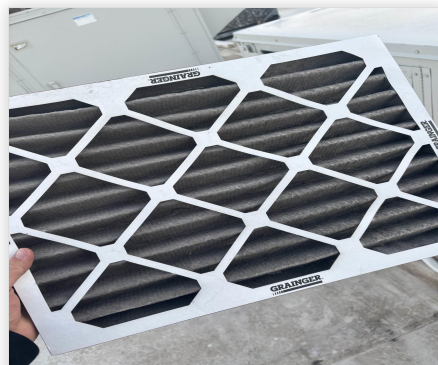
Issue Name : RTs: Dirty Filters
Description : The filters inside the RTUs are dirty. Recommend replacing.
Created By : National TAB **Assigned To :** National TAB - Dan Hertenstein
Status : Open
Priority : Low **Asset Tag :**
Originated Date : 03/19/2026 - Kalen Kemp - National TAB

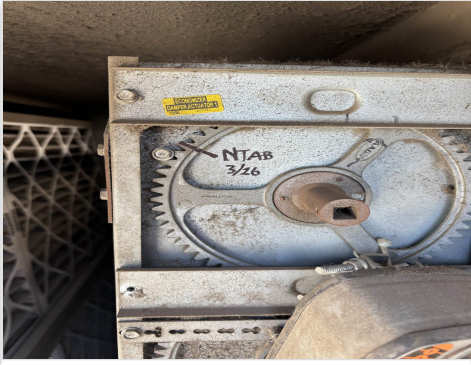
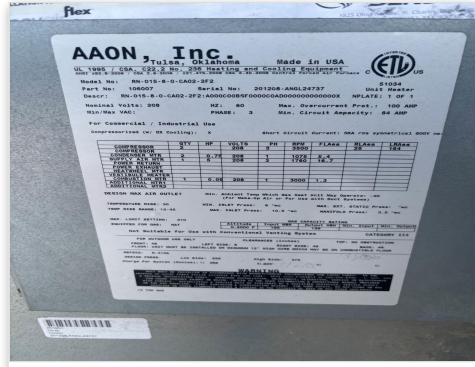
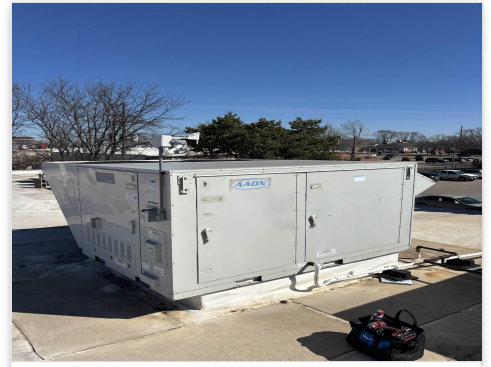
Asset: RT-1

- MOTOR DATA RETRIEVED FROM UNIT TAG.
- FINAL FILTERS ARE DIRTY.
- EVAPORATOR COIL IS DIRTY.
- NO VFD OR SPEED CONTROLLER. UNABLE TO ADJUST FAN SPEED.
- CURB NOT ALIGNED PROPERLY WITH SUPPLY DROP. CAUSING LARGE AMOUNT OF AIR LEAKAGE ABOVE CEILING. MEASURED TOTAL AIRFLOW BY ADDING OA CFM AND RA CFM.
- OA ACTUATOR NOT CONNECTED TO OA DAMPER ARM. OA DAMPER POSITION SET MANUALLY.
- DISCHARGE PRESSURE READING TAKEN AT UNIT ON THE ROOF. READING IS LOW DUE TO AIR LEAKAGE AT THE DROP.

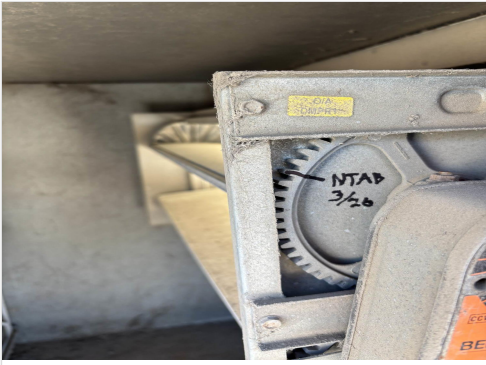
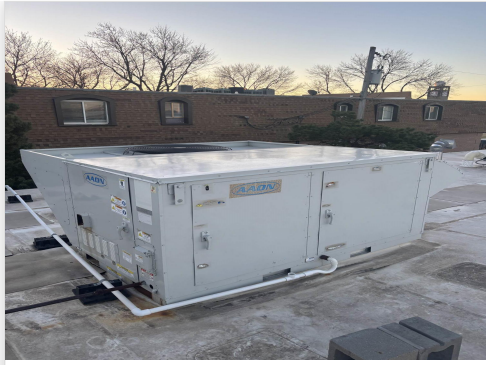
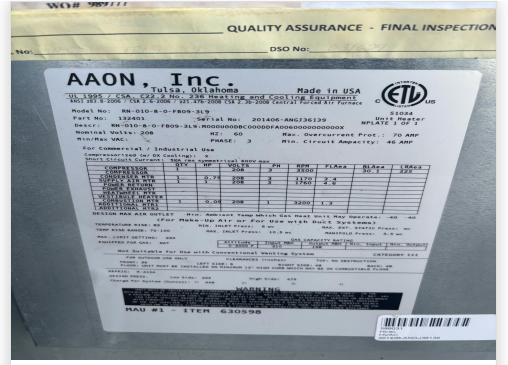
Asset: RT-2

- MOTOR DATA RETRIEVED FROM UNIT TAG.
- FINAL FILTERS ARE DIRTY.
- EVAPORATOR COIL IS DIRTY.
