**Report: TAB Report**  
**Function: Test, Adjust, & Balance**  
**Date: 12/05/2025**  
**Completed By: National TAB**

## 12-01-25 APPLEBEES PEMBROKE PINES, FL

Flynn Restaurant Group  
6200 Oak Tree Boulevard  
Suite 250  
Independence, OH 44131

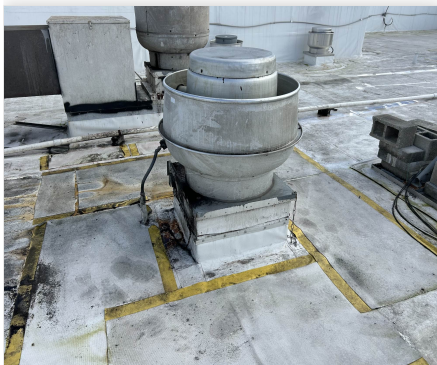
**Issue Name :** EF 1 Grease Drain  
**Description :** EF-1 is missing a grease drain, grease has accumulated on the roof near the fan and has made the surrounding area slippery.  
**Created By :** National TAB                      **Assigned To :** National TAB - Dan Hertenstein  
**Status :** Open  
**Priority :** High                                      **Asset Tag :**  
**Originated Date :** 12/05/2025 - Mark Johnson - National TAB

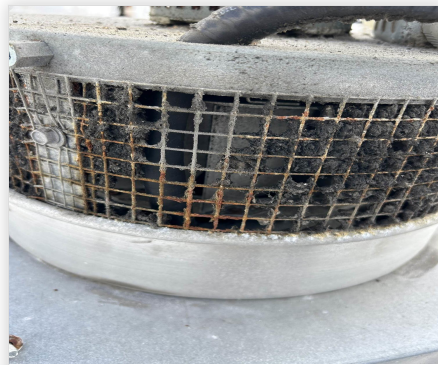
**Issue Name :** EF-5 Not Functional  
**Description :** EF-5 (restrooms) is not running. Fan blades are clogged with debris and the motor is humming loudly but not spinning.  
**Created By :** National TAB                      **Assigned To :** National TAB - Dan Hertenstein  
**Status :** Open  
**Priority :** Urgent                                      **Asset Tag :**  
**Originated Date :** 12/05/2025 - Mark Johnson - National TAB

EF 5 - Motor humming, no rotation

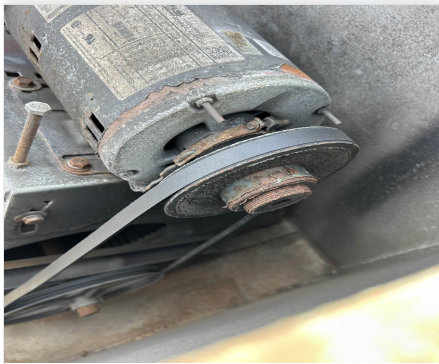
**Issue Name :** MUA Pulleys Rusted  
**Description :** MUA pulleys are rusted and worn.  
**Created By :** National TAB                      **Assigned To :** National TAB - Dan Hertenstein  
**Status :** Open  
**Priority :** **Medium**                                      **Asset Tag :**  
**Originated Date :** 12/05/2025 - Mark Johnson - National TAB

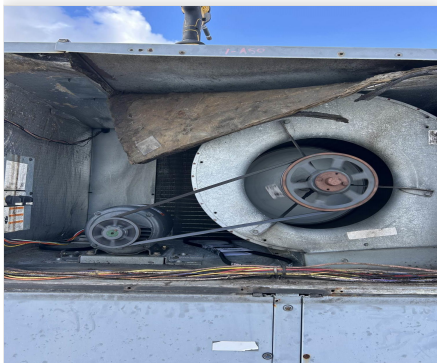
**Issue Name :** RTU 1 - Loose Insulation  
**Description :** There is loose insulation in the blower compartment of RTU 1. Insulation is hanging low and at risk of being caught in the pulleys. Recommend repair.  
**Created By :** National TAB                      **Assigned To :** National TAB - Dan Hertenstein  
**Status :** Open  
**Priority :** High                                      **Asset Tag :**  
**Originated Date :** 12/05/2025 - Mark Johnson - National TAB

Loose insulation in blower compartment of RTU 1, in danger of getting caught on blower wheel.

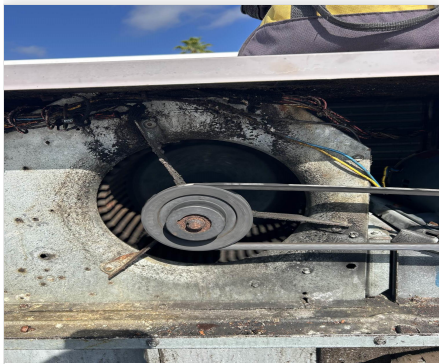
**Issue Name :** RTU 5 Blower Dirty  
**Description :** RTU 5's blower wheel is getting dirty and may need cleaned soon.  
**Created By :** National TAB                      **Assigned To :** National TAB - Dan Hertenstein  
**Status :** Open  
**Priority :** Medium                                      **Asset Tag :**  
**Originated Date :** 12/05/2025 - Mark Johnson - National TAB

RTU 5 wheel is dirty

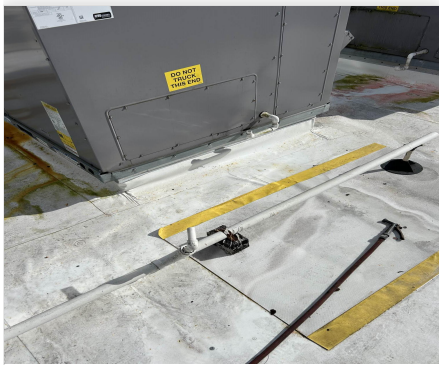
**Issue Name :** RTU Condensate Drains  
**Description :** RTU condensate drains are broken, water is pooling around each unit as a result.  
**Created By :** National TAB                      **Assigned To :** National TAB - Dan Hertenstein  
**Status :** Open  
**Priority :** High                                      **Asset Tag :**  
**Originated Date :** 12/05/2025 - Mark Johnson - National TAB

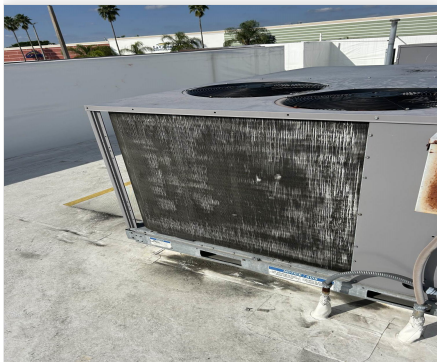
**Issue Name :** RTU Condenser Coils  
**Description :** There is some fin damage on all RTU condenser coils.  
**Created By :** National TAB                      **Assigned To :** National TAB - Dan Hertenstein  
**Status :** Open  
**Priority :** Medium                                      **Asset Tag :**  
**Originated Date :** 12/05/2025 - Mark Johnson - National TAB

Some coil damage on all RTUs

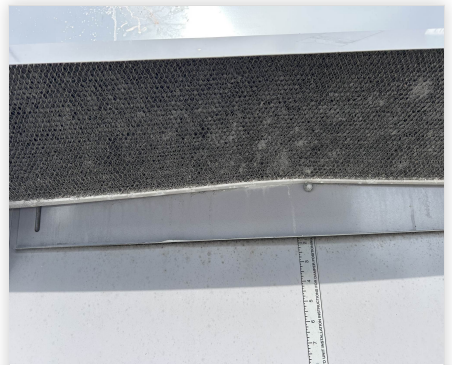
**Issue Name :** RTUs - OA Filters  
**Description :** Outside air intake filters are dirty or damaged on all RTUs. Recommend repair/replacement.  
**Created By :** National TAB                      **Assigned To :** National TAB - Dan Hertenstein  
**Status :** Open  
**Priority :** Urgent                                      **Asset Tag :**  
**Originated Date :** 12/05/2025 - Mark Johnson - National TAB

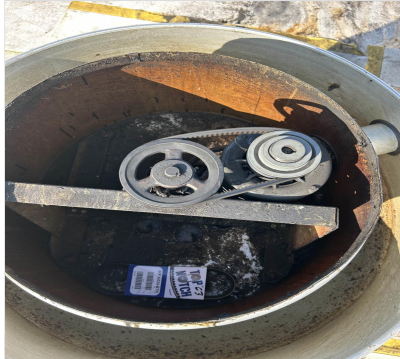
Belts loose - EF 1 and EF 2

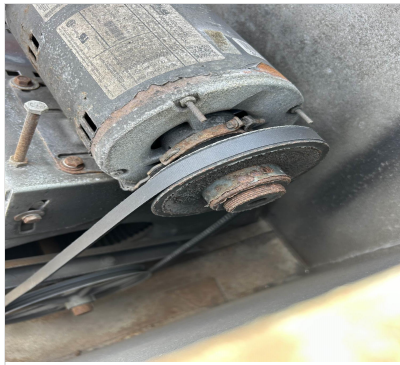
Pulleys rusted

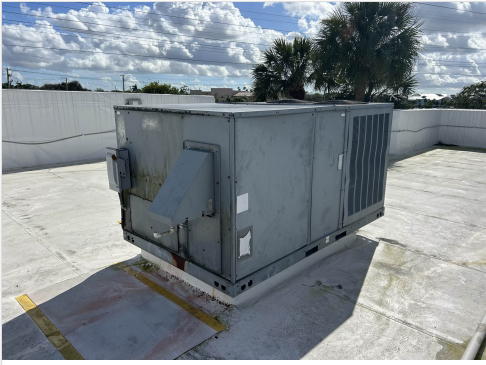
Notes:  
Unit data sticker is not legible.
