Report: TAB Report
Function: Test, Adjust, & Balance
Date: 12/05/2025
Completed By: National TAB

12-01-25 APPLEBEES PEMBROKE PINES, FL

Project Summary

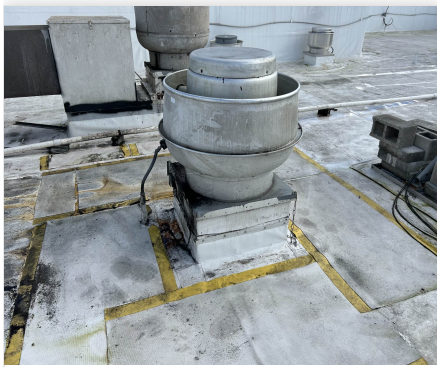
Issue Name : EF 1 Grease Drain
Description : EF-1 is missing a grease drain, grease has accumulated on the roof near the fan and has made the surrounding area slippery.
Created By : National TAB **Assigned To :** National TAB - Dan Hertenstein
Status : Open
Priority : High **Asset Tag :**
Originated Date : 12/05/2025 - Mark Johnson - National TAB

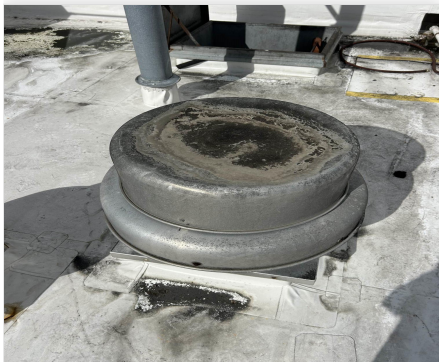
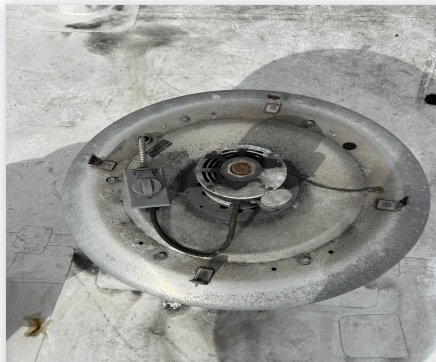
Issue Name : EF-4 Not Functional
Description : EF-4 (water room) is not powered.
Created By : National TAB **Assigned To :** National TAB - Dan Hertenstein
Status : Open
Priority : **Urgent** **Asset Tag :**
Originated Date : 12/05/2025 - Mark Johnson - National TAB

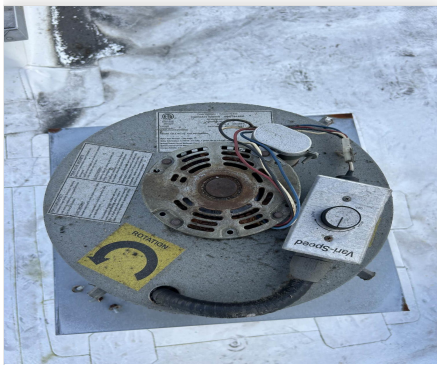
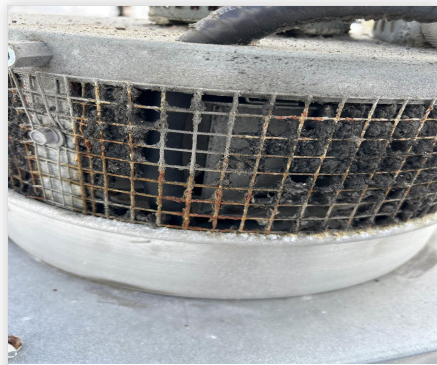
Issue Name : EF-5 Not Functional
Description : EF-5 (restrooms) is not running. Fan blades are clogged with debris and the motor is humming loudly but not spinning.
Created By : National TAB **Assigned To :** National TAB - Dan Hertenstein
Status : Open
Priority : Urgent **Asset Tag :**
Originated Date : 12/05/2025 - Mark Johnson - National TAB

EF 5 - Motor humming, no rotation

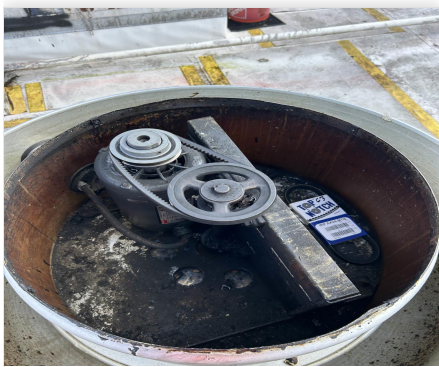
Issue Name : EFs 1, 2 - Loose Belts
Description : Belts are slightly loose on EFs 1 and 2. May need adjusted or replaced soon.
Created By : National TAB **Assigned To :** National TAB - Dan Hertenstein
Status : Open
Priority : Medium **Asset Tag :**
Originated Date : 12/05/2025 - Mark Johnson - National TAB

Belts loose - EF 1 and EF 2

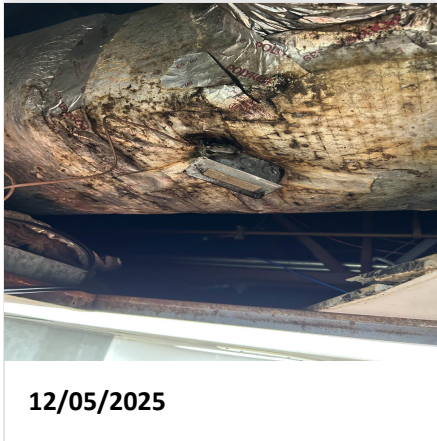
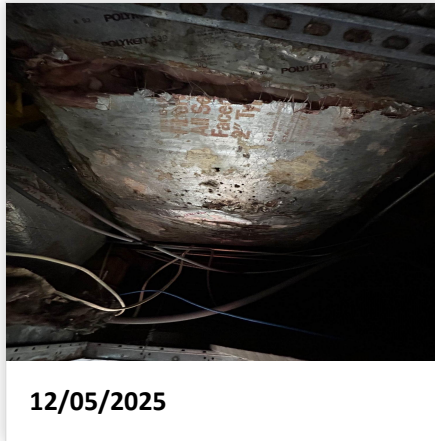
Issue Name : Kitchen Ductwork - Water Damage
Description : Much of the ductwork in the kitchen has wet and sagging insulation. Recommend service.
Created By : National TAB **Assigned To :** National TAB - Dan Hertenstein
Status : Open
Priority : Urgent **Asset Tag :**
Originated Date : 12/05/2025 - Mark Johnson - National TAB

Wet and sagging insulation throughout kitchen ductwork

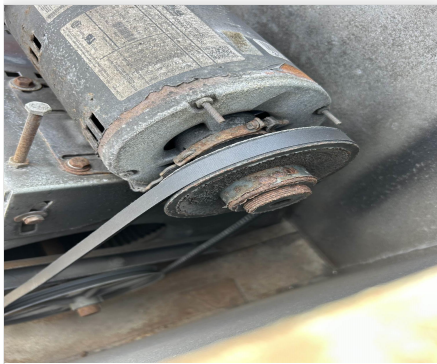
Issue Name : MUA Pulleys Rusted
Description : MUA pulleys are rusted and worn.
Created By : National TAB **Assigned To :** National TAB - Dan Hertenstein
Status : Open
Priority : **Medium** **Asset Tag :**
Originated Date : 12/05/2025 - Mark Johnson - National TAB

Pulleys rusted

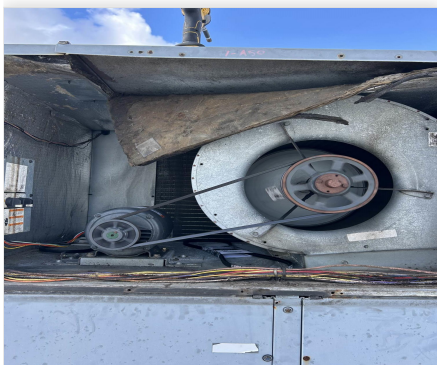
Issue Name : RTU 1 - Loose Insulation
Description : There is loose insulation in the blower compartment of RTU 1. Insulation is hanging low and at risk of being caught in the pulleys. Recommend repair.
Created By : National TAB **Assigned To :** National TAB - Dan Hertenstein
Status : Open
Priority : High **Asset Tag :**
Originated Date : 12/05/2025 - Mark Johnson - National TAB

Loose insulation in blower compartment of RTU 1, in danger of getting caught on blower wheel.

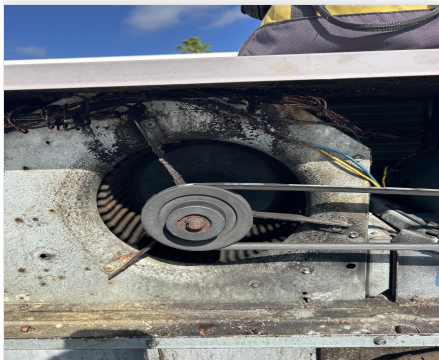
Issue Name : RTU 5 Blower Dirty
Description : RTU 5's blower wheel is getting dirty and may need cleaned soon.
Created By : National TAB **Assigned To :** National TAB - Dan Hertenstein
Status : Open
Priority : Medium **Asset Tag :**
Originated Date : 12/05/2025 - Mark Johnson - National TAB

RTU 5 wheel is dirty

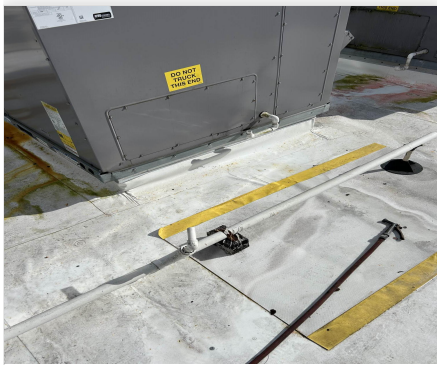
Issue Name : RTU Condensate Drains
Description : RTU condensate drains are broken, water is pooling around each unit as a result.
Created By : National TAB **Assigned To :** National TAB - Dan Hertenstein
Status : Open
Priority : High **Asset Tag :**
Originated Date : 12/05/2025 - Mark Johnson - National TAB

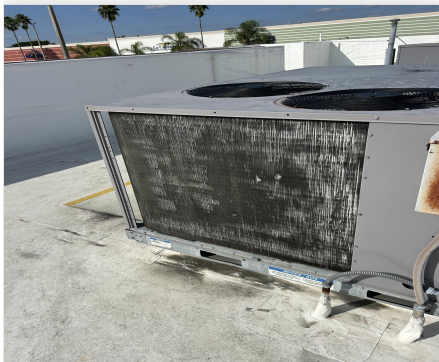
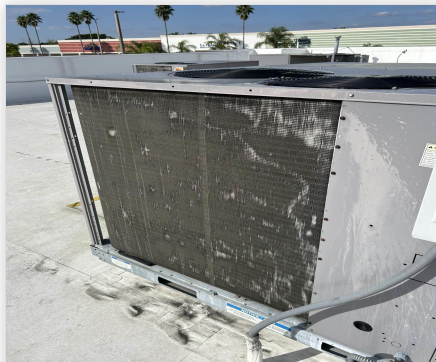
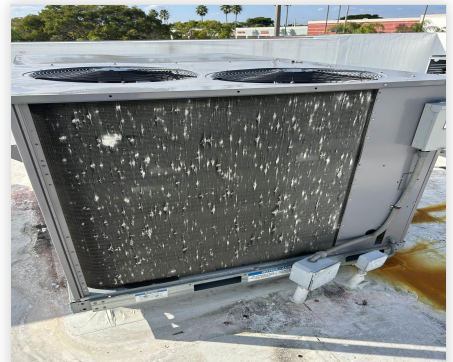
Issue Name : RTU Condenser Coils
Description : There is some fin damage on all RTU condenser coils.
Created By : National TAB **Assigned To :** National TAB - Dan Hertenstein
Status : Open
Priority : Medium **Asset Tag :**
Originated Date : 12/05/2025 - Mark Johnson - National TAB

Some coil damage on all RTUs

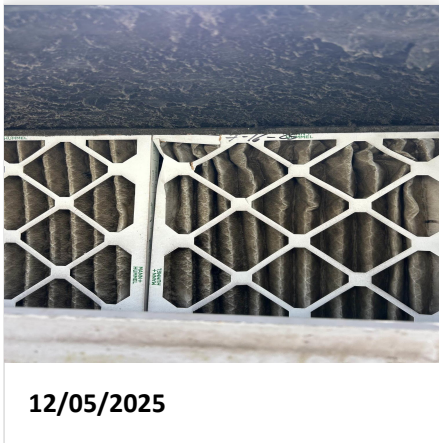
Issue Name : RTU Filters Dirty
Description : All RTU final filters are dirty and need replaced soon.
Created By : National TAB **Assigned To :** National TAB - Dan Hertenstein
Status : Open
Priority : High **Asset Tag :**
Originated Date : 12/05/2025 - Mark Johnson - National TAB

All filters are dirty and need replaced

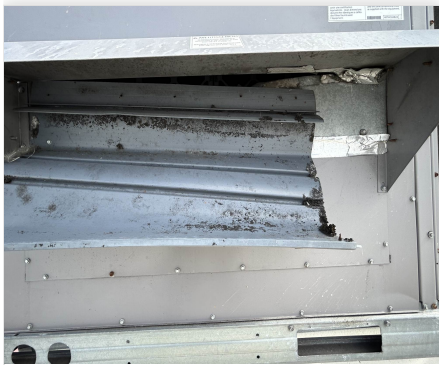
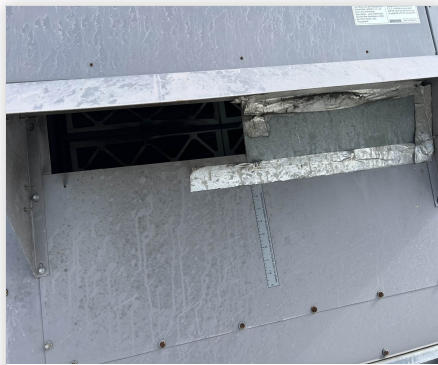
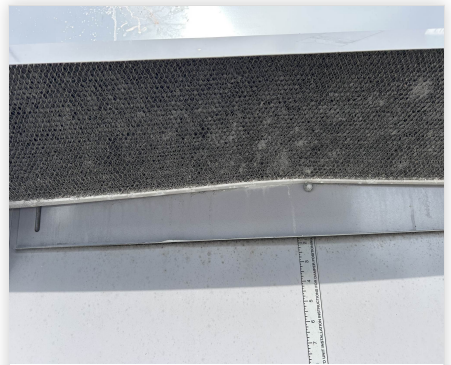
Issue Name : RTUs - OA Filters
Description : Outside air intake filters are dirty or damaged on all RTUs. Recommend repair/replacement.
Created By : National TAB **Assigned To :** National TAB - Dan Hertenstein
Status : Open
Priority : Urgent **Asset Tag :**
Originated Date : 12/05/2025 - Mark Johnson - National TAB

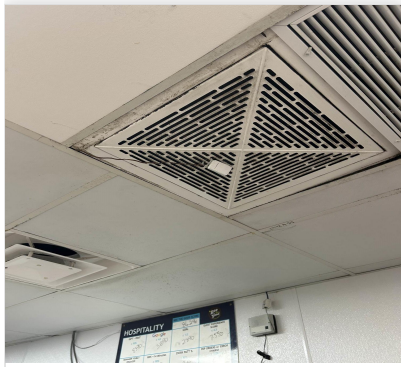
Some dirty tiles and diffusers around kitchen

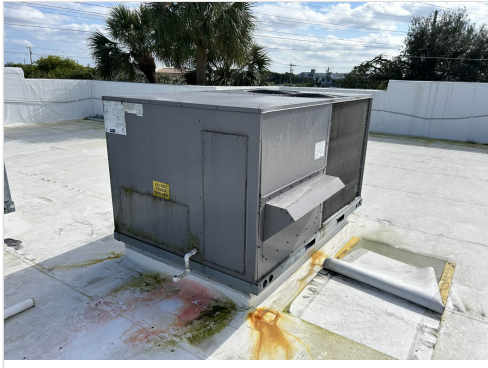
[1] Damper is broken in half, OA is fully open on one side as a result.

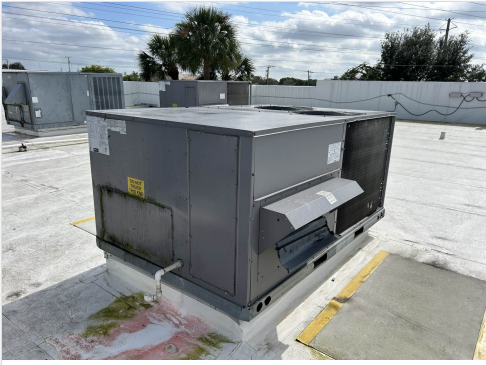
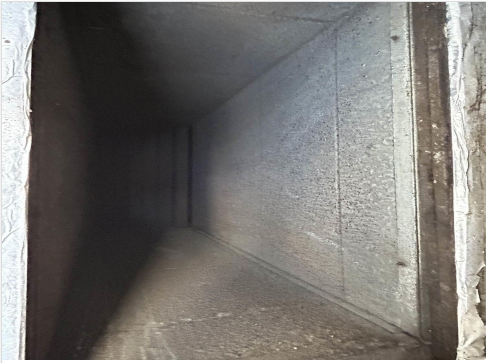
[1] A negligible amount of outside air is present due to damage to OA damper (very small gap at top-right corner). Cannot be accurately measured on the roof.
