Report: TAB REPORT
Function: Test, Adjust, & Balance
Date: 03/06/2023

PROJECT
02-27-23 CULVERS - FRANKFORT, IN

Project: 02-27-23 CULVERS - FRANKFORT, IN

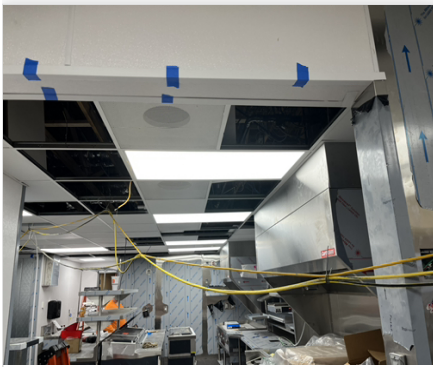
Tiles.jpeg

Issue Name : Ceiling tiles around hoods need to be installed.
Description : There are tiles around the hoods that are missing that will need to be installed to assure proper smoke capture.
Created By : National TAB **Assigned To :** National TAB - Jacob Davidson
Status : Open
Originated Date : 02/27/2023 - Jacob Davidson - National TAB

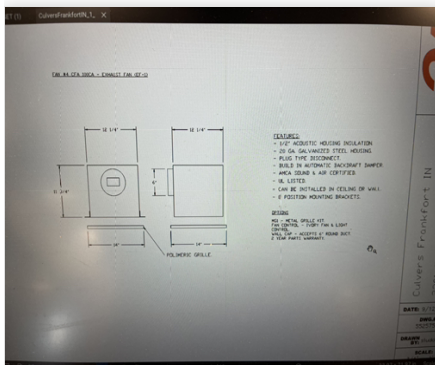
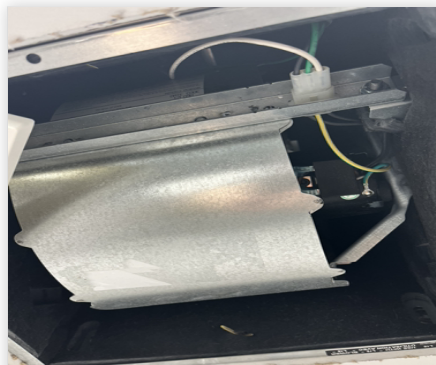
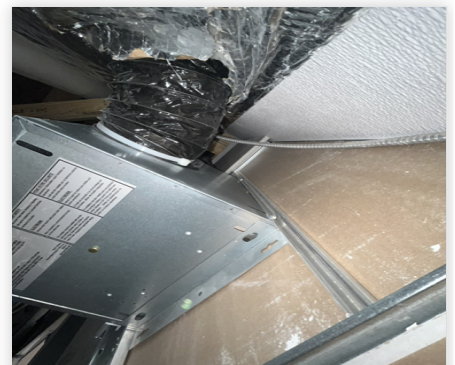
Issue Name : EF1A Mop Room high flow

Description : The exhaust fan for the mop room is scheduled for 75CFM and is getting 104 CFM. There does not seem to be any speed control for the unit. Unit is underamping and in an open area, so this should not cause any major issues.

Test Data		
	Design	Actual
CFM	75	104
Fan RPM	493	493
Fan Rotation	-	CCW
Motor RPM	-	493
System SetPt	-	NO SPEED CONTROL
RL Voltage	-	119V
RL Amperage	-	0.41A
Total ESP	0.125"	0.09"
Fan Inlet SP	-	UTO
Fan Discharge SP	-	0.09"

- **03/07/2023** **National TAB - Will Turnbough**
 - No further action is recommended.

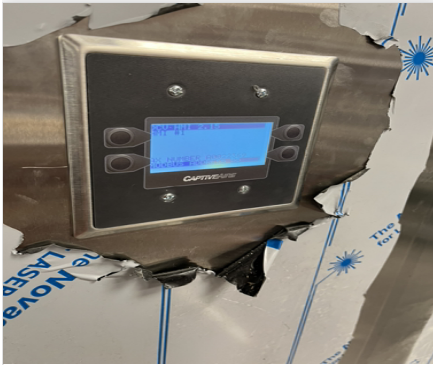
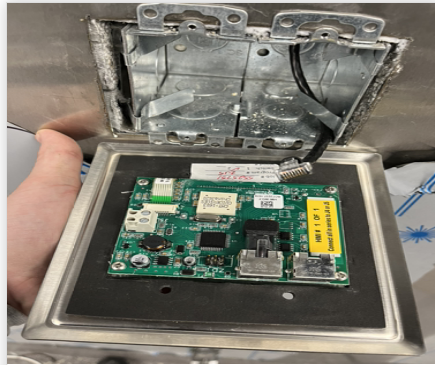
Issue Name : HD1/HD2 faulty BOARD needs a replacement

Description : The HMI for the hoods will not move from the screen pictured. After troubleshooting it with John from Captive Aire customer support, we've determined that the board needs to be replaced under warranty. Without the HMI, tech will not be able to adjust speeds on either fan for proper balancing. Airflow for the exhaust fans is above design as a result

Notes: HMI FOR HOODS IS DEFECTIVE AND NEEDS TO BE REPLACED. TECH CANNOT ADJUST SPEEDS OF THE UNITS UNTIL THEN. BASED ON FAN LAW, TECH DETERMINED THAT THE SPEED WILL NEED TO BE DECREASED TO 38.7HZ ON THE HMI.

Notes: HMI FOR HOODS IS DEFECTIVE AND NEEDS TO BE REPLACED. TECH CANNOT ADJUST SPEEDS OF THE UNITS UNTIL THEN. BASED ON FAN LAW, TECH DETERMINED THAT THE SPEED NEEDS TO BE DECREASED TO 36.3HZ TO BE IN DESIGN.

- **03/07/2023 National TAB - Will Turnbough**
 - Once resolved, PRV-2 (Griddle) should be slowed down to 38.7 Hz to achieve design airflow. And PRV-3 (Fryer) should be slowed down to 36.3 Hz.

- **03/02/2023 National TAB - Jacob Davidson**
 - The HMI came in with a board and after replacing, no changes happened. The board in the hood panel needs to be replaced and rewired by the EC. HD1 should be decreased to 38.7hz and HD2 should be reduced to 36.3hz

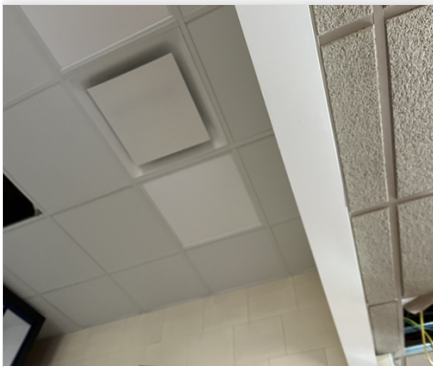
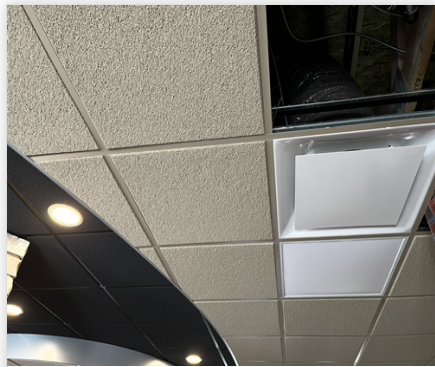
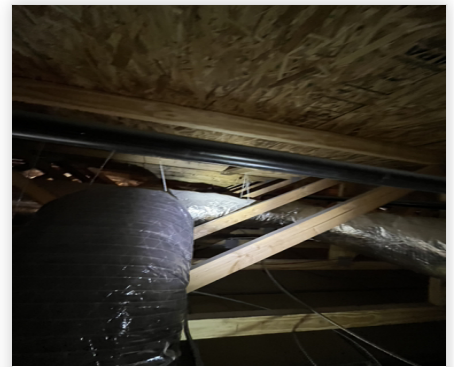
Issue Name : RTU1 SGRD4/SGRD23 Low Flow

Description : Diffusers 4 and 23 on RTU1 are low. The dampers on each diffuser are fully open. Both diffusers are at the end of the duct after a 90 degree turn. This could be causing turbulence in the duct. Both diffusers are in open space so there should not be any noise or comfort issues with the diffusers.

Asset	Notes
SGRD4	DAMPER IS FULLY OPEN. TECH IS UNABLE TO PUSH MORE AIR TO DIFFUSER. DIFFUSER IS IN AN OPEN AREA AND COMFORT S HOULD NOT BE AN ISSUE.
SGRD23	DAMPER IS FULLY OPEN. TECH IS UNABLE TO PUSH MORE AIR TO DIFFUSER. DIFFUSER IS IN OPEN AREA AND SHOULDN'T CA USE COMFORT ISSUES.

- **03/07/2023** **National TAB - Will Turnbough**
 - No further action is recommended.
-
- **02/28/2023** **National TAB - Jacob Davidson**
 - Added GRD section of ductwork

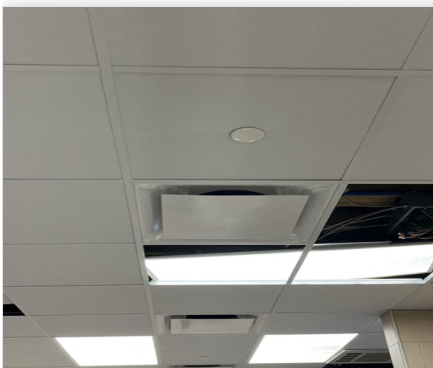
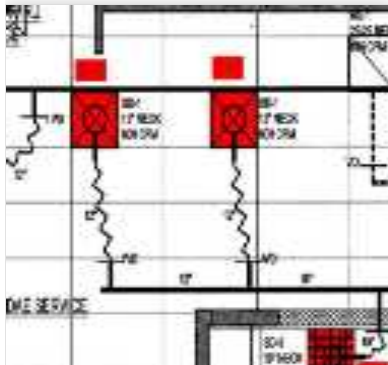
Issue Name : RTU2 SGRD1/SGRD2 low flow

Description : Diffusers are scheduled for 600 CFM a piece but tech is unable to push more air to the end of the duct without throwing the cookline out of balance. These diffusers are in an open area and should not cause any comfort issues

Asset	Notes
SGRD1	DAMPER IS FULLY OPEN. UNABLE TO PUSH MORE AIR TO THE DIFFUSER
SGRD2	DAMPER IS FULLY OPEN. UNABLE TO PUSH ANYMORE AIR TO DIFFUSER.

- No further action is recommended.
