Report: PUNCH
Function: Test, Adjust, & Balance
Date: 02/10/2026
Completed By: National TAB

PROJECT
02-09-26 QT #1098 ROCK HILL, SC

QUIKTRIP
4705 SOUTH 129TH EAST AVENUE
TULSA, OK 74134

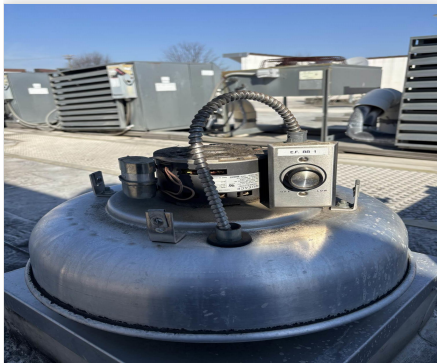
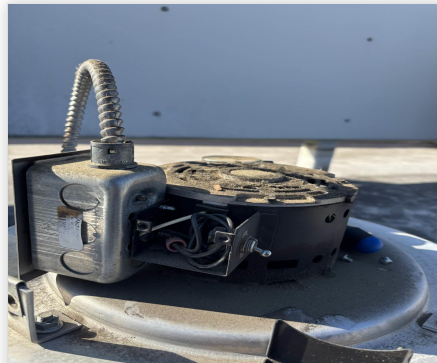
Issue Name : EF-1: High total exhaust
Description : Potentiometer set to lowest speed on speed dial. No low speed potentiometer present, cannot lower fan speed. ~200% of design.
Created By : National TAB **Assigned To :** National TAB - Dan Hertenstein
Status : Open
Priority : Medium **Asset Tag :**
Originated Date : 02/10/2026 - Cody Mauro - National TAB

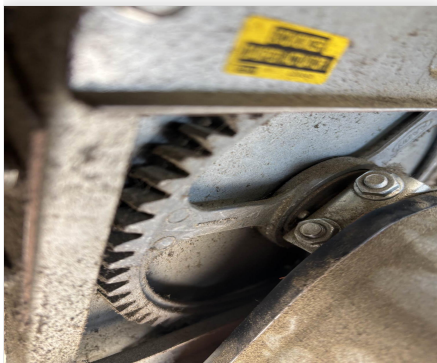
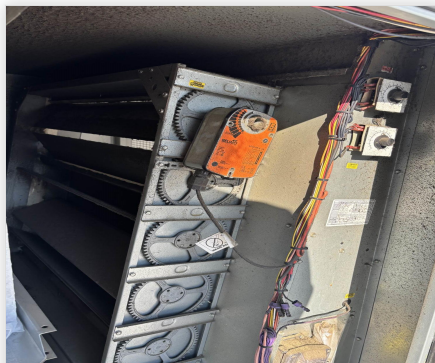
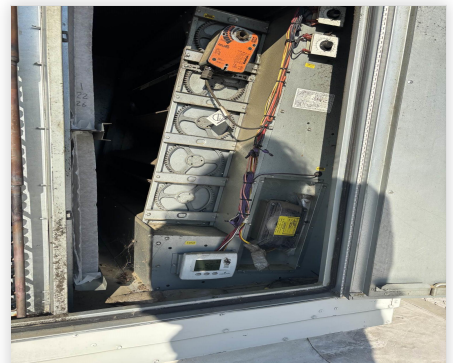
Issue Name : RTU2: Economizer not functional
Description : RTU3 economizer not functional, does not communicate when setting adjusting setpoints in emerson controls. Unable to manually loosen actuator screws for manually OA adjustment.
Created By : National TAB **Assigned To :** National TAB - Dan Hertenstein
Status : Open
Priority : High **Asset Tag :**
Originated Date : 02/10/2026 - Cody Mauro - National TAB

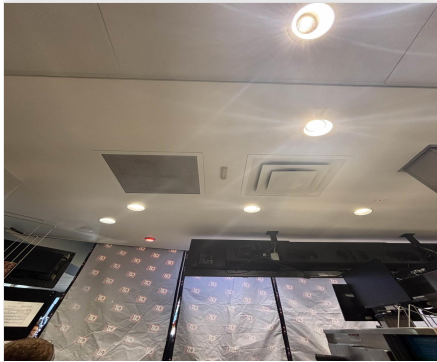
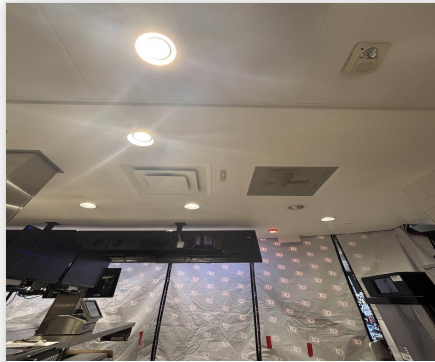
Issue Name : RTU3: Incorrect cookline diffusers
Description : Cookline diffusers are supposed to be TITUS 300FS with their proper deflection blades.
Created By : National TAB **Assigned To :** National TAB - Dan Hertenstein
Status : Open
Priority : High **Asset Tag :**
Originated Date : 02/09/2026 - Cody Mauro - National TAB
