Overall Summary

The purpose of the visit to Freddy's in Edmond, OK was to address smoke capture concerns.

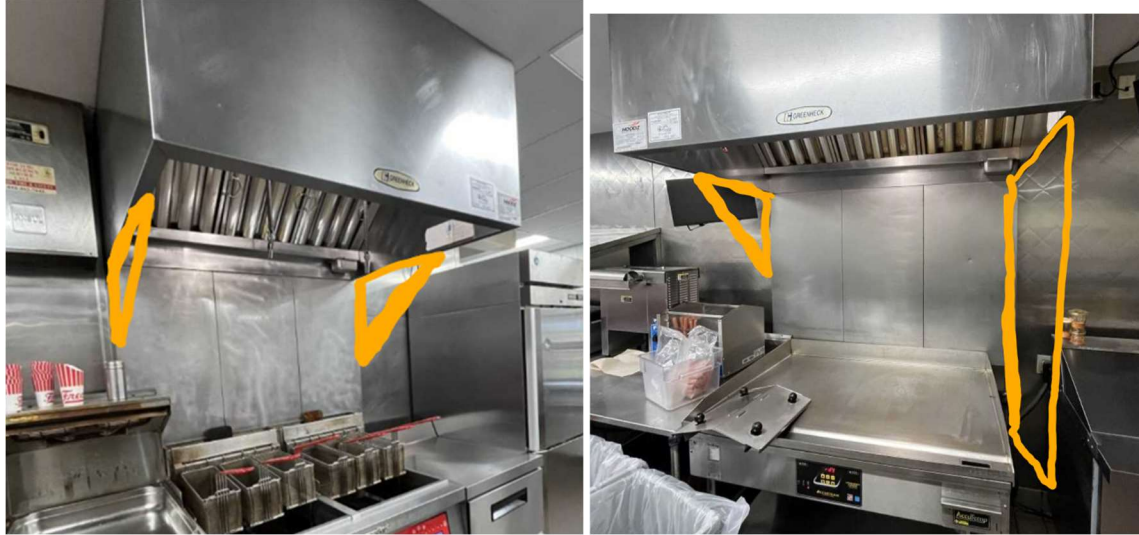
Recommend end panel locations

3. Full vertical end panel needs to be added to the right side of the griddle hood. A quarter end panel needs to be added to the left of the griddle hood.
