Report: Sweathouz Punchlist
Function: Test, Adjust, & Balance
Date: 03/12/2025
Completed By: National TAB

PROJECT
SWEATHOUZ RENOVATION (WEST
CHESTER, OH)

Project: SWEATHOUZ RENOVATION

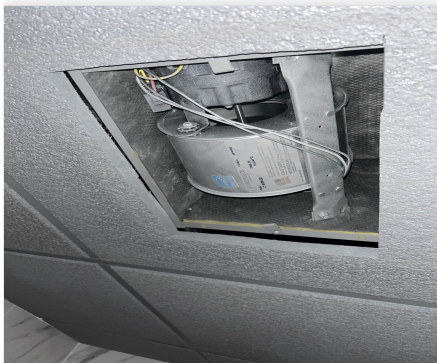
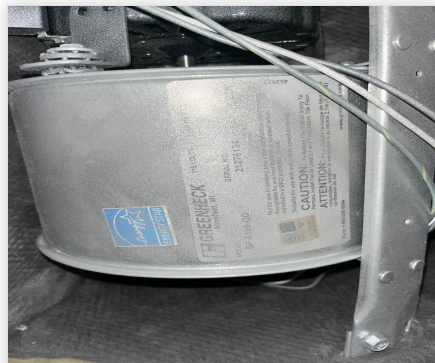
Issue Name : EF-B5.
Description : EF-B5 incorrect fan installed. Fan does not match other installed fans. Fan does not have a speed controller. Fan is not sealed at the ceiling.
Created By : National TAB **Assigned To :** National TAB - Nick Payne
Status : Open
Priority : Urgent **Asset Tag :** EF-B5
Originated Date : 03/12/2025 - Cody Collett - National TAB
