Report: Deficiency Report
Function: Test, Adjust, & Balance
Date: 09/17/2025
Completed By: National TAB

PROJECT
09-15-25 CAVA NAPLES, FL

4180 COLLIER BLVD

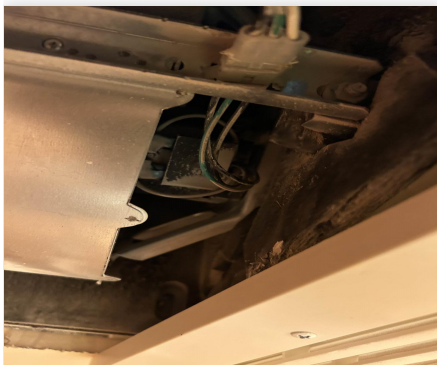
Issue Name : CEFs - Speed Controllers
Description : Both ceiling exhaust fans (restrooms) are missing speed controllers. Fans are running at 144% design and cannot be adjusted. Recommend installing speed controllers.
Created By : National TAB **Assigned To :** National TAB - Mark Johnson
Status : Open
Priority : High **Asset Tag :**
Originated Date : 09/17/2025 - Mark Johnson - National TAB

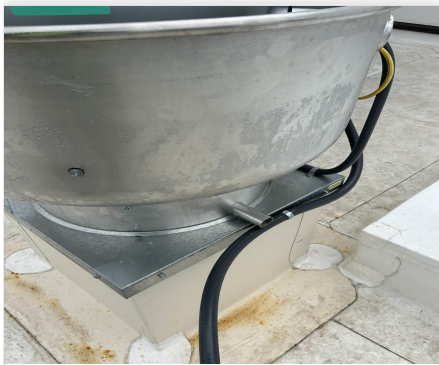
Issue Name : KF 1 - Grease Drain Pan
Description : The hood exhaust fan is missing the grease drain pan. Recommend installing per plan.
Created By : National TAB **Assigned To :** National TAB - Mark Johnson
Status : Open
Priority : Medium **Asset Tag :**
Originated Date : 09/17/2025 - Mark Johnson - National TAB

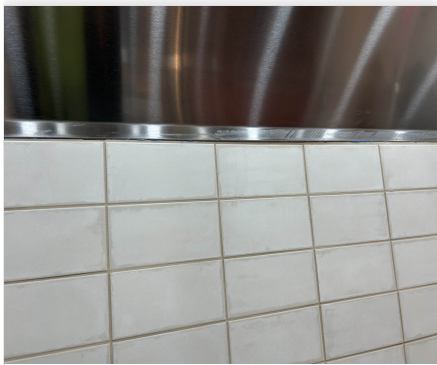
Issue Name : Kitchen Hood - Caulking
Description : Kitchen hood is missing caulking (less than 1/8" thick) along the rear edge. Recommend sealing.
Created By : National TAB **Assigned To :** National TAB - Will Turnbough
Status : Open
Priority : Low **Asset Tag :**
Originated Date : 09/17/2025 - Mark Johnson - National TAB

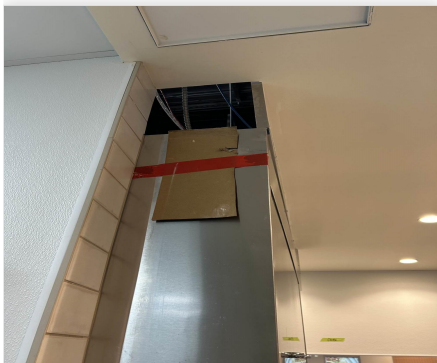
Issue Name : Kitchen Hood - Ceiling Enclosure
Description : There is a missing enclosure panel on the back corner of the kitchen hood, leaving a small gap that's open to the ceiling. Recommend installing.
Created By : National TAB **Assigned To :** National TAB - Mark Johnson
Status : Open
Priority : High **Asset Tag :**
Originated Date : 09/17/2025 - Mark Johnson - National TAB

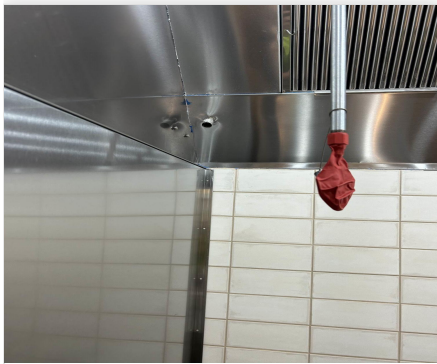
Issue Name : Kitchen Hood - Grease Cups
Description : Hood grease cups are not yet installed. Recommend installing.
Created By : National TAB **Assigned To :** National TAB - Will Turnbough
Status : Open
Priority : Medium **Asset Tag :**
Originated Date : 09/17/2025 - Mark Johnson - National TAB

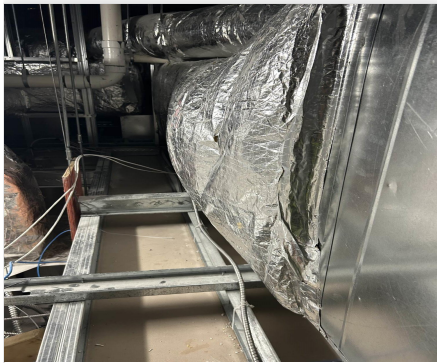
Issue Name : RTU 2 - Duct Leakage
Description : The section of RTU 1's trunk line near the main drop appears to be experiencing leakage; the surrounding insulation is puffing out, and airflow can be felt from gaps in insulation. Recommend mechanical inspection.
Created By : National TAB **Assigned To :** National TAB - Will Turnbough
Status : Open
Priority : Urgent **Asset Tag :**
Originated Date : 09/17/2025 - Mark Johnson - National TAB

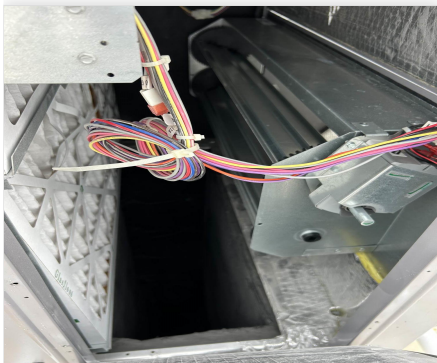
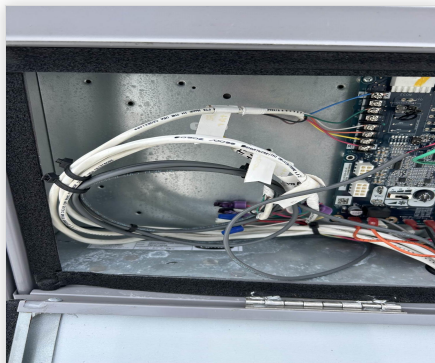
Issue Name : RTUs - Economizer Controls
Description : Both RTUs are missing economizer controllers. Economizer dampers open to 100% when energized, and setpoints cannot be adjusted. Damper positions will be manually set for TAB. Recommend installing controllers and setting to minimum OA positions (marked on dampers).
Created By : National TAB **Assigned To :** National TAB - Will Turnbough
Status : Open
Priority : Urgent **Asset Tag :**
Originated Date : 09/17/2025 - Mark Johnson - National TAB

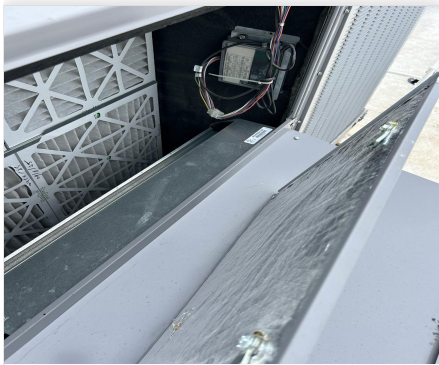
Issue Name : RTUs - Filter Access Doors
Description : Filter access doors on both RTUs are missing hinges. Doors come off completely when opened. Recommend installing hinges.
Created By : National TAB **Assigned To :** National TAB - Mark Johnson
Status : Open
Priority : Low **Asset Tag :**
Originated Date : 09/17/2025 - Mark Johnson - National TAB
