**Report: Deficiency Report
Function: Test, Adjust, & Balance
Date: 12/17/2025
Completed By: National TAB**

PROJECT
City BBQ (Johnson City, TN)

Issue List

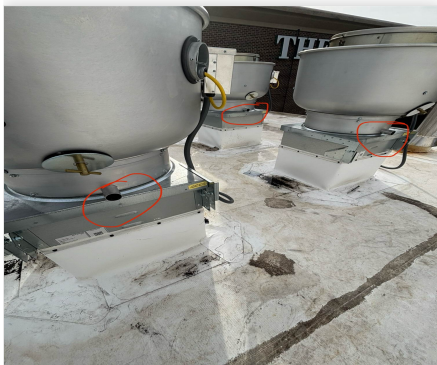
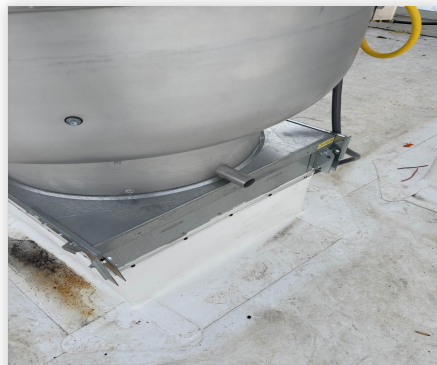
Issue Name : Missing grease cups
Description : The KEF for Hood 2, as well as all three exhaust fans for the smokers are missing their grease capture cups on the outside of the fans.
Created By : National TAB **Assigned To :** National TAB - Dan Hertenstein
Status : Open
Priority : Medium **Asset Tag :** KH-1
Originated Date : 12/17/2025 - Christian Moller - National TAB

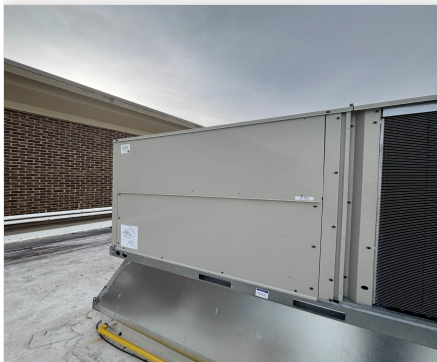
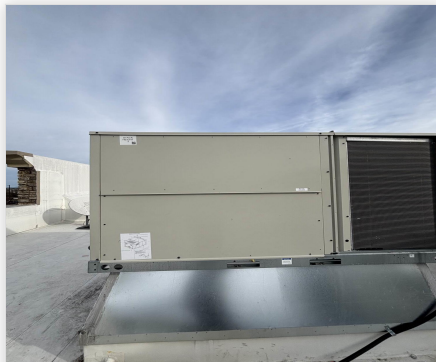
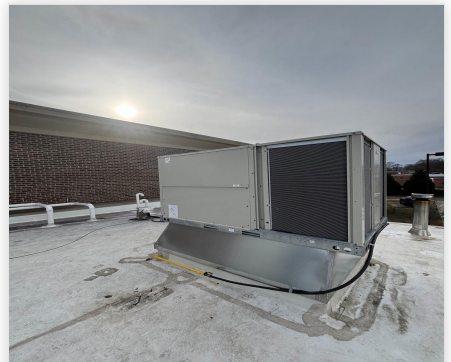
Issue Name : No OA on RTU's
Description : None of the RTU's have OA intakes. OA could not be balanced.
Created By : National TAB **Assigned To :** National TAB - Dan Hertenstein
Status : Open
Priority : Urgent **Asset Tag :**
Originated Date : 12/17/2025 - Christian Moller - National TAB

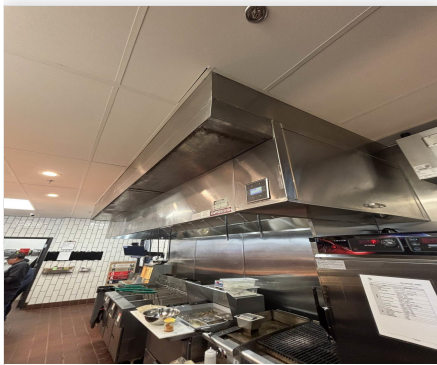
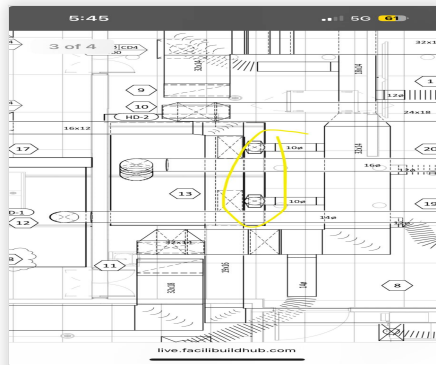
Issue Name : Only PSP on Hood 2
Description : The plans show an ACPSP on hood 2, with supply running from RTU 2 to the hood. There is only the PSP portion on the hood, no supply from the RTU.
Created By : National TAB **Assigned To :** National TAB - Dan Hertenstein
Status : Open
Priority : High **Asset Tag :** KH-1
Originated Date : 12/17/2025 - Christian Moller - National TAB
