**Report: TAB REPORT
Function: Test, Adjust, & Balance
Date: 02/21/2023**

**PROJECT
02-20-23 FREDDY'S - BELLEVILLE, IL**

**Freddy's Frozen Custard & Steakburgers (CORPORATE)
260 N Rock Rd
Suite 200
Wichita, KS 67206**

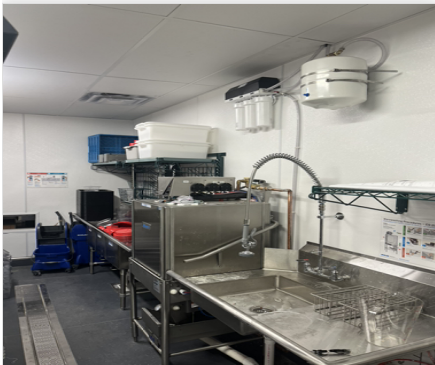
Nohood.jpeg

Issue Name : 1. INFO: Positive Net Airflow-Hood 3 and KEF-3 Not Installed.

Description : Dish Hood (HD-3) and it's respective fan were not installed. Due to its deletion, building was scheduled to be over 1000 cfm positive. Reduced outside airflow on RTU-1 to bring net building pressure within an acceptable range.

[1] RTU-1 OA reduced due to deletion of KEF-3 and its hood (HD-3). As scheduled, net airflow would have pushed building pressure beyond 0.02" W.C. tolerance.

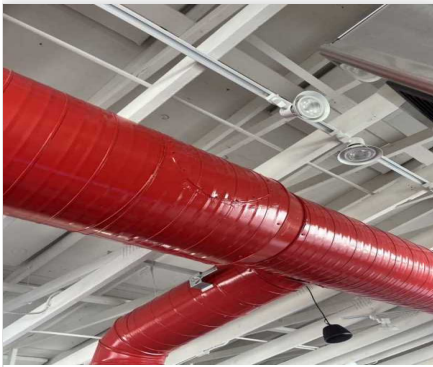
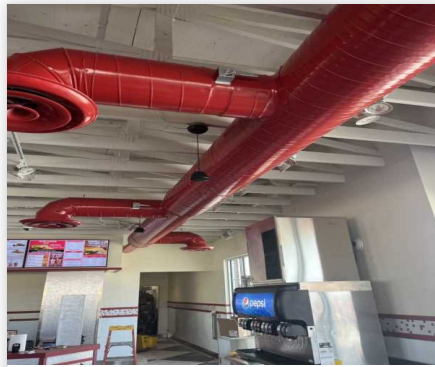
Issue Name : 2. RTU-1 Diffuser 1-9 Deleted

Description : RTU-1 diffuser 1-9 was deleted due to obstruction from ice machine. Scheduled supply airflow distributed evenly amongst dining diffusers.

Asset	Notes
SGRD9	[1] DIFFUSER NOT INSTALLED DUE TO ICE MACHINE. SCHEDULED AIRFLOW DISTRIBUTED EVENLY IN DINING ROOM.

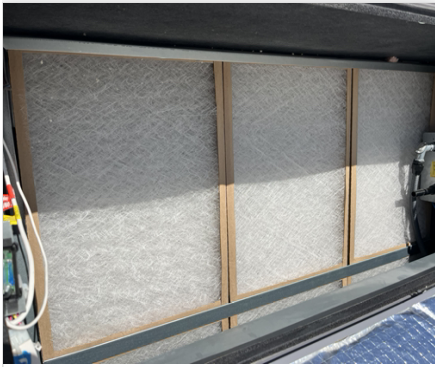
RTU-1filters.jpeg

Issue Name : 3. RTU-1 has construction filters installed.

Description : RTU-1 still has throwaway construction filters installed. Recommend correct final filters are installed at turnover.
