PlanGrid Task Report - Oct 9, 2024

TAB Punch List

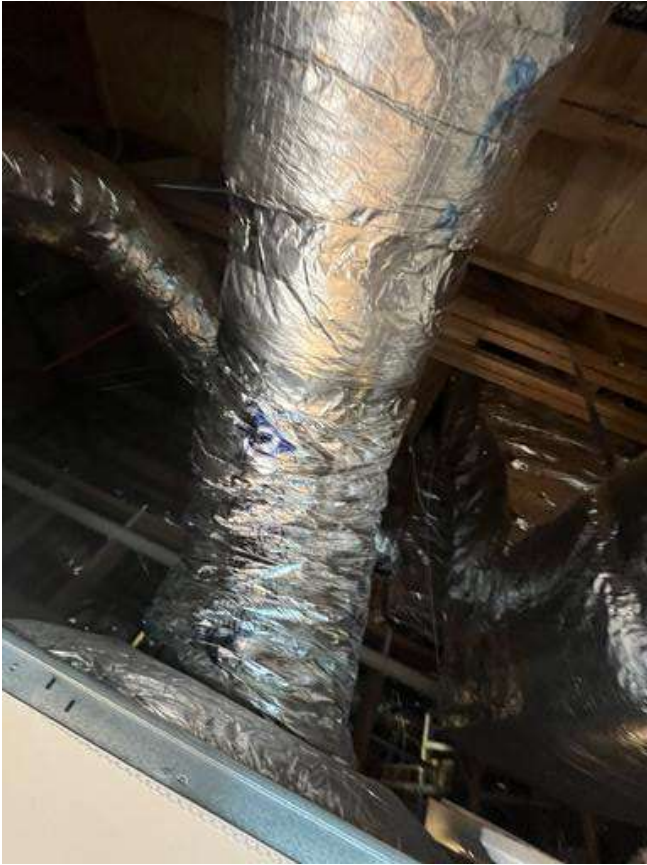
#636 [DUCT 007] [NEW] CRITICAL – Diffuser rigid 90's.

Ensure rigid 90 degree fittings are secured to diffusers, with hard pipe risers adjusted to meet take off height elevation and connected to horizontal flex. No flex in drops allowed per details.

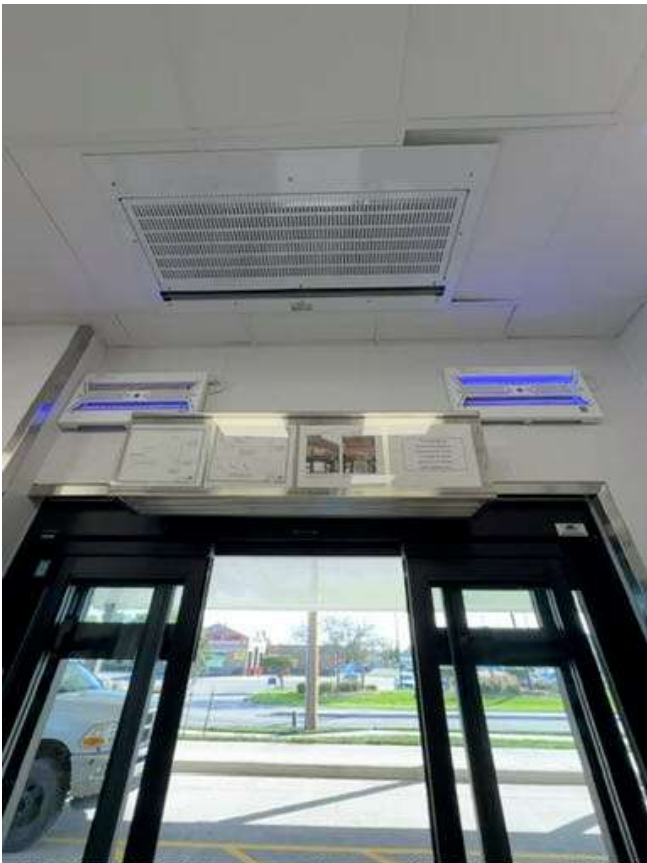
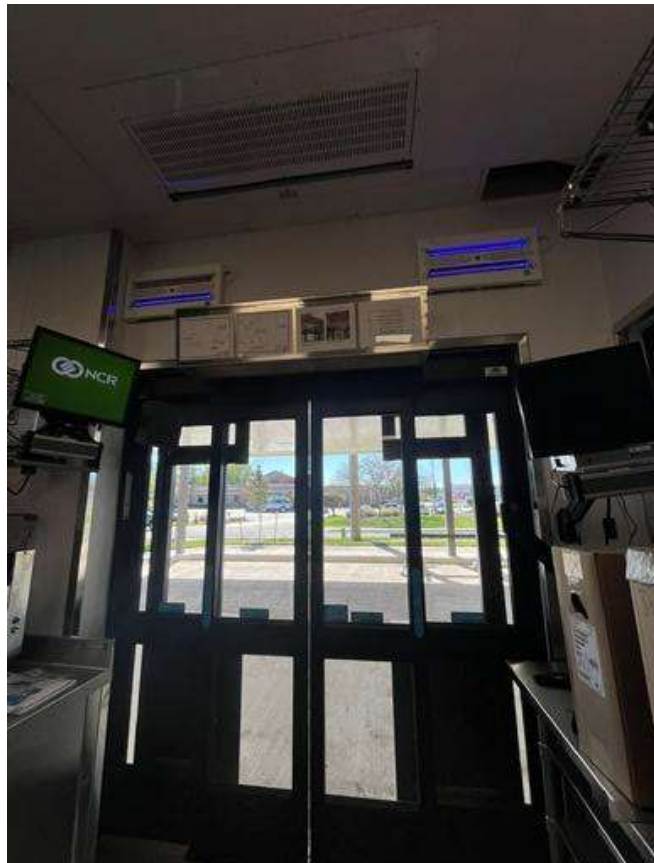
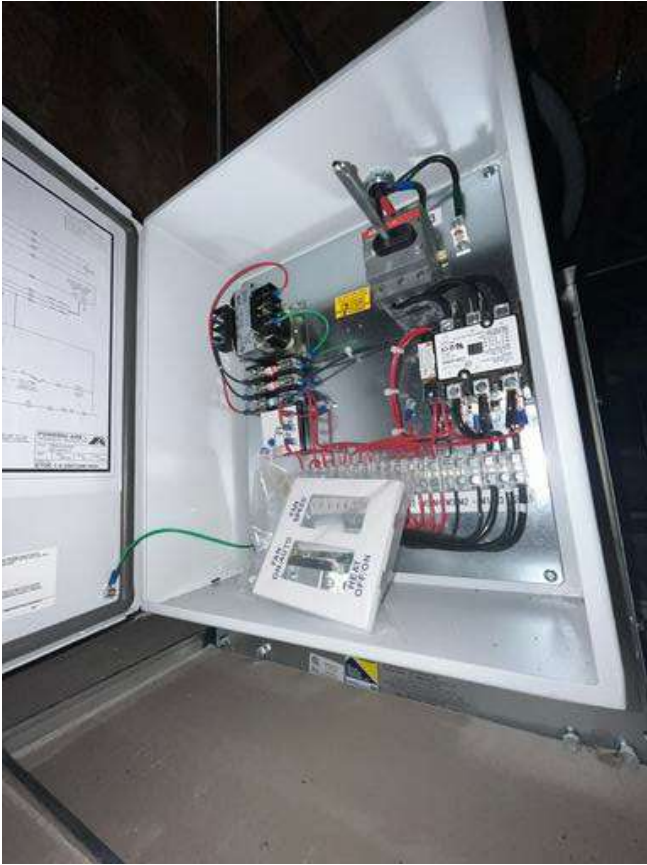
#633 Drive thru doors air curtain not operational

Description
The drive thru door air curtain is not wired, and missing switches.

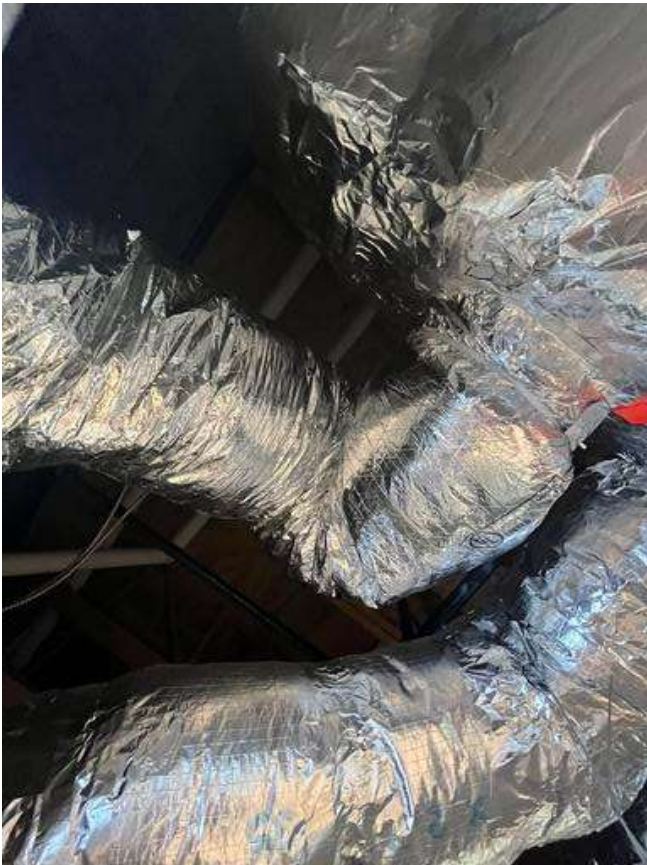
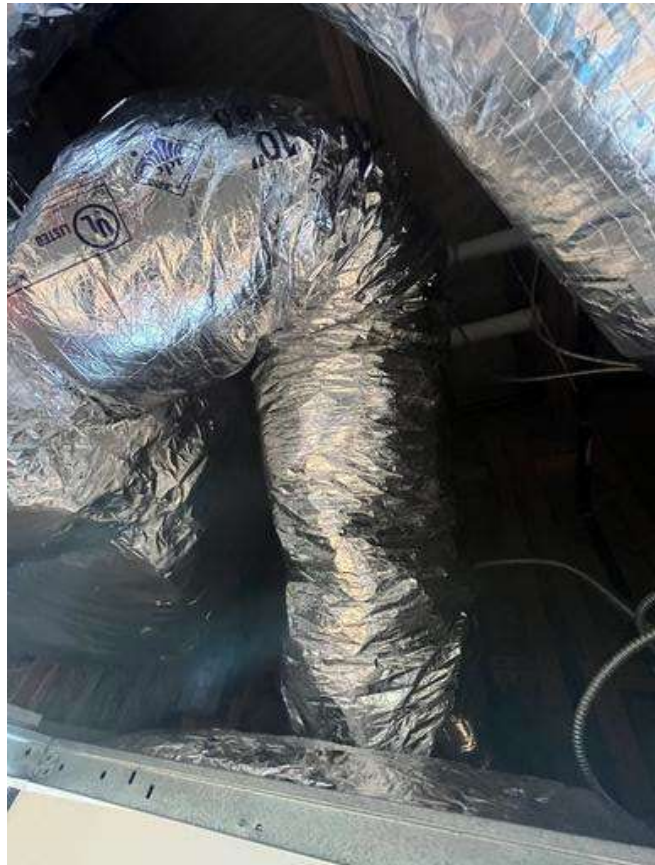
#632 [DUCT 016] Duct is restricted

Duct 3-11 just outside of play place flex duct is restricted due to tight 90 degree turns in flex duct, unable to push air flow to bring diffuser up to design total flow.

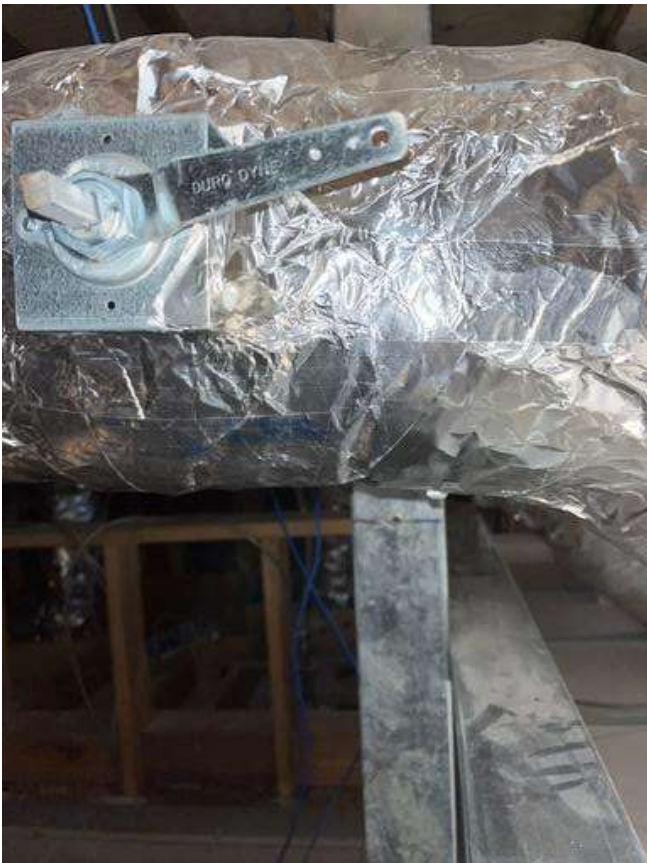
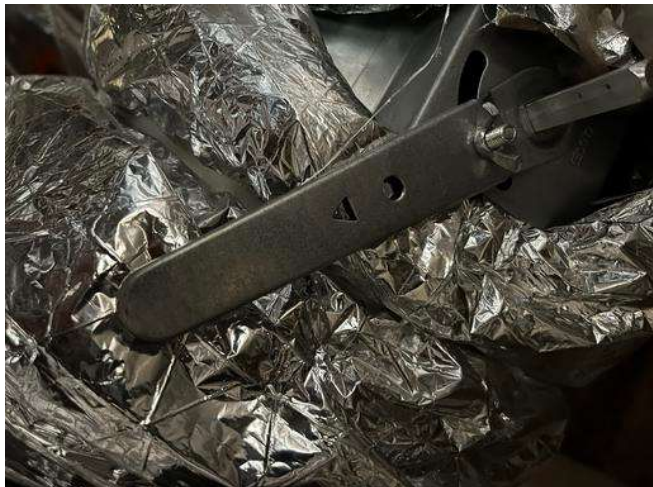
#631 [DUCT 009] CRITICAL Dampers Incorrect type.

4 diffusers in dining room
3-18,3-17,3-16,3-14. Have
the wrong dampers installed.

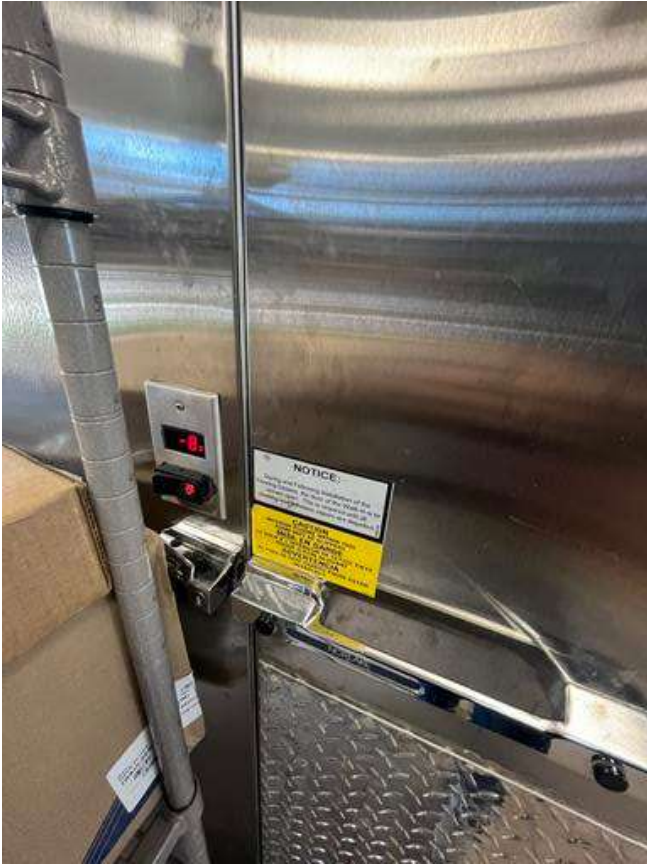
#629 [REFG 500] [NEW] WIF Temperature

WIF temperature holding at -6F. Should be holding at 0 degrees.

This is a National Vendor issue.

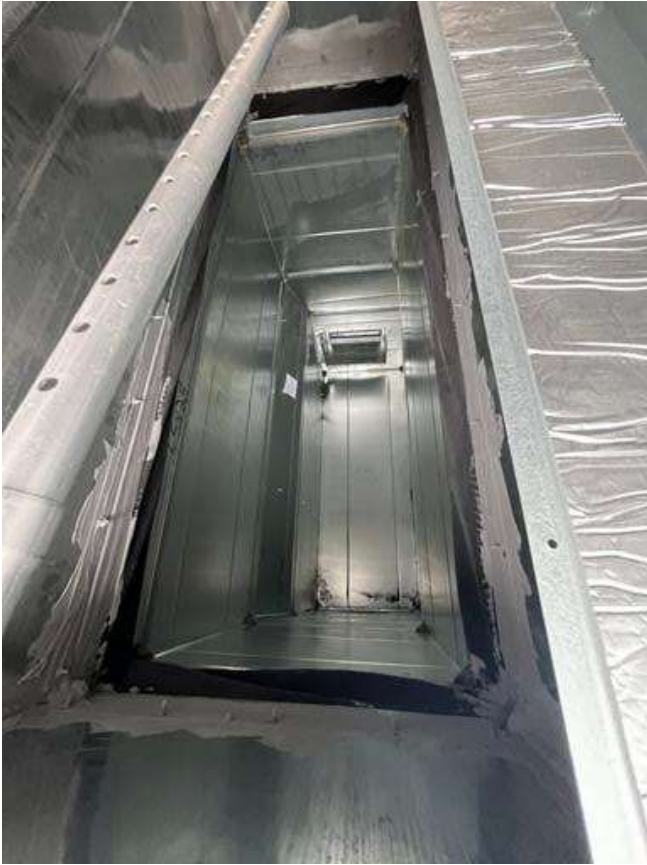
#628 [DUCT 002] [NEW] CRITICAL – Turning vanes not in supply duct.

Description
AC-2 Turning vanes are not present in the supply duct and need to be added per specification.

Checked and confirmed that the turning vanes are in fact in place.

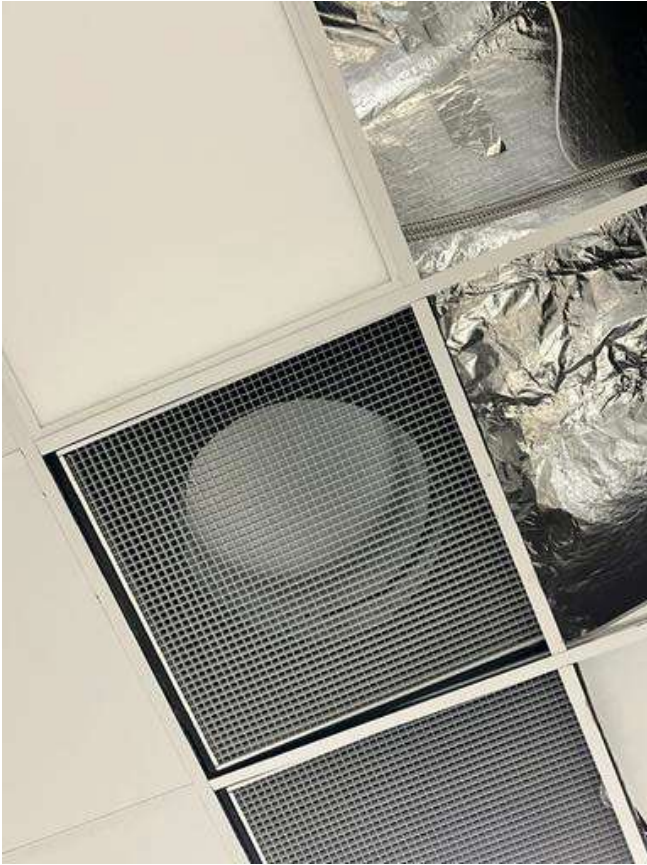
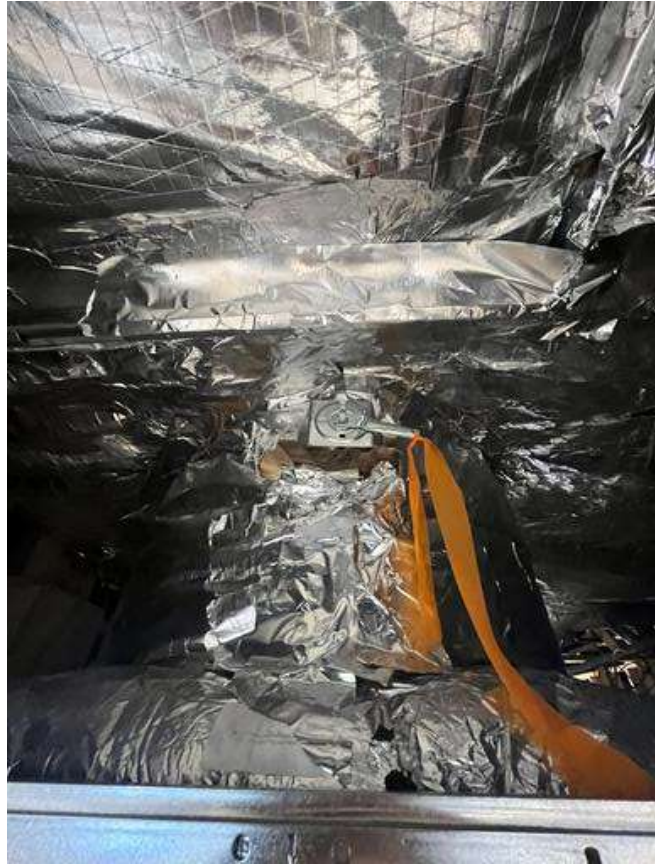
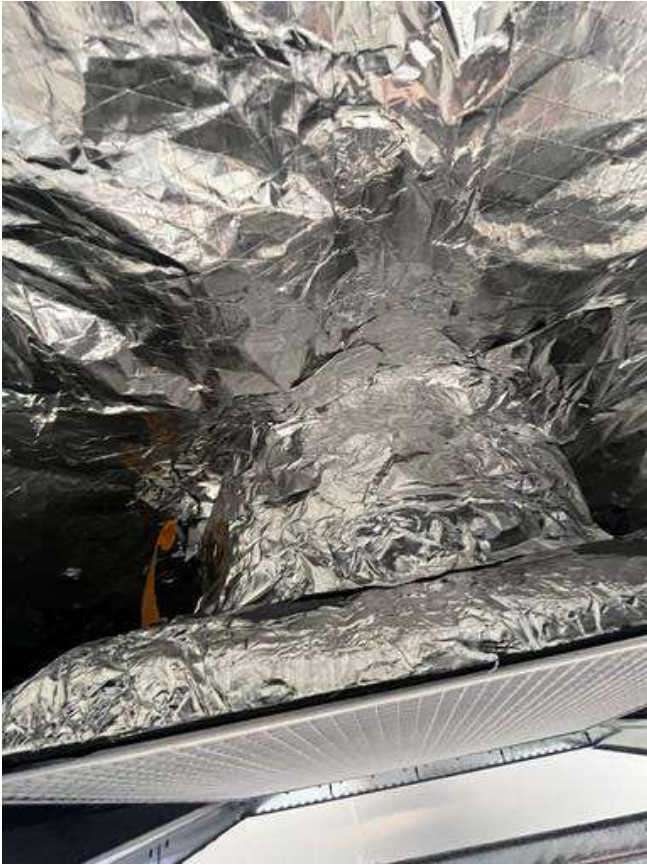
#627 [DUCT 011] [NEW] CRITICAL – Damper(s) bound.

AC-1 Return Damper(s)
bound from restriction or
bound at start collar
connection, unable to
balance system until
corrected.

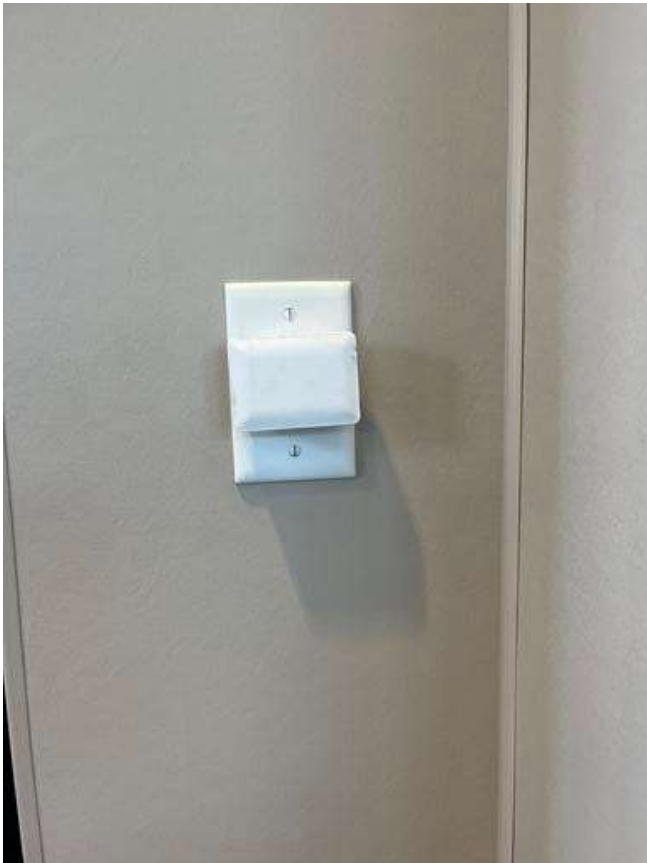
#625 [CNTL 508] [NEW] Controls labeling.

Sensor in play place does not have labeling present.

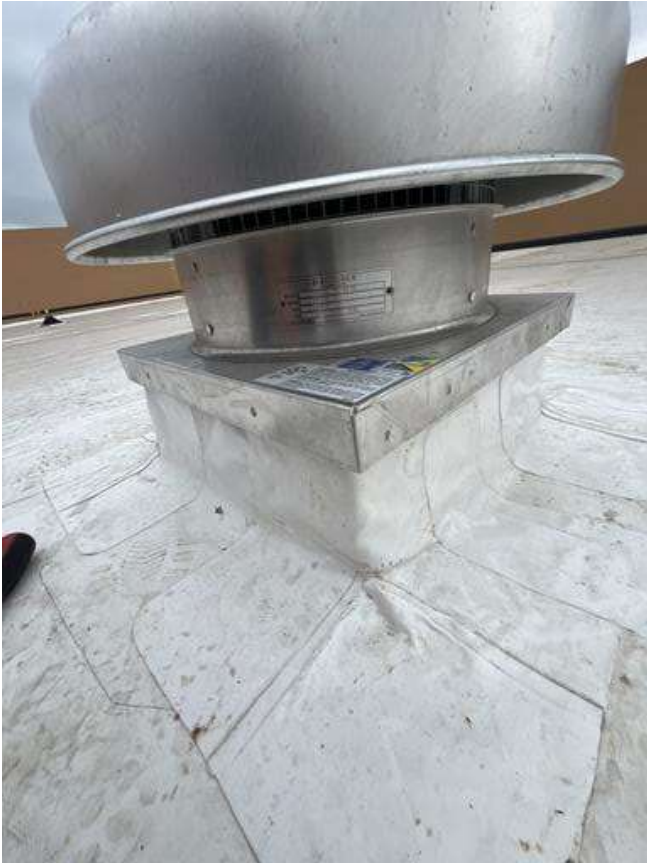
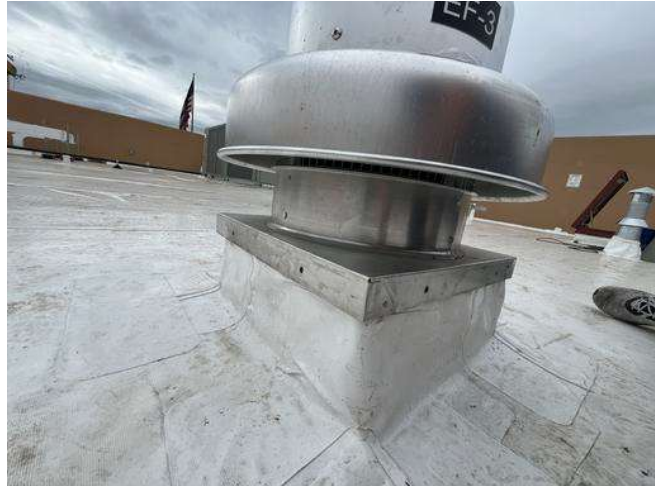
#624 [EXHA 501] [NEW] Restroom fan is not secured.

Restroom fan is to be secured with screws at all corners of curb.

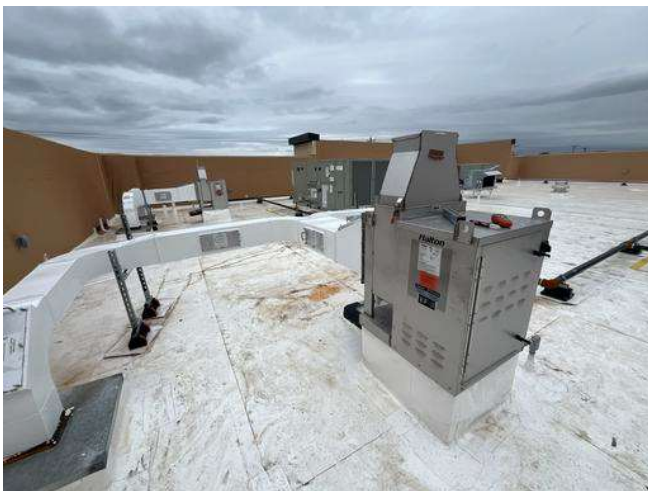
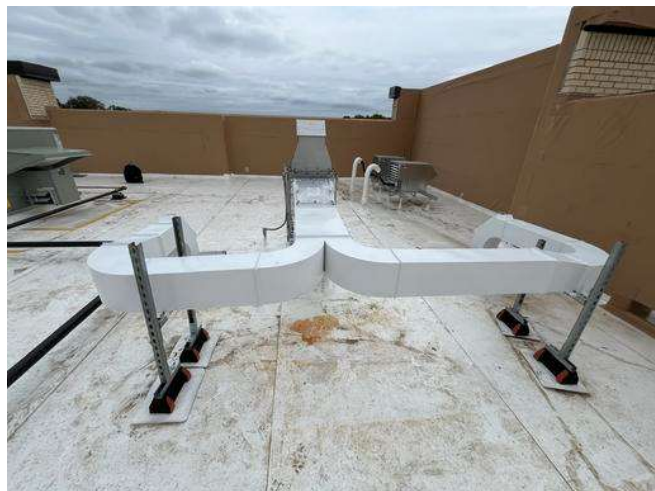
#622 [EXHA 510] [NEW] Grease exhaust duct is not supported.

Exhaust duct is to be supported per kitchen hood exhaust fan detail on 6'0" centers.

Grease duct stands are wrong manufacturer per plan. Will also need more support for ducts as per plan states for every 6' or more a stand needs to be placed.

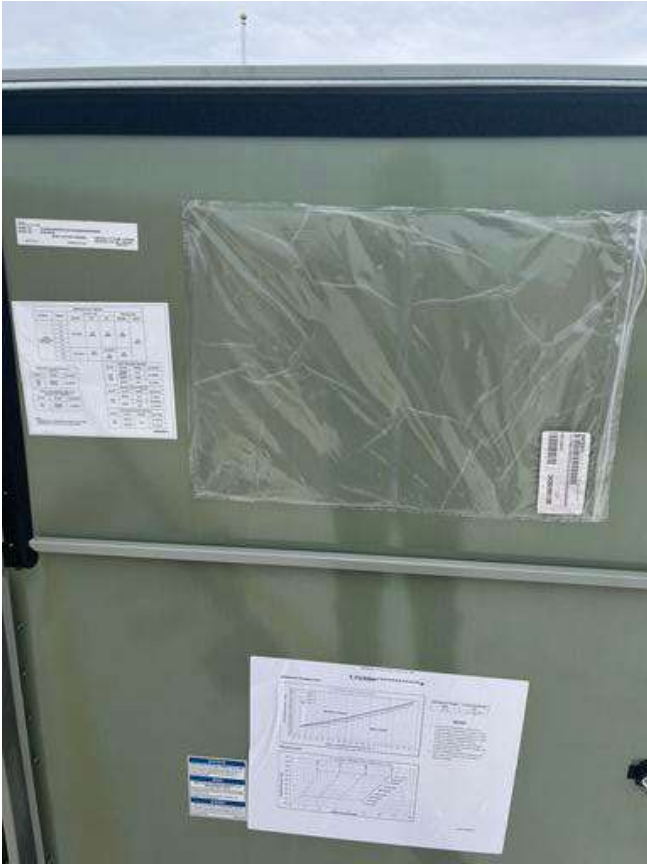
#621 [UNIT 501] [NEW] Equipment low voltage diagrams

AC-1,AC-2,AC-3 missing laminated copy of controls detail low voltage wiring diagrams.

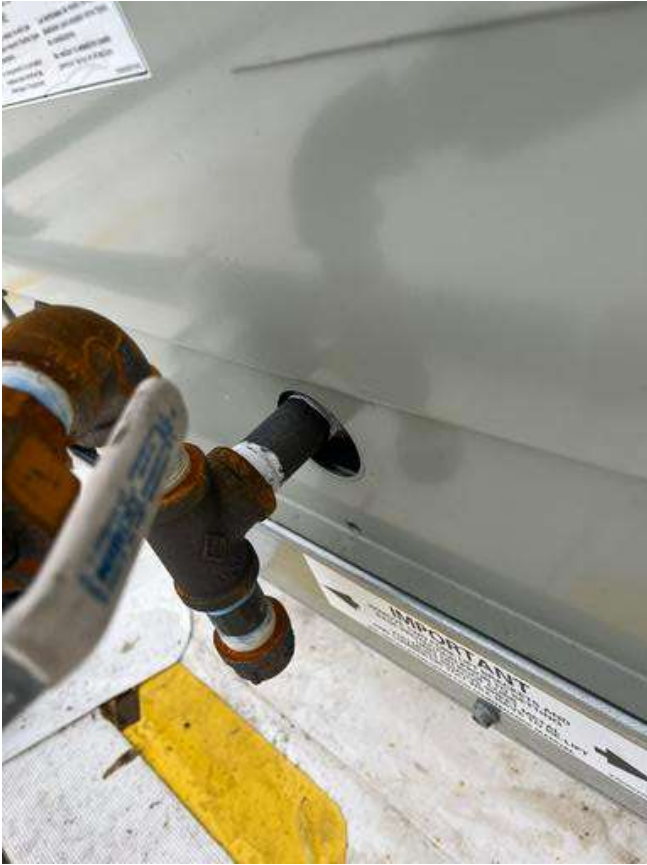
#620 [UNIT 510] [NEW] Gas inlet grommet.

AC gas inlet grommet is missing at the gas line/RTU penetration point.

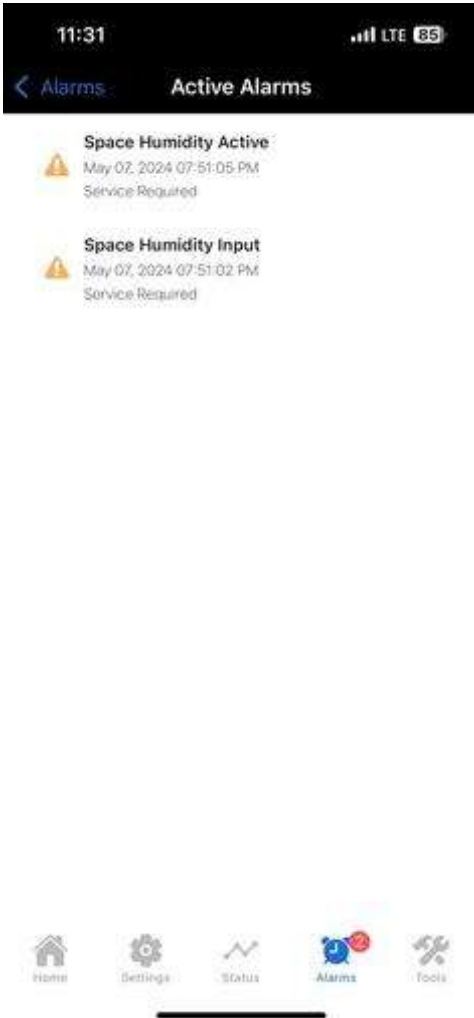
#617 [UNIT 999] [NEW] (MISC) AC Alarms

All AC units have alarms showing 1. "Space humidity active" 2. Space humidity input.

This is a Trane issue and they are scheduled to come back and fix this week.
