# 5571 PRE-GRID PUNCH LIST

Prepared by Ben Searles

Mar 21, 2025

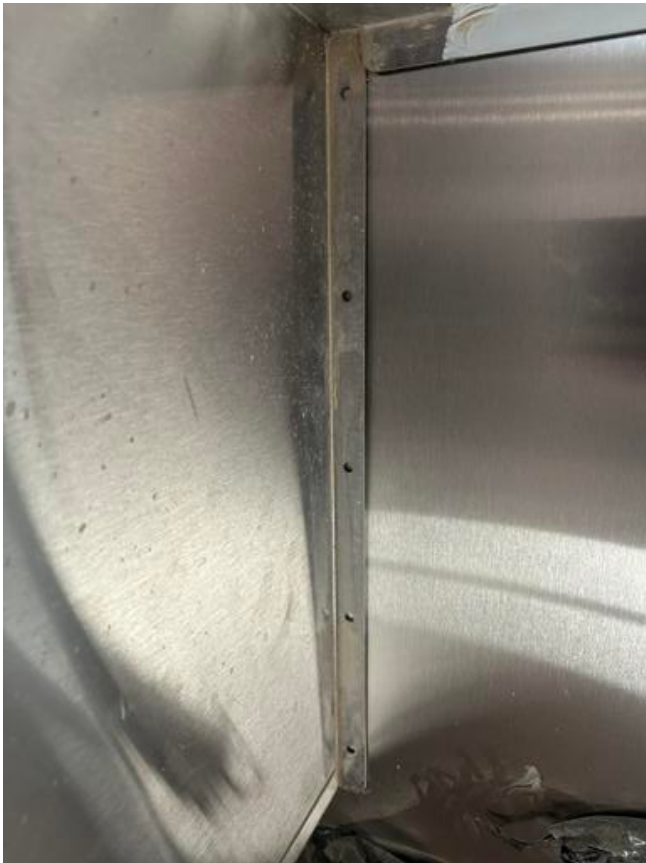
IMG\_0606

**#35 [HOOD 509] [NEW] Hood back panes.**

Hoods are to be secured to back panes via pre-punch holes with stainless steel screws.

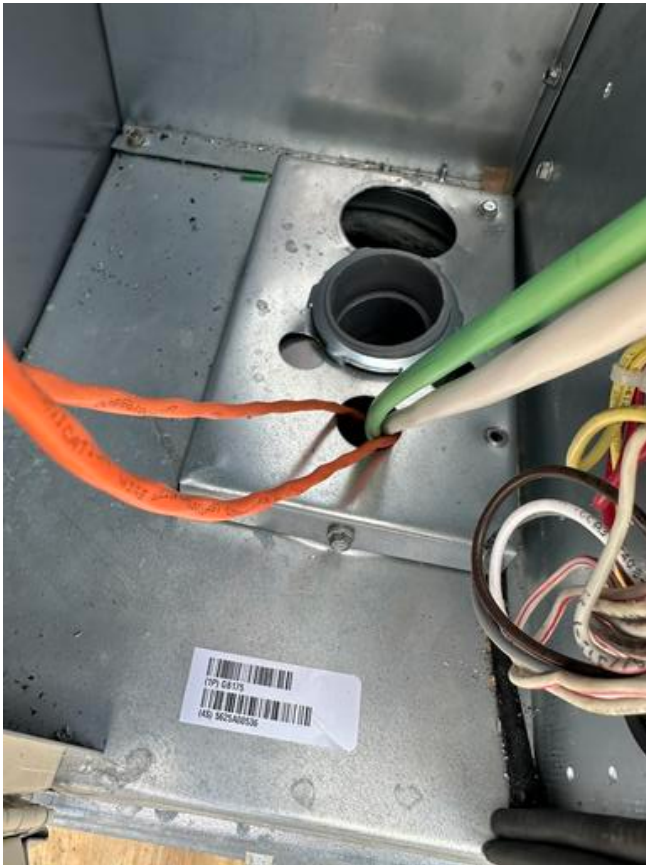
IMG\_0609

### #34 [UNIT 505] [NEW] Equipment wiring portals.

<b>Status</b> Open	<b>Start Date</b> Mar 20, 2025
<b>Type</b> Planned Work	<b>Created</b> Mar 21, 2025 11:24 AM bens@nationaltab.com
<b>Description</b> AC1 is missing a low voltage wiring grommet.	<b>Last Updated</b> Mar 21, 2025 11:25 AM

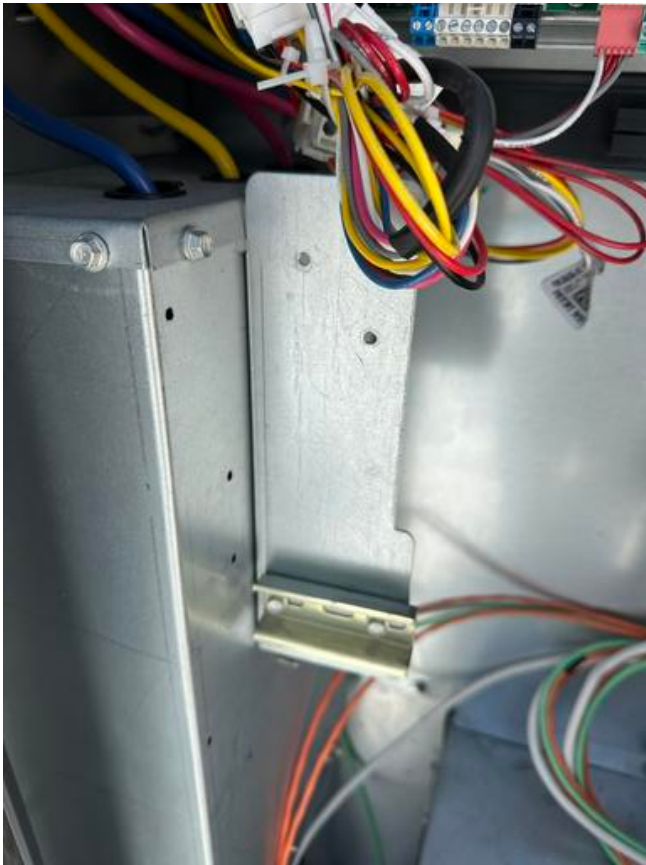
IMG\_0616

### #33 [UNIT 506] [NEW] Equipment GFI outlets.

AC4 GFI outlet is not installed.

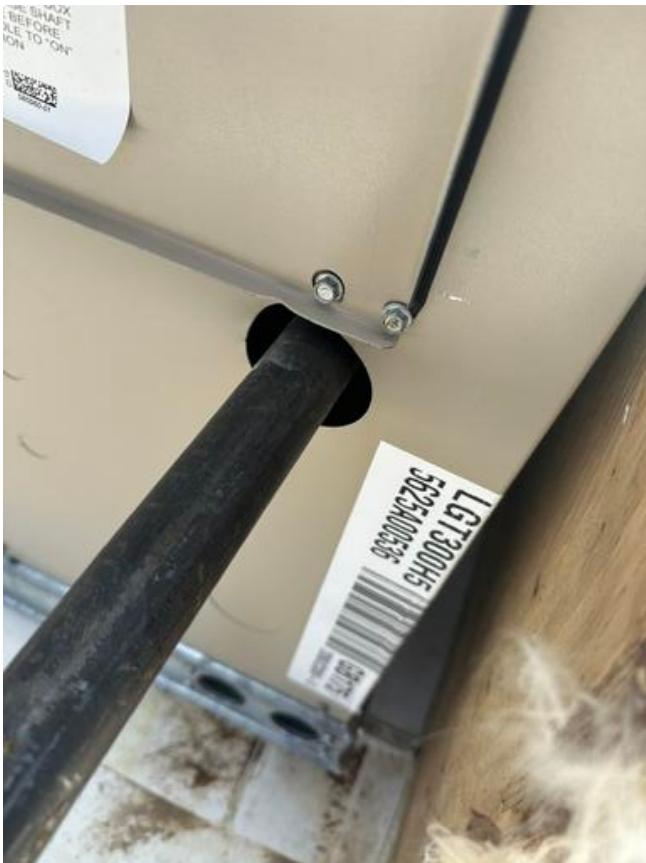
IMG\_0608

### #32 [UNIT 510] [NEW] Gas inlet grommet.

AC1 gas inlet grommet is missing at the gas line/RTU penetration point.
