**Report: TAB**

**Function: Test, Adjust, & Balance**

**Date: 07/16/2025**

## 07-14-25 FREDDY'S DENTON, TX

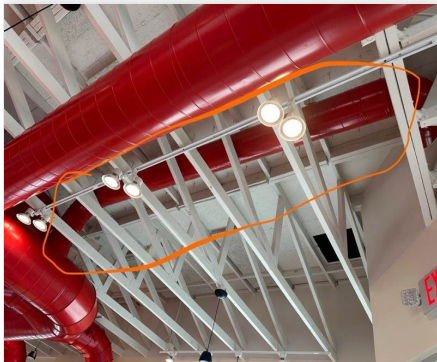
**Issue Name :** DIFFUSER 1-7  
**Description :** Airflow unable to reach this diffuser, possibly due to the transition coming off from the top of the duct or damper is closed inside. Both static pressure when the damper was opened and closed were -0.0011" before and after the damper. There appears to be a bit of leakage as well.  
**Created By :** National TAB                      **Assigned To :** National TAB - Will Turnbough  
**Status :** Open  
**Priority :** Urgent                                      **Asset Tag :**  
**Originated Date :** 07/16/2025 - Cavin Van - National TAB

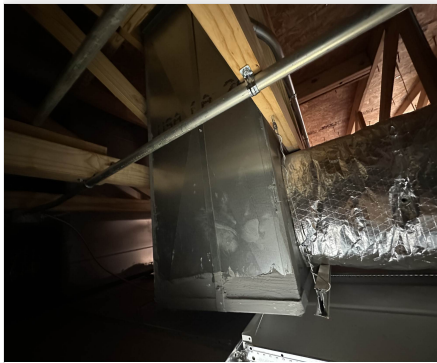
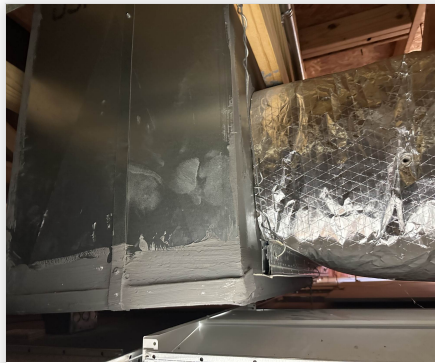
**Issue Name :** DOAS UNIT  
**Description :** The DOAS unit has low airflow due to the transition from the drop to the duct flex having no turning vane, causing air to be turbulent and total airflow to be restricted at 88% total design airflow. The unit also has leakage around the drop in the ceiling.  
**Created By :** National TAB                      **Assigned To :** National TAB - Will Turnbough  
**Status :** Open  
**Priority :** Urgent                                      **Asset Tag :**  
**Originated Date :** 07/15/2025 - Cavin Van - National TAB

- **07/15/2025 National TAB - Cavin Van**
  - Discharge (@drop before flex duct transition): 0.1389" Discharge (after drop in flex duct): 0.0467" Discharge (@unit): 0.373" Fan Suction: -0.6495" Mixed Air:-0.0946" Voltage: 204/205/204 Amps: 5.27/5.0/5.0 Fan RPM: 1739

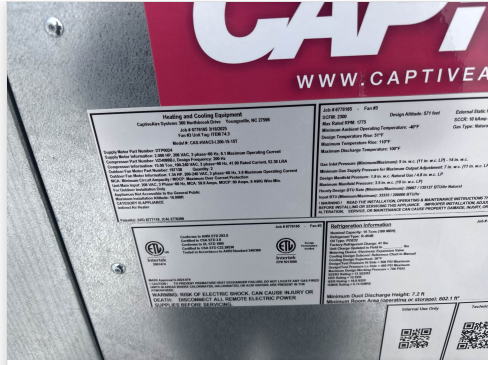
Asset: DOAS1

Notes:  
The diffuser total equates to more than schedule design. Unit was balanced to diffuser design.
