Report: TAB PRACTICE

Function: Test, Adjust, & Balance

07-14-25 FREDDY'S DENTON, TX

KT Ventures

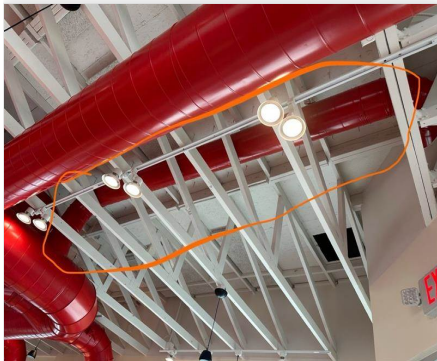
Issue Name : DIFFUSER 1-7
Description : Airflow unable to reach this diffuser, possibly due to the transition coming off from the top of the duct or damper is closed inside. Both static pressure when the damper was opened and closed were -0.0011" before and after the damper. There appears to be a bit of leakage as well.
Created By : National TAB **Assigned To :** National TAB - Will Turnbough
Status : Open
Priority : Urgent **Asset Tag :**
Originated Date : 07/16/2025 - Cavin Van - National TAB

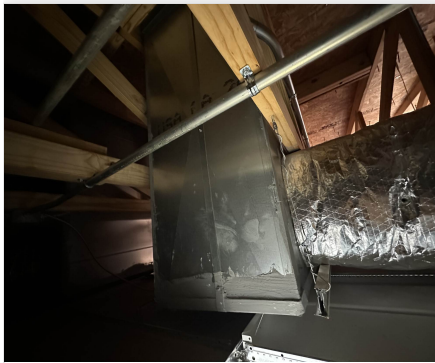
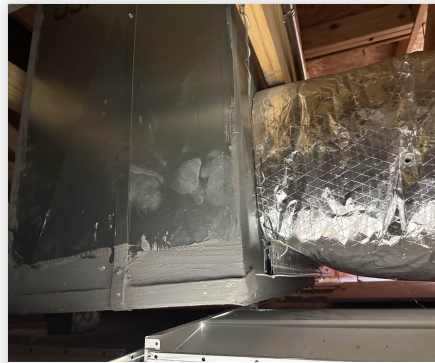
Issue Name : DOAS UNIT
Description : The DOAS unit has low airflow due to the transition from the drop to the duct having no turning vane, causing air to be turbulent and total airflow to be restricted at 88% total airflow design. The unit also has leakage around the drop in the ceiling.
Created By : National TAB **Assigned To :** National TAB - Will Turnbough
Status : Open
Priority : Urgent **Asset Tag :**
Originated Date : 07/15/2025 - Cavin Van - National TAB

- **07/15/2025 National TAB - Cavin Van**
 - Discharge (@drop before flex duct transition): 0.1389" Discharge (after drop in flex duct): 0.0467" Discharge (@unit): 0.373" Fan Suction: -0.6495" Mixed Air:-0.0946" Voltage: 204/205/204 Amps: 5.27/5.0/5.0 Fan RPM: 1739

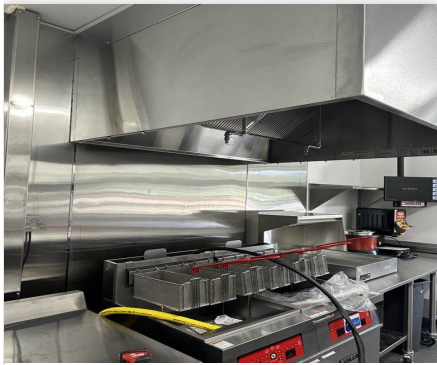
Issue Name : No End/Side Panels
Description : Currently there are no end/panels or side panels installed, so smoke captures fails.
Created By : National TAB **Assigned To :** National TAB - Cavin Van
Status : Open
Priority : Medium **Asset Tag :**
Originated Date : 07/16/2025 - Cavin Van - National TAB

According to GC end panels would not fit on either hood, so end panels are not installed.

Smoke test for the fryer fails due to lack of side/end panel.

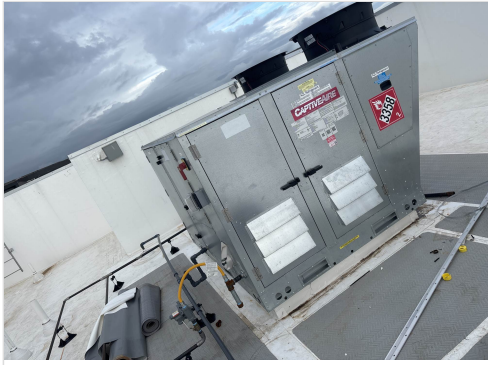
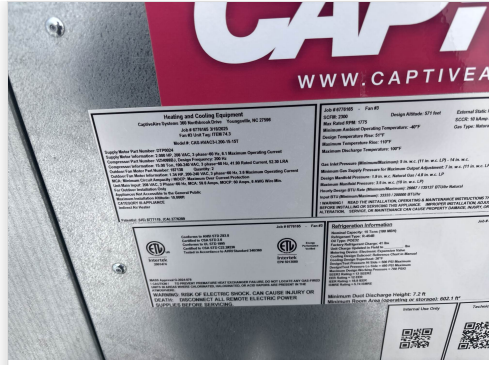
Asset: DOAS1

The diffuser total equates to more than schedule design. Unit was balanced proportionally to balance schedule.

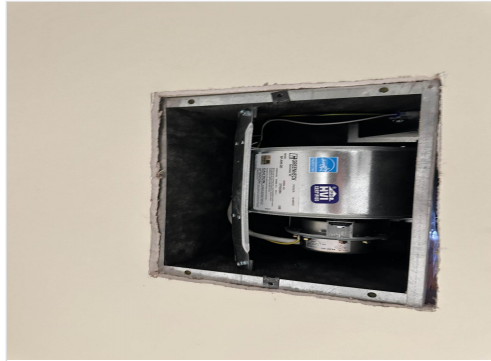
Asset: EF1

Notes:
Static pressure was not accessible due to cemented ceiling.

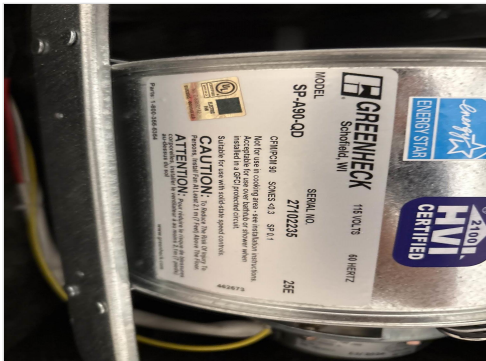
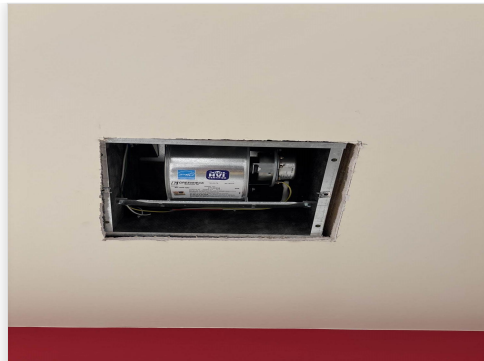
Asset: EF2

Notes:
Static pressure was not accessible due to cemented ceiling.

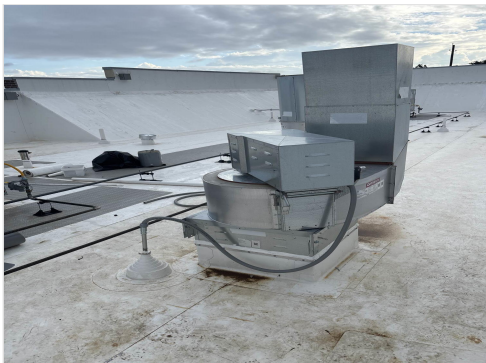
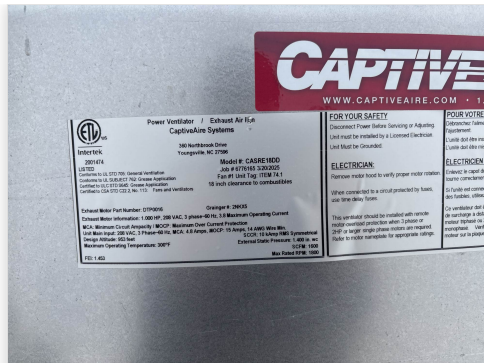
Asset: KEF1

[1] UNABLE TO LIFT FAN TO OBTAIN FAN INLET SP.
