**Report: TAB**

**Function: Test, Adjust, & Balance**

**Date: 07/16/2025**

## **07-14-25 FREDDY'S DENTON, TX**

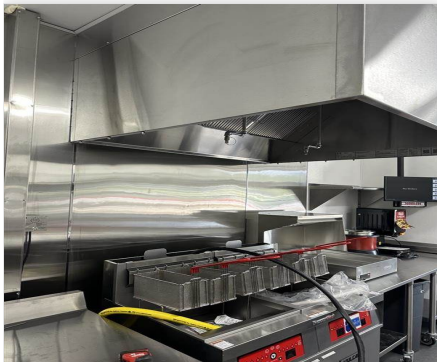
**Issue Name :** No End/Side Panels  
**Description :** Currently there are no end/panels or side panels installed, so smoke captures fails.  
**Created By :** National TAB                      **Assigned To :** National TAB - Cavin Van  
**Status :** Open  
**Priority :** Medium                                      **Asset Tag :**  
**Originated Date :** 07/16/2025 - Cavin Van - National TAB

According to GC end panels would not fit on either hood, so end panels are not installed.

Smoke test for the fryer fails due to lack of side/end panel.
