**Report: TAB Report**  
**Function: Test, Adjust, & Balance**  
**Date: 07/18/2025**  
**Completed By: National TAB**

**PROJECT**  
**07-07-25 WAWA #5453 OCALA, FL**

Project: 07-07-25 WAWA #5453 OCALA, FL

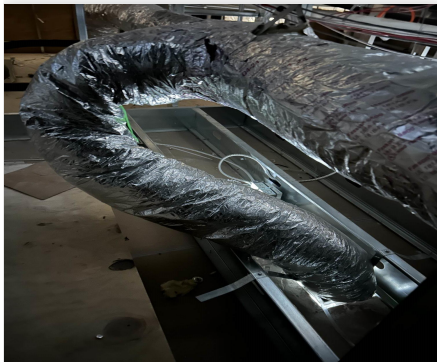
**Issue Name :** Diffusers 1-14, 1-15 - Low Flow  
**Description :** Supply diffusers 1-14 and 1-15 (rear vestibule, men’s restroom) are at 75% and 85% of design, respectively. Dampers are fully open. Flex was adjusted and shortened by MC to improve airflow slightly. Further balancing would hurt overall system performance. Recommend monitoring these spaces for comfort issues.  
**Created By :** National TAB                      **Assigned To :** National TAB - Dan Hertenstein  
**Status :** Open  
**Priority :** High                                      **Asset Tag :**  
**Originated Date :** 07/13/2025 - Mark Johnson - National TAB

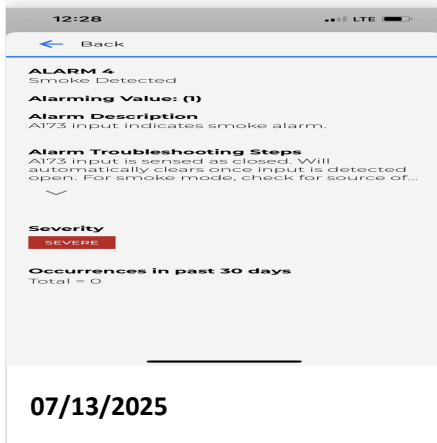
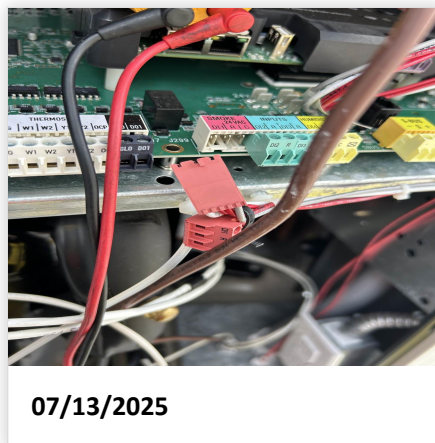
**Issue Name :** RTU 3 - Smoke Alarm  
**Description :** RTU 3 was found to have its smoke detector plug disconnected. Connecting the plug immediately triggers a smoke alarm, locking out the unit. Recommend inspection.  
**Created By :** National TAB                      **Assigned To :** National TAB - Dan Hertenstein  
**Status :** Open  
**Priority :** Urgent                                      **Asset Tag :**  
**Originated Date :** 07/13/2025 - Mark Johnson - National TAB

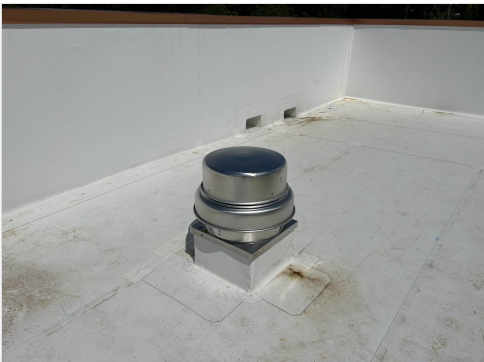
**Issue Name :** EF-1 - High Flow  
**Description :** EF-1 is currently running at 913 CFM (114% design). Slowing the fan further causes the motor to overamp, except at extremely low speeds. All exhaust grilles are balanced proportionally to the high total. Recommend motor inspection and monitoring for comfort issues around the space.  
**Created By :** National TAB                      **Assigned To :** National TAB - Dan Hertenstein  
**Status :** Open  
**Priority :** Medium                                      **Asset Tag :**  
**Originated Date :** 07/13/2025 - Mark Johnson - National TAB

EF-1 total flow = +14% design. All grilles are balanced proportionally to the high total.

Notes:  
Fan cannot be slowed further without overramping motor.
