**Report: TAB Report
Function: Test, Adjust, & Balance
Date: 02/12/2026
Completed By: National TAB**

**PROJECT
02-09-26 QT #1061 ROCK HILL, SC**

**QUIKTRIP
4705 SOUTH 129TH EAST AVENUE
TULSA, OK 74134**

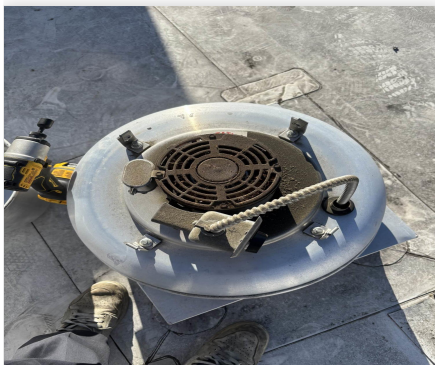
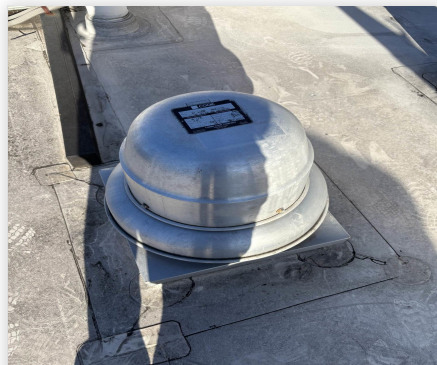
Issue Name : EF-1 not working
Description : EF-1 is not running. Upon arrival the speed controller was in the high setpoint, this may have burnt the motor out causing it to shut off. Needs immediate repair to balance.
Created By : National TAB **Assigned To :** National TAB - Dan Hertenstein
Status : Open
Priority : Urgent **Asset Tag :** EF1
Originated Date : 02/12/2026 - Christian Moller - National TAB

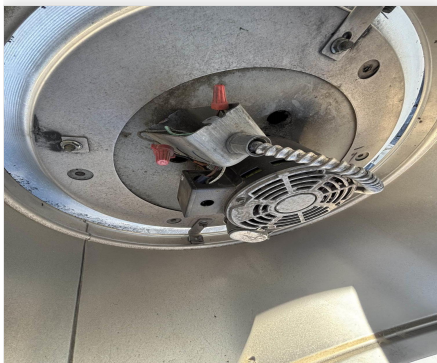
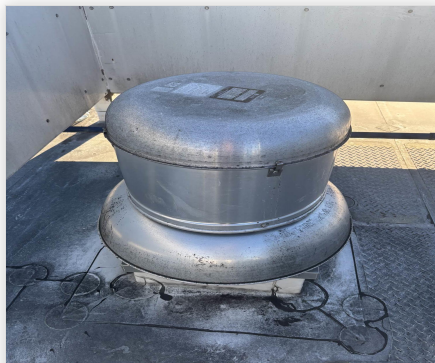
Issue Name : EF-2 no speed controller
Description : EF-2 is missing its speed controller. The combi oven portion of the unit is balanced, however, if the men's RR needs more exhaust the speed controller must be fixed.
Created By : National TAB **Assigned To :** National TAB - Dan Hertenstein
Status : Open
Priority : Medium **Asset Tag :** EF2
Originated Date : 02/12/2026 - Christian Moller - National TAB

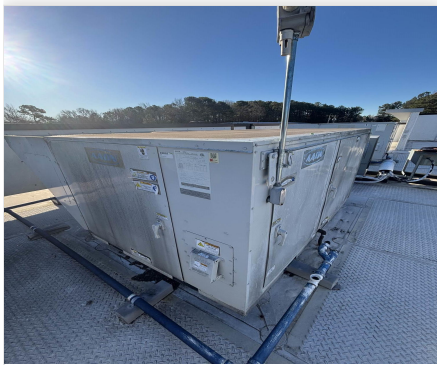
Issue Name : RTU 3 left in hand
Description : RTU 3 does not go into its highest speed when the hood is turned on, as per design. So the unit was left in hand at max speed.
Created By : National TAB **Assigned To :** National TAB - Dan Hertenstein
Status : Open
Priority : High **Asset Tag :** RT-3
Originated Date : 02/12/2026 - Christian Moller - National TAB

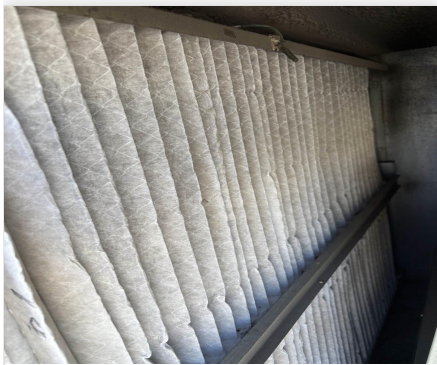
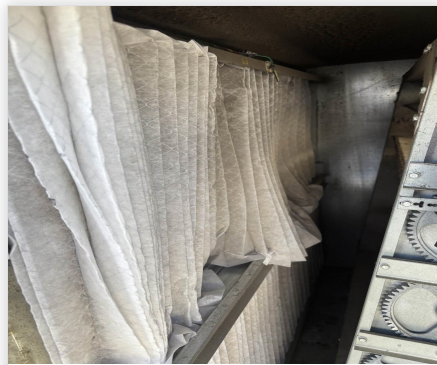
Issue Name : Unit final filters dirty
Description : All RTU final filters were dirty due to the dust and dirt from renovations. They were not dirty enough to effect balancing but will need to be replaced in the near future.
Created By : National TAB **Assigned To :** National TAB - Dan Hertenstein
Status : Open
Priority : Medium **Asset Tag :**
Originated Date : 02/12/2026 - Christian Moller - National TAB

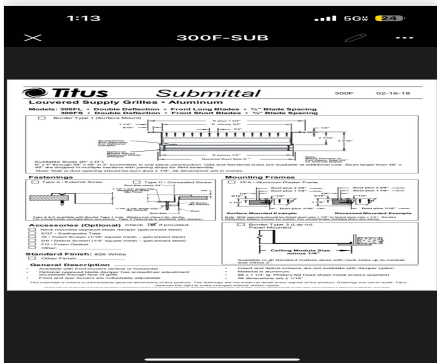
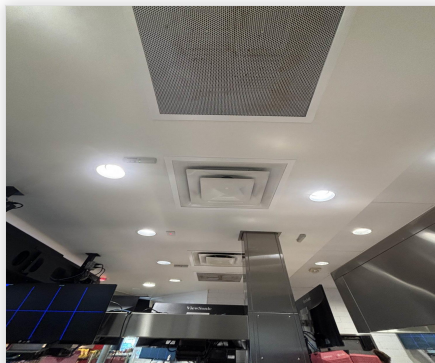
Issue Name : Wrong cook line diffusers
Description : The cook line diffusers are not the louvered supply grilles with adjustable deflection blades as per design. The ones installed now work fine as temporary grilles.
Created By : National TAB **Assigned To :** National TAB - Dan Hertenstein
Status : Open
Priority : High **Asset Tag :** RT-3
Originated Date : 02/12/2026 - Christian Moller - National TAB
