PlanGrid Task Report - Jan 23, 2025

L05138 Charlotte Hall FSU (MD)

29920 Three Notch Road, Charlotte Hall, Maryland

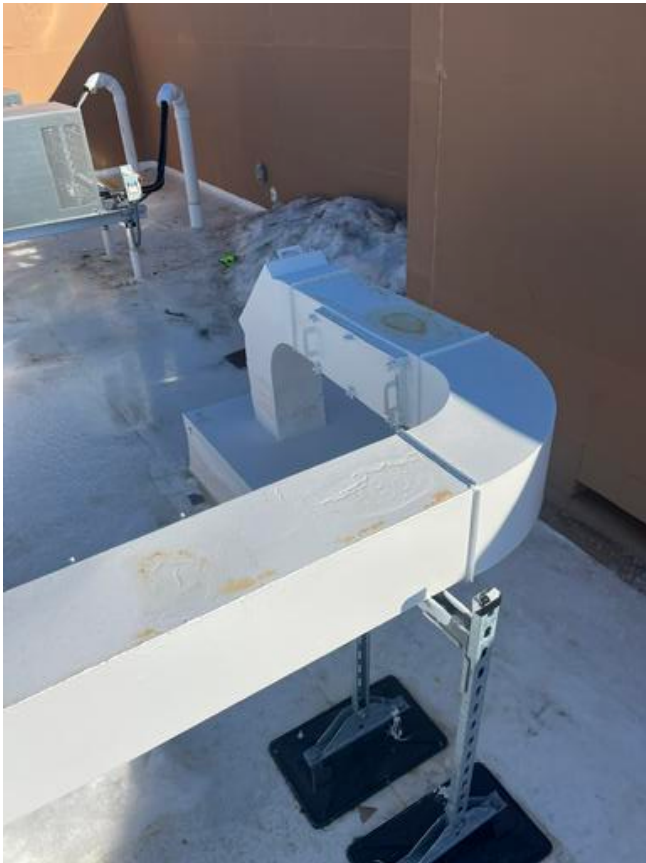
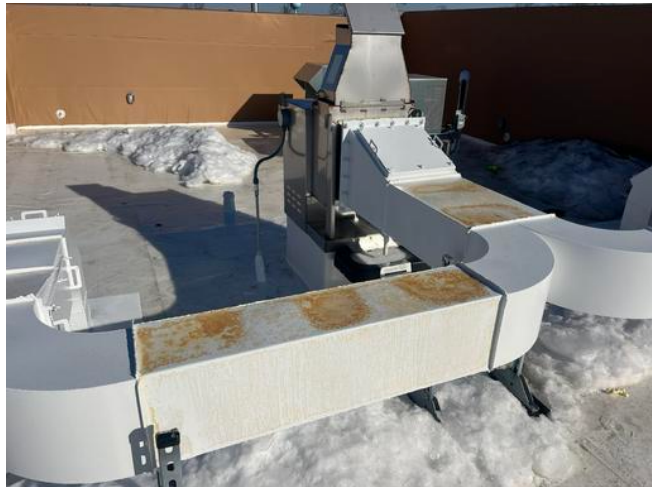
#108 [EXHA 509] [NEW] Grease exhaust duct Paint

Grease duct is painted per specification. However, rust is showing through in several spots. Recommend this is addressed.

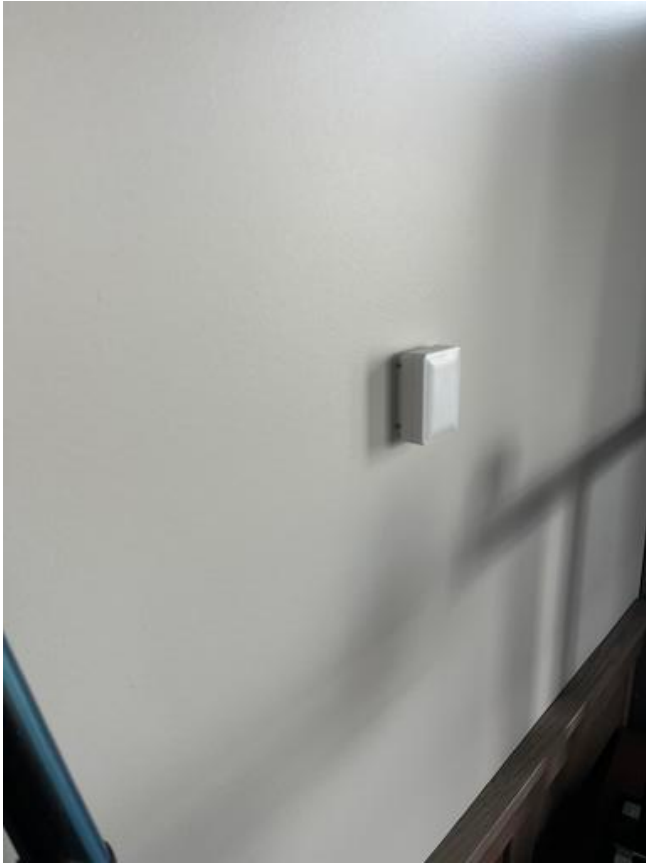
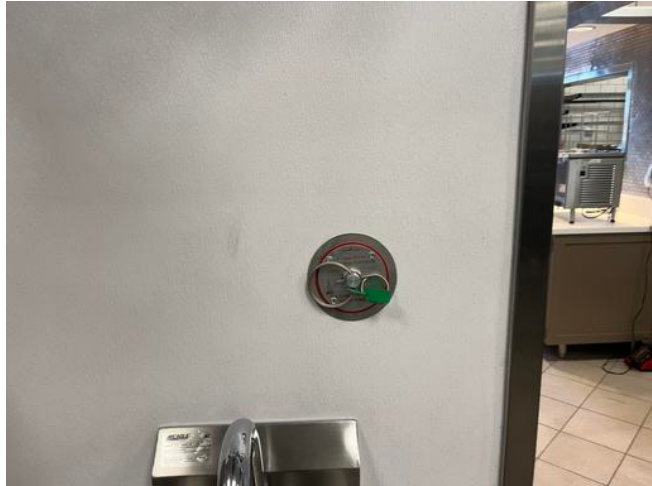
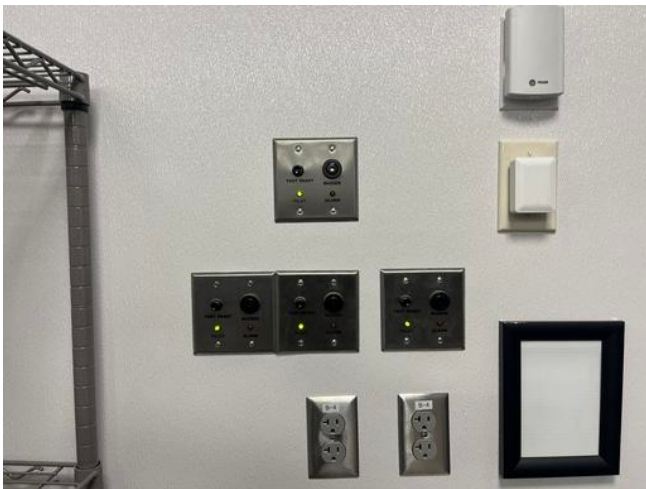
#107 [CNTL 508] [NEW] Controls labeling.

Label all sensors, humidistats, thermostats, smoke annunciators and remote space mounted OADs, MODs, VFD's for which piece of equipment they serve.

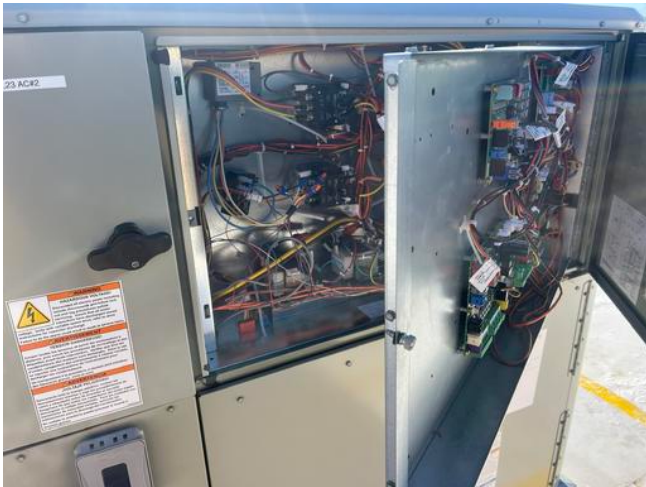
#106 [UNIT 504][NEW] Equipment Fresh Air Tempering

Units with Fresh Air Tempering kits are to have the discharge sensor routed per specification into the discharge duct via wiring portal. If Trane set turn-on/turn-off temps to 60/65 in Kitchen, 62/67 in Drive-Thru/Serving, 63/68 in Dining/Play Area.

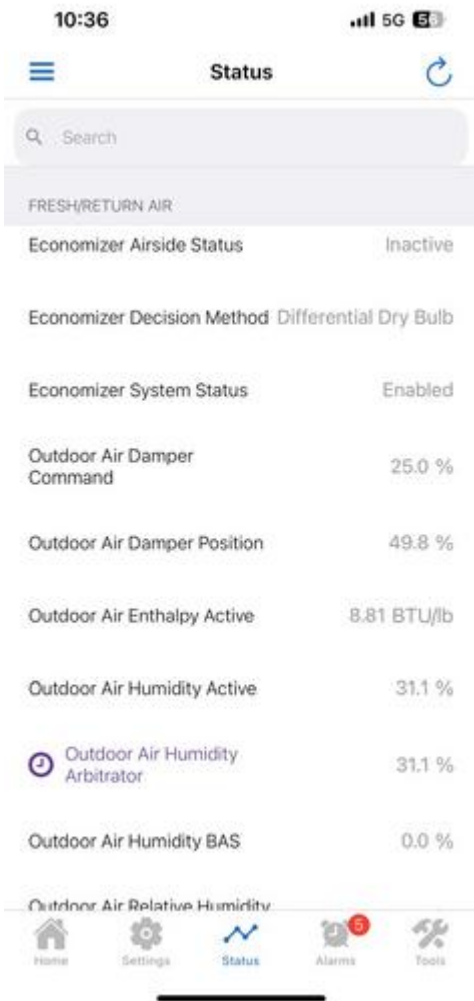
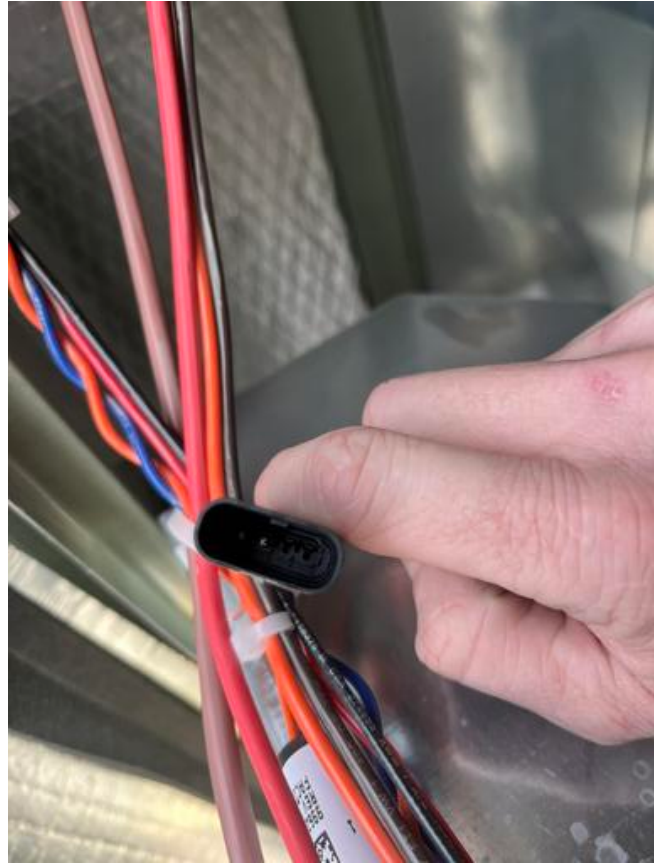
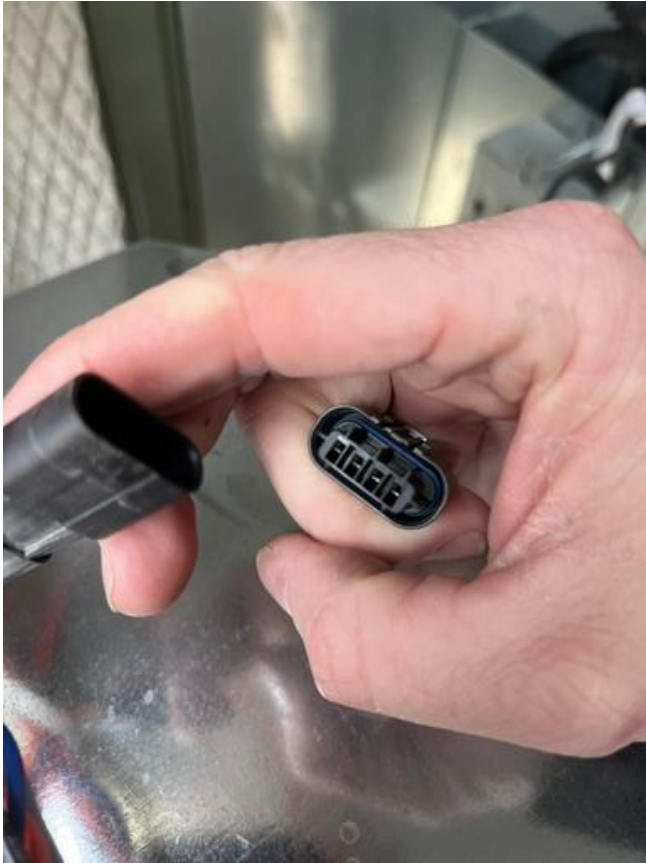
#105 [UNIT 999][NEW](MISC) AC-1 OA Damper Feedback

AC-1 OA damper was not functional on arrival. The connector was damaged from the factory, MC corrected. Damper is now operating properly and goes to correct setpoint, however, damper feedback indicates damper is at 49%, when it is only at 25%. While damper is operating properly, recommend this issue is addressed while unit is under warranty.
