Warabeya North America (Columbus, OH)

Project Issue Information

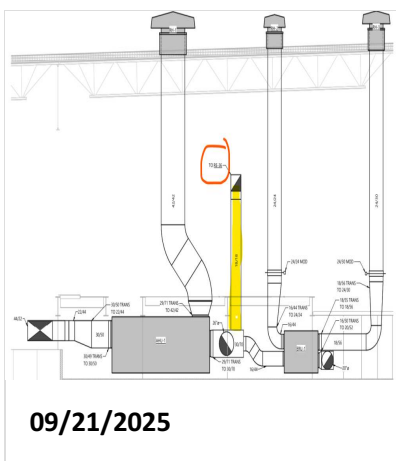
Issue Name : AHU1-Return-RE36 duct Issue
Description : No motorized Damper installed in Duct going to RE36 Relief fan. When Fan is off per SOO AHU is pulling air in not only from returns from space but also pulling air in from outside through re36 relief duct causing inadequate return airflow & too much OA for AHU Unit.
Created By : National TAB **Assigned To :** National TAB - Joe Hertenstein
Status : Open
Priority : High **Asset Tag :**
Originated Date : 09/21/2025 - Joe Hertenstein - National TAB
