Report: TAB Survey
Function: Test, Adjust, & Balance
Date: 11/19/2025
Completed By: National TAB

09-01-25 BOJANGLES #1264 MARIETTA, GA

Budderfly

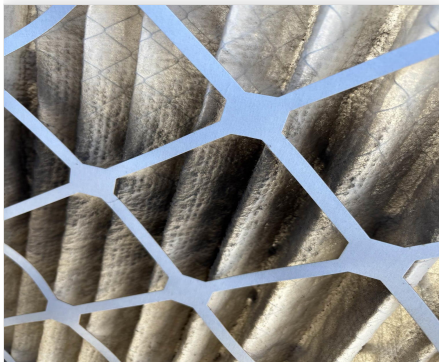
Issue Name : All RTUs: Dirty Filters
Description : All filters in each RTU is dirty and recommended to be replaced.
Created By : National TAB **Assigned To :** National TAB - Dan Hertenstein
Status : Open
Priority : Medium **Asset Tag :**
Originated Date : 11/18/2025 - Sagar Patel - National TAB

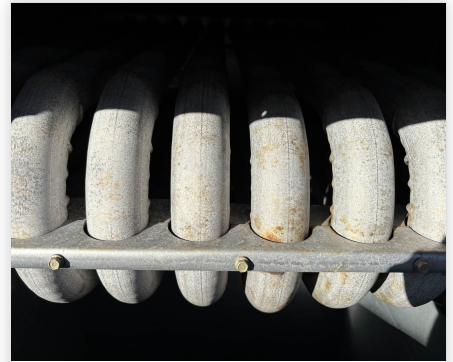
Issue Name : All RTUs: Dirty Heat Exchangers
Description : The heat exchangers in each RTU is showing rust. Cleaning is recommended.
Created By : National TAB **Assigned To :** National TAB - Dan Hertenstein
Status : Open
Priority : Medium **Asset Tag :**
Originated Date : 11/18/2025 - Sagar Patel - National TAB

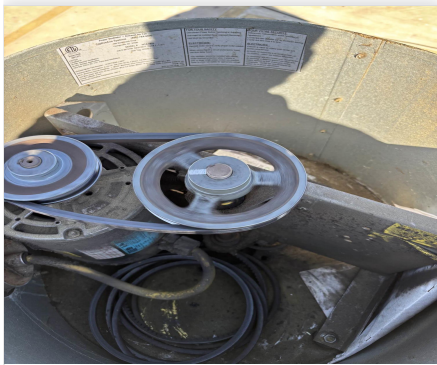
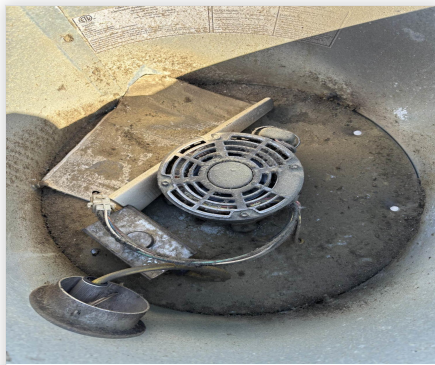
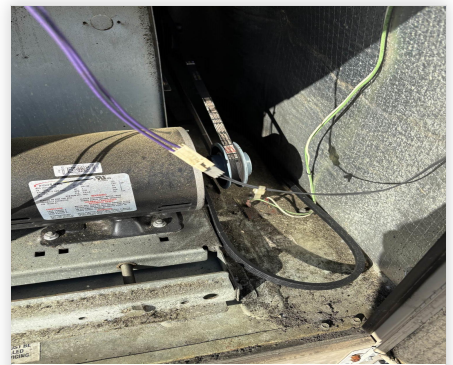
Issue Name : All Units on Roof: Dirty Motor Compartment
Description : All RTUs, MAU, and Exhaust Fans on the roof have dirty motor compartment.
Created By : National TAB **Assigned To :** National TAB - Dan Hertenstein
Status : Open
Priority : High **Asset Tag :**
Originated Date : 11/18/2025 - Sagar Patel - National TAB

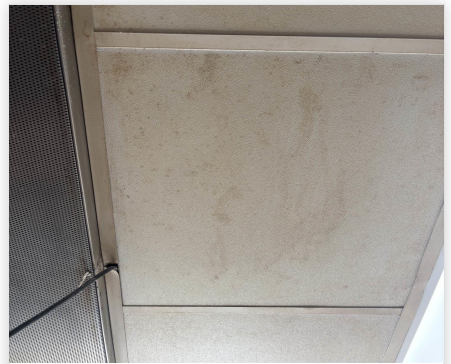
Issue Name : Dirty Diffusers and Stained Ceiling Tiles
Description : Diffusers in the kitchen and ceiling tiles around the hood are stained.
Created By : National TAB **Assigned To :** National TAB - Dan Hertenstein
Status : Open
Priority : **Medium** **Asset Tag :**
Originated Date : 11/18/2025 - Sagar Patel - National TAB

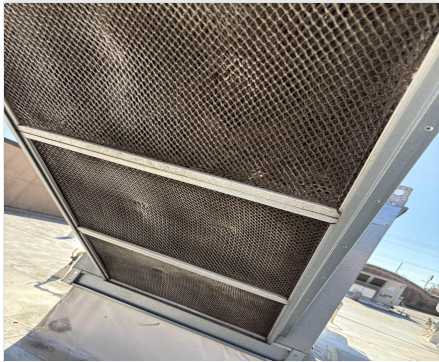
Issue Name : MAU: OA Filters Damaged
Description : The outside air filters on the make-up air unit are showing signs of damage.
Created By : National TAB **Assigned To :** National TAB - Dan Hertenstein
Status : Open
Priority : Medium **Asset Tag :**
Originated Date : 11/18/2025 - Sagar Patel - National TAB

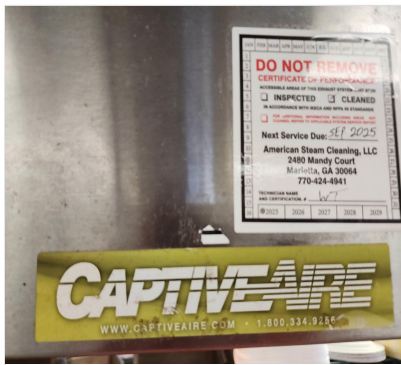
Hood nameplate

Label Faded
