**Report: Test Report**  
**Function: Test, Adjust, & Balance**  
**Date: 11/19/2025**  
**Completed By: National TAB**

**09-01-25 BOJANGLES #1264 MARIETTA, GA**

Budderfly

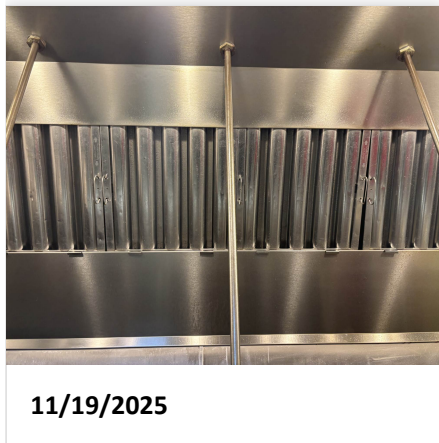
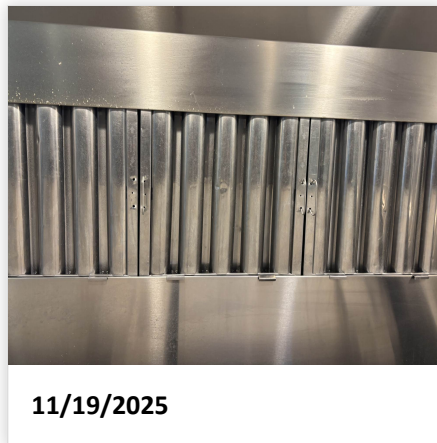
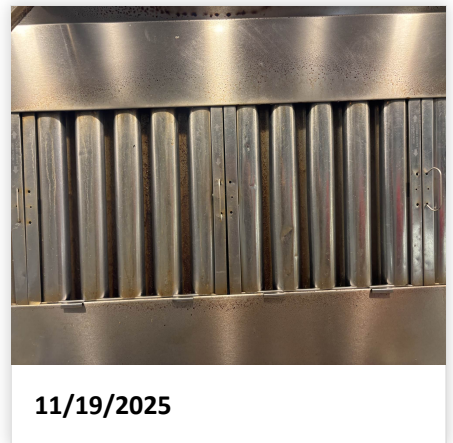
**Issue Name :** All Hoods: Dirty Filters and Minor Damage  
**Description :** The hood filters are dirty and showing minor damage.  
**Created By :** National TAB                      **Assigned To :** National TAB - Dan Hertenstein  
**Status :** Open  
**Priority :** High                                      **Asset Tag :**  
**Originated Date :** 11/18/2025 - Sagar Patel - National TAB

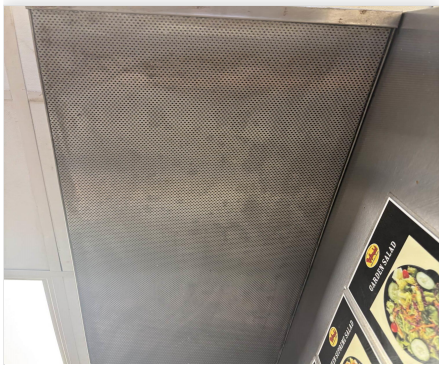
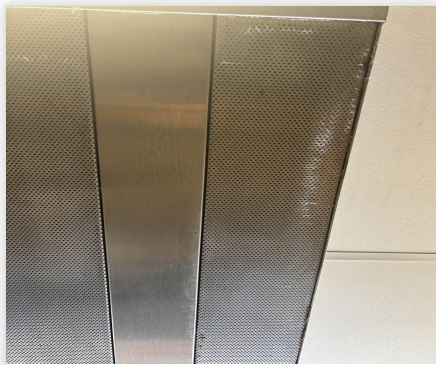
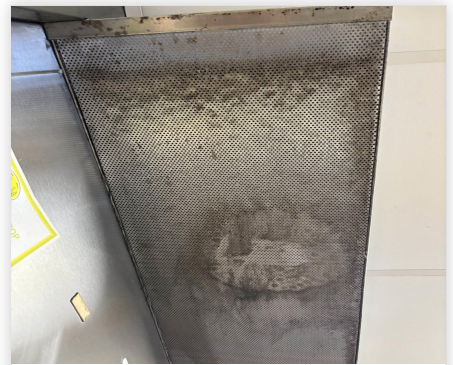
**Issue Name :** All Hoods: MAU Supply Plenum and ACPSP are dirty  
**Description :** The make-up air for all hoods is dirty and the ACPSP for Hood 3 is dirty. Cleaning is recommended  
**Created By :** National TAB                      **Assigned To :** National TAB - Dan Hertenstein  
**Status :** Open  
**Priority :** High                                      **Asset Tag :**  
**Originated Date :** 11/18/2025 - Sagar Patel - National TAB

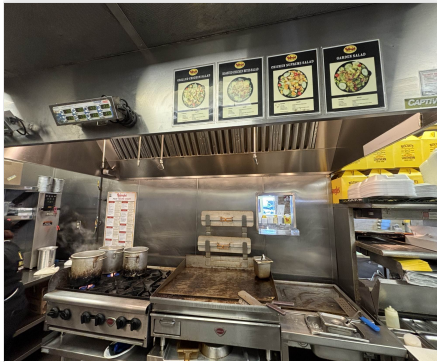
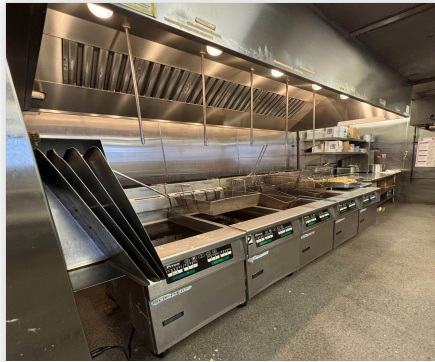
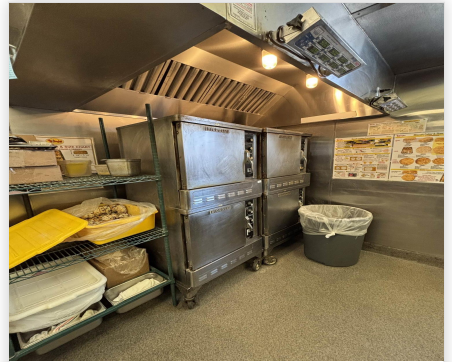
**Issue Name :** All Hoods: Missing End Panels  
**Description :** Hood 1 is missing both end panels. Hood 2 is missing the right end panel. Hood 3 is missing the left end panel  
**Created By :** National TAB                      **Assigned To :** National TAB - Dan Hertenstein  
**Status :** Open  
**Priority :** Medium                                      **Asset Tag :**  
**Originated Date :** 11/18/2025 - Sagar Patel - National TAB

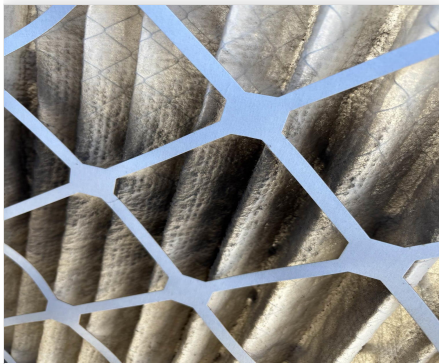
**Issue Name :** All RTUs: Dirty Filters  
**Description :** All filters in each RTU is dirty and recommended to be replaced.  
**Created By :** National TAB                      **Assigned To :** National TAB - Dan Hertenstein  
**Status :** Open  
**Priority :** Medium                                      **Asset Tag :**  
**Originated Date :** 11/18/2025 - Sagar Patel - National TAB

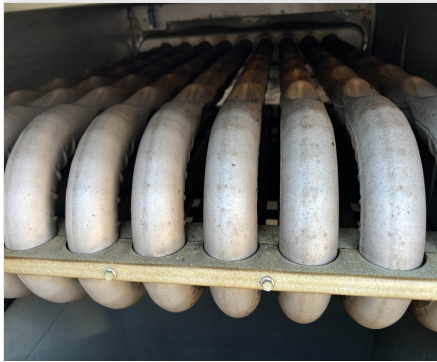
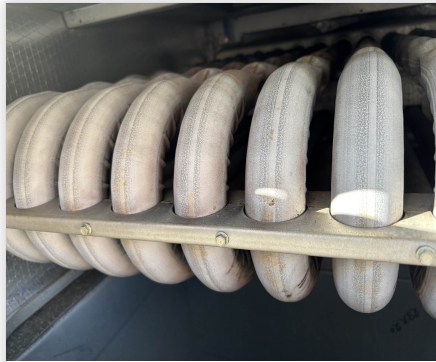
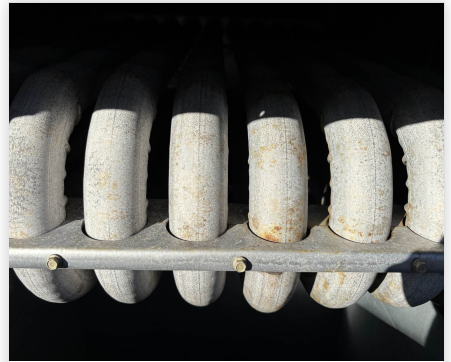
**Issue Name :** All RTUs: Dirty Heat Exchangers  
**Description :** The heat exchangers in each RTU is showing rust. Cleaning is recommended.  
**Created By :** National TAB                      **Assigned To :** National TAB - Dan Hertenstein  
**Status :** Open  
**Priority :** Medium                                      **Asset Tag :**  
**Originated Date :** 11/18/2025 - Sagar Patel - National TAB

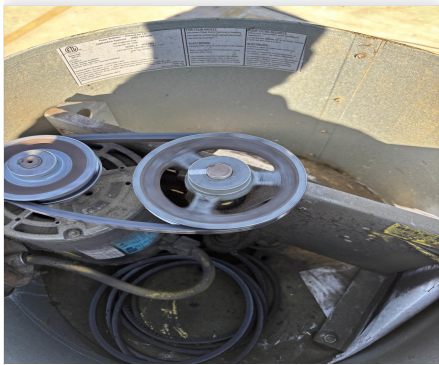
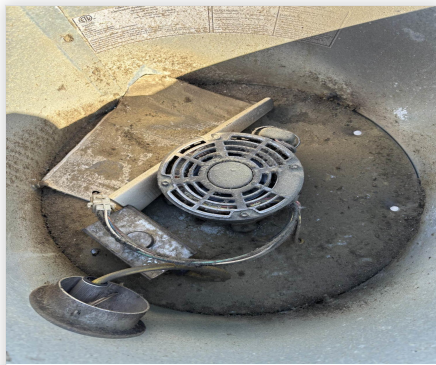
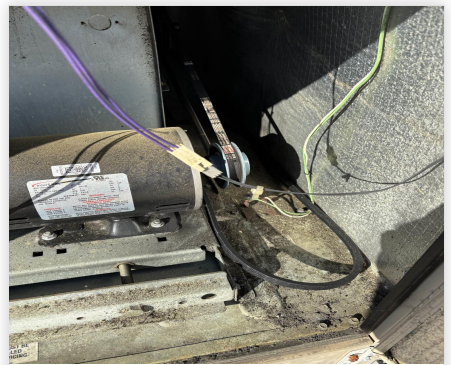
**Issue Name :** All Units on Roof: Dirty Motor Compartment  
**Description :** All RTUs, MAU, and Exhaust Fans on the roof have dirty motor compartment.  
**Created By :** National TAB                      **Assigned To :** National TAB - Dan Hertenstein  
**Status :** Open  
**Priority :** High                                      **Asset Tag :**  
**Originated Date :** 11/18/2025 - Sagar Patel - National TAB

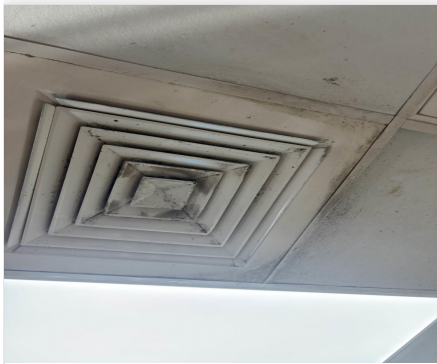
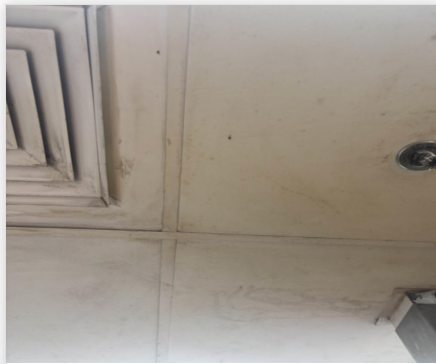
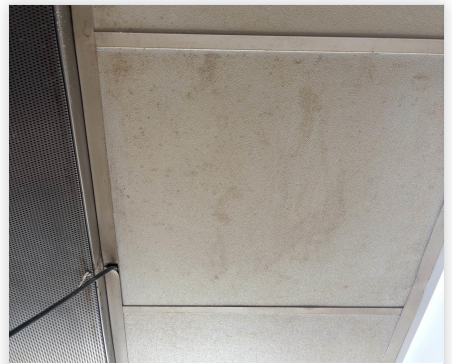
**Issue Name :** Dirty Diffusers and Stained Ceiling Tiles  
**Description :** Diffusers in the kitchen and ceiling tiles around the hood are stained.  
**Created By :** National TAB                      **Assigned To :** National TAB - Dan Hertenstein  
**Status :** Open  
**Priority :** Medium                                      **Asset Tag :**  
**Originated Date :** 11/18/2025 - Sagar Patel - National TAB

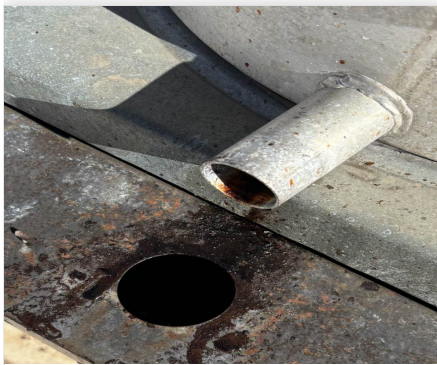
**Issue Name :** EF 1 & 2: Tube to Connect to Grease Catch  
**Description :** A tube should be connected from the exhaust fan leading into the grease catch for no grease to escape  
**Created By :** National TAB                      **Assigned To :** National TAB - Dan Hertenstein  
**Status :** Open  
**Priority :** Medium                                      **Asset Tag :**  
**Originated Date :** 11/18/2025 - Sagar Patel - National TAB

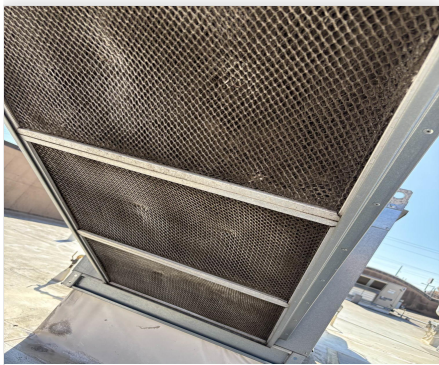
**Issue Name :** MAU: OA Filters Damaged  
**Description :** The outside air filters on the make-up air unit are showing signs of damage.  
**Created By :** National TAB                      **Assigned To :** National TAB - Dan Hertenstein  
**Status :** Open  
**Priority :** Medium                                      **Asset Tag :**  
**Originated Date :** 11/18/2025 - Sagar Patel - National TAB

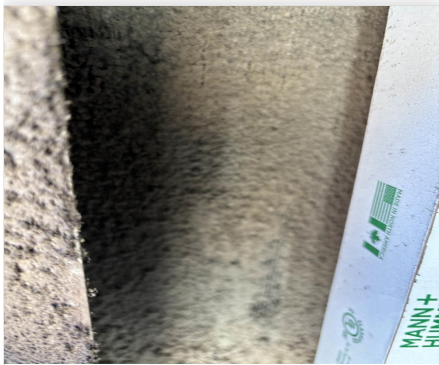
**Issue Name :** RTU 1: Dirty Evaporator Coils  
**Description :** The evaporator coils facing the air filters is dirty. Cleaning is recommended  
**Created By :** National TAB                      **Assigned To :** National TAB - Dan Hertenstein  
**Status :** Open  
**Priority :** High                                      **Asset Tag :**  
**Originated Date :** 11/18/2025 - Sagar Patel - National TAB

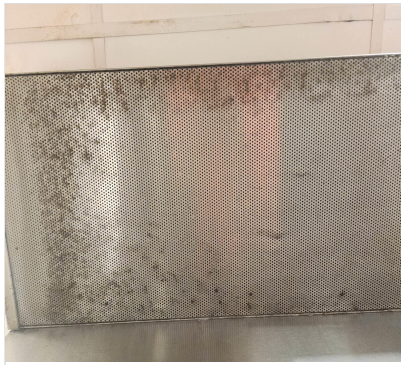
Is the MUA discharge plenum clean and not clogged? If there is a PSP shine a light into the perforated metal and see if the top layer appears to be clogged Fail
