Report: TAB Survey
Function: Test, Adjust, & Balance
Date: 11/19/2025
Completed By: National TAB

09-01-25 BOJANGLES #1264 MARIETTA, GA

Budderfly

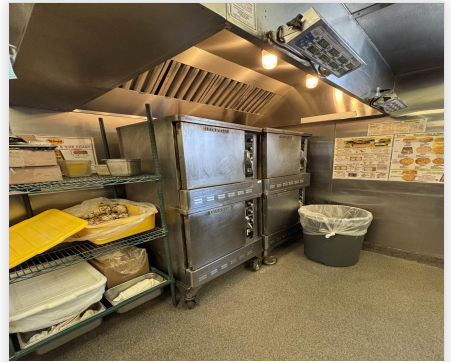
Issue Name : All Hoods: Missing End Panels
Description : Hood 1 is missing both end panels. Hood 2 is missing the right end panel. Hood 3 is missing the left end panel
Created By : National TAB **Assigned To :** National TAB - Dan Hertenstein
Status : Open
Priority : Medium **Asset Tag :**
Originated Date : 11/18/2025 - Sagar Patel - National TAB

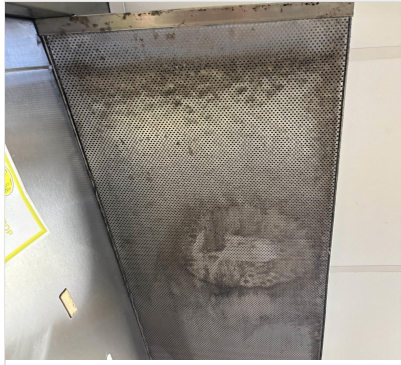
MUA plenum

Is the MUA discharge plenum clean and not clogged? If there is a PSP shine a light into the perforated metal and see if the top layer appears to be clogged Fail

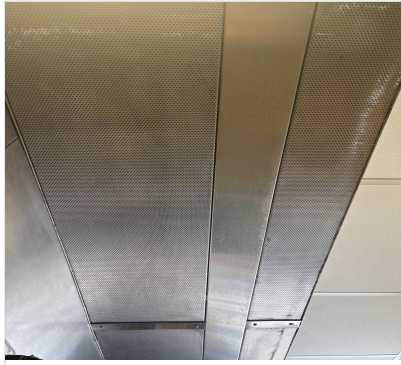
MUA plenum

Is the MUA discharge plenum clean and not clogged? If there is a PSP shine a light into the perforated metal and see if the top layer appears to be clogged Fail
