**National TAB
1329 E. KEMPER ROAD
SUITE 4210
CINCINNATI, OH 45246**

**Report: TAB REPORT
Function: Test, Adjust, & Balance
Date: 11/11/2022**

**PROJECT
11-07 CULVERS - SPARTA, WI**

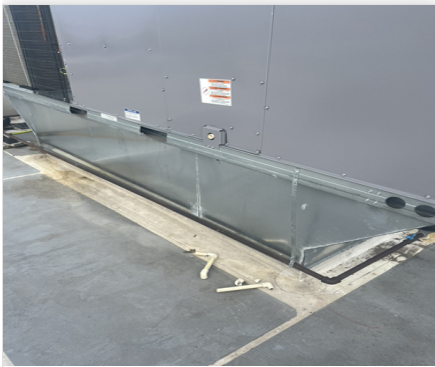
Issue Name : RESOLVED: RTU-2 Condensate drain not installed
Description : Condensate drain was found damage and broken on roof. Recommend replacement.
Created By : National TAB **Assigned To :** National TAB - Michael McDonnell
Status : Closed
Originated Date : 11/10/2022 - Michael McDonnell - National TAB
