Report: TAB REPORT
Function: Test, Adjust, & Balance
Date: 11/11/2022

PROJECT
11-07 CULVERS - SPARTA, WI

Project: 11-07 CULVERS - SPARTA, WI

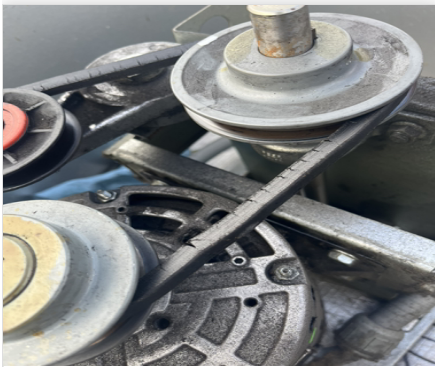
Issue Name : 3. PRV-3 (fryer) needs belt replacement.

Description : Belt is cracked and worn, recommend replacement. Belt size installed is AP23.
