**Report: TAB REPORT  
Function: Test, Adjust, & Balance  
Date: 11/11/2022**

**PROJECT  
11-07 CULVERS - SPARTA, WI**

Project: 11-07 CULVERS - SPARTA, WI

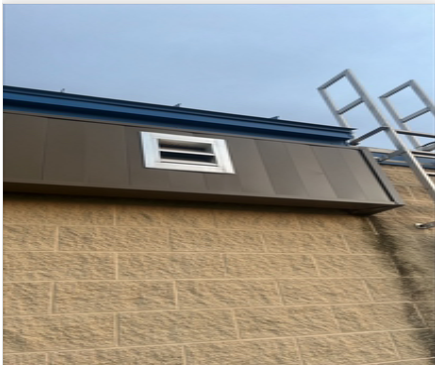
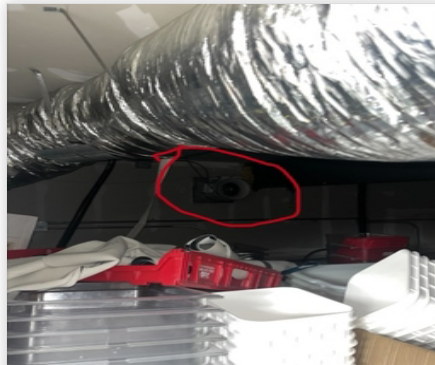
**Issue Name :** 1. Exhaust fan above walk-in.

**Description :** Exhaust fan is installed and operating, exhausting from above walk-in cooler to rear of building. Unsure of purpose. If not necessary, recommend disabling to reduce negative airflow.

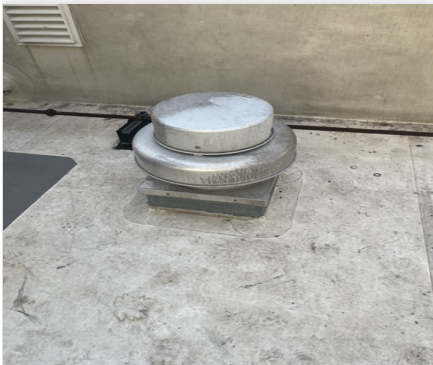
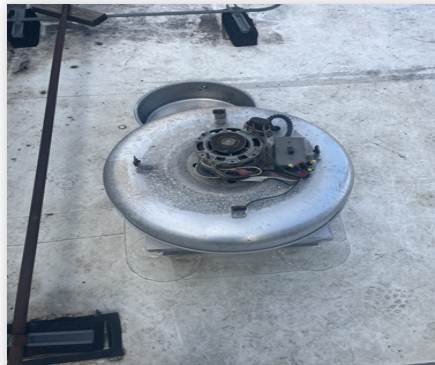
**Issue Name :** 2. PRV-1 (RR) not operational.

**Description :** PRV-1 was not operating on arrival. Fan has power on the roof but was not rotating and motor was hot to the touch. Motor likely needs replacement. Turned off at the roof disconnect.

Notes:[1] FAN IS NOT OPERATIONAL. FAN HAD POWER BUT MOTOR WAS VERY HOT AND NOT ROTATING. MOTOR NEEDS REPLACEMENT. LEFT OFF AT ROOF DISCONNECT.

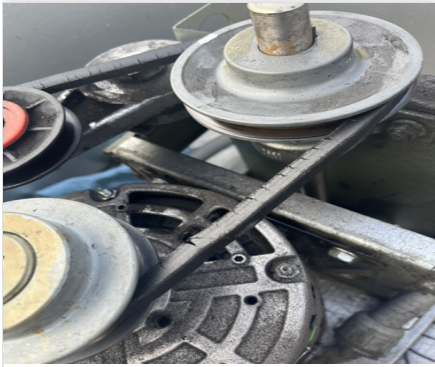
**Issue Name :** 3. PRV-3 (fryer) needs belt replacement.

**Description :** Belt is cracked and worn, recommend replacement. Belt size installed is AP23.

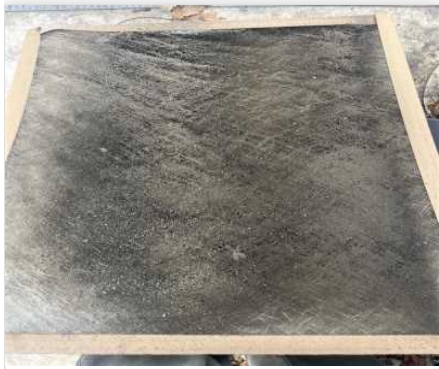
**Issue Name :** 4. RTU-2 (kitchen) final filters dirty.

**Description :** Throwaway filters are dirty, recommend replacement with pleated filters.

General		
	Design	Actual
Fan Rotation Correct	-	YES
Unit Filters Clean	-	VERY DIRTY, NEED REPLACEMENT
Condensate Drain Installed	-	YES

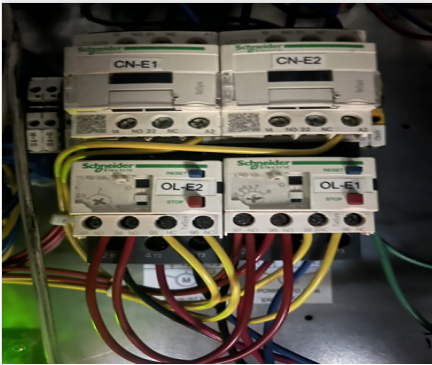
**Issue Name :** RESOLVED: PRV-2 and PRV-3 wired to incorrect contactors.

**Description :** PRV-2 is wired to the incorrect contactor with lower amperage rating and causing the fan to trip above 4amps. Motor is rated for 5.9 amps. PRV-3, with lower motor amperage rating, is wired to the higher rated contactor (8amps). Recommend swapping contactors so PRV-2 can be set to design airflow.

- **11/11/2022** National TAB - Michael McDonnell
  - E.C. swapped contactors and fan was sped to design airflow. No further action necessary.

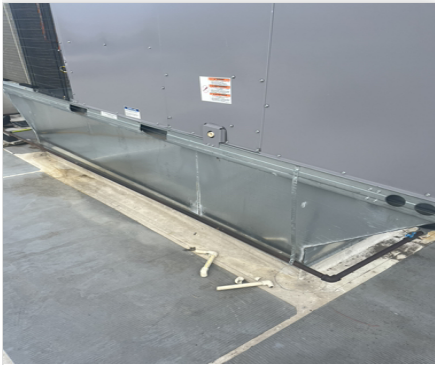
**Issue Name :** RESOLVED: RTU-2 Condensate drain not installed  
**Description :** Condensate drain was found damage and broken on roof. Recommend replacement.  
**Created By :** National TAB **Assigned To :** National TAB - Michael McDonnell  
**Status :** Closed  
**Originated Date :** 11/10/2022 - Michael McDonnell - National TAB
